2016+ Nissan Titan Radio Removal Nissan Connect Factory Radio Upgrade

Dash Disassembly

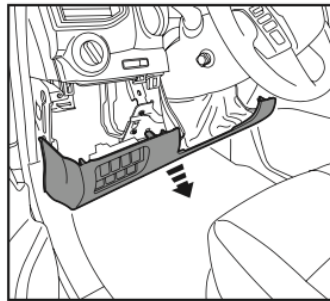
1. Remove the (2) Phillips screws securing the knee bolster panel below the steering column, and then unclip the panel. It is not necessary to completely remove the panel. (Figure A)
2. Unclip and remove the passenger door sill and kick panel. (Figure B)
3. Remove the (5) T-20 Torx screws securing the glove box and then remove. There are (2) screws below the glove box, and (3) screws exposed when you open the glove box. (Figures C and D)

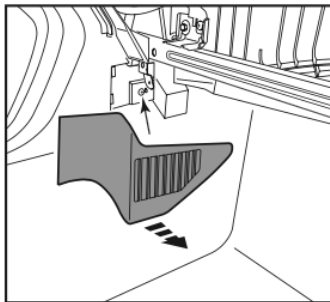
4. Unclip and remove the (2) side trim panels at the front of the center console, and then remove the (1) Phillips screw exposed behind each panel. *Tip: Pull out on the front sides of the console to release for later steps.* (Figure E)
5. Slide both of the front seats forward and then remove the (2) 12mm bolts from the rear sides of the center console. Slide the seat back once done. (Figure F)
6. Unclip and remove either the front console pocket or heated seat controls, depending on options available. (Figure G)

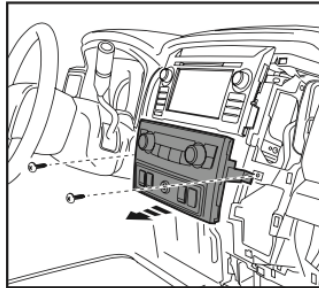
10. Remove the (2) Phillips screws securing the climate control panel and then remove. (Figure K)
11. Remove the (4) Phillips screws securing the radio and then remove. (Figure L)
12. Slightly loosen the (8) T-20 Torx screws securing the radio brackets. Remove the (2) T-20 Torx screws securing the "white" climate control module below the radio and then remove. This module will be reused in kit assembly. (Figure M)
