Izen Engineering External Customer Quality Control Report

Company: *****	Prepared by: Ben Izen
Part ID: *****	Date: 30/07/2023

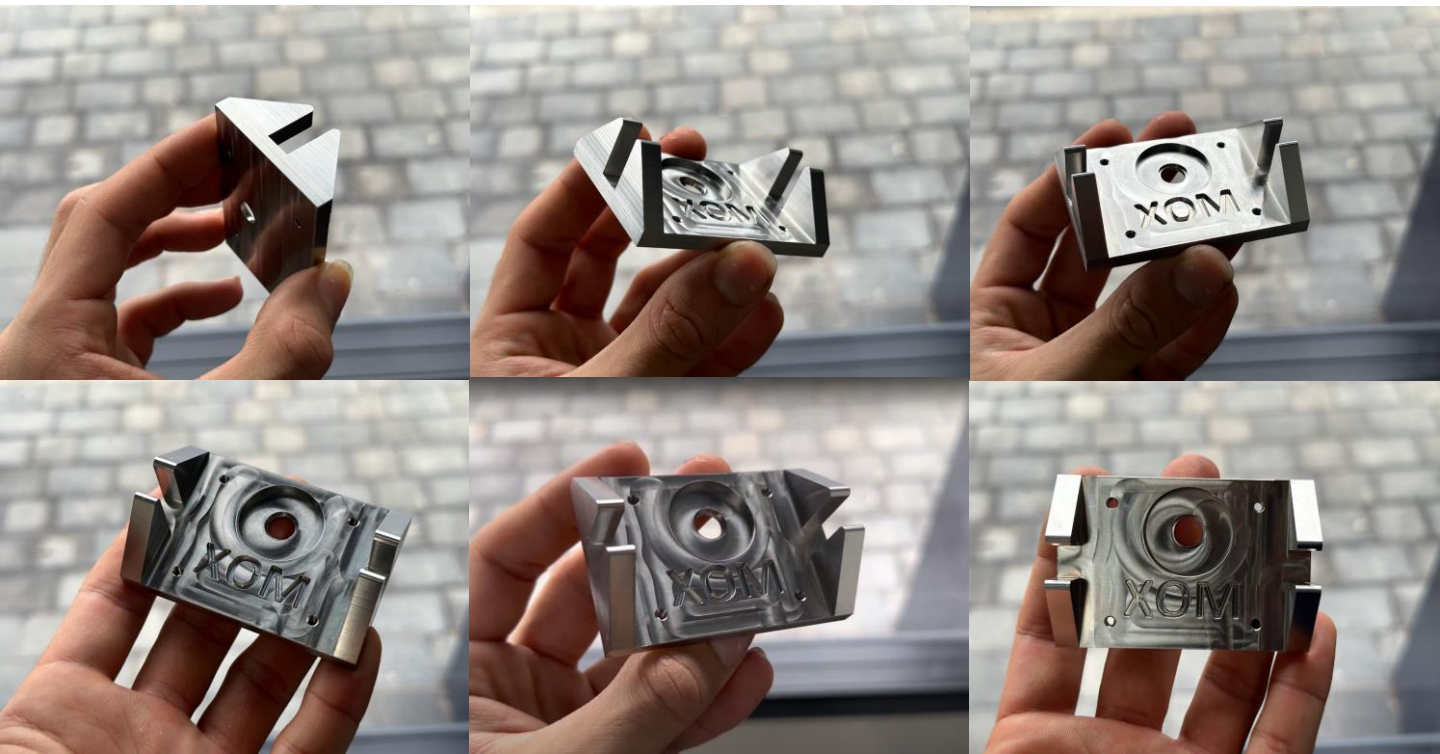
Criteria	Conclusion	Comment
Machining finish quality	70%	Minor crop circles on top and bottom face. Line on side wall. Lines on 45° face.
Scratches	Minor	Few minor scratches hardly visible
Dents	None	
Quantity	1	
General drawing compliance	Good	
Other
