Tech Tips:

GE185 – Speedo Pinion Housing

Solving the Gearbox Speedo Pinion Housing Oil Leak

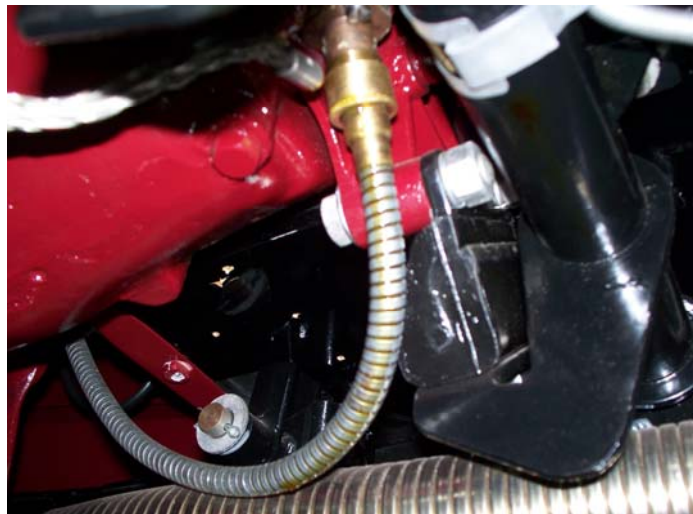
Now, where was the oil coming from? Rear axles, differential, engine, brakes, where....? What, the speedo cable!

How can this be?

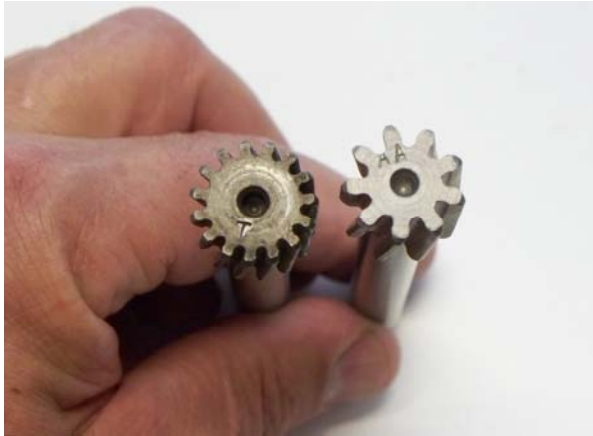
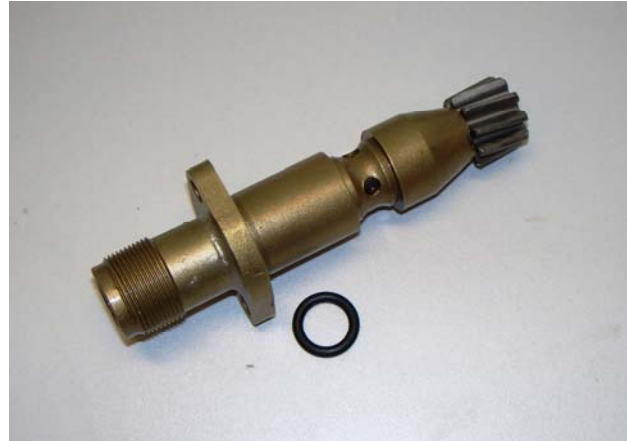
The problem lies within the speedo housing. The housing was machined to a close tolerance to accept the speedo pinion shaft and retard any leakage. In order to preclude any further leakage, the housing was also machined with a reverse scroll inside to draw the oil back into the gearbox as the shaft turned. The speedo pinion housing was also made of brass. Because of this, it is softer than the steel pinion shaft and has a tendency to wear quicker. The “reverse scroll” was a common engineering method for our cars and was used in other applications for the same purpose. Examples include the rear axle shaft oil return bushings or the reverse scrolls in the differential pinion cap. As we have now discovered, after 60 years, all of these housings / bushings have worn and the result is continuous “weepage”. So can the speedo pinion housing be replaced?

You may get lucky, but the housing is not a readily available replacement item. You might be able to salvage a better used housing from another model car as the housing itself is the same for all models. However, the pinion gears are different. The TC/TB pinion gear is distinguishable by having 9 teeth and is stamped "AA" on the end. The TD/TF pinion gear can be identified by having 15 teeth and are normally stamped "T" on the end of the gears. So check to make sure the gearing is correct for your car. But if the replacement housing still leaks what is left?

After months of different attempts to solving this problem, a permanent solution has been found, which is to modify an original pinion housing core to accept a modern O-ring, deep inside the housing core. These modified housings are now available from FTFU on an exchange basis to help those that are experiencing this habitual problem. This converted housing will work for the TB/TC/TD&TF. Installation is simply to remove the cable end cap and then the 2 retainer screws and reverse install the new housing with a little sealant around the flange.
