COVENTRY ROAD, MARTON

MAGMA CASE STUDY

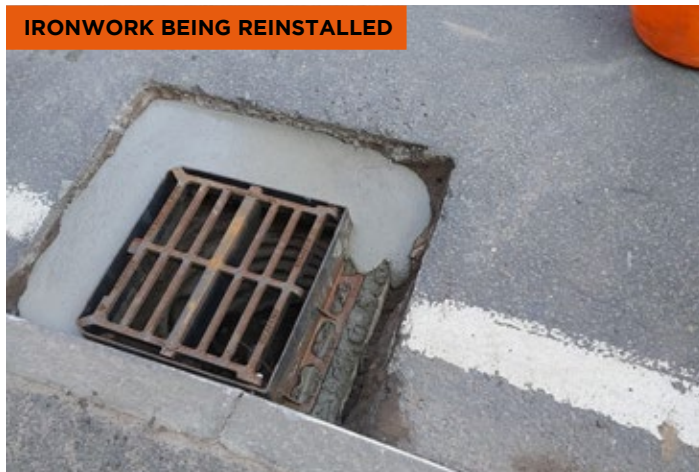
IRONWORK BEING REINSTALLED

Once the ironworks had been lifted, re-bedded, we were able to backfill with HardMaster W615 rapid set cementitious material with PermaFyx L271 MMA surfacing system on top and ThermaBand R171 to overband. We then used MagmaLine R110 to reinstate the white edge line. The 2 Balfour Beatty operatives on site (Simon & Nick) were very supportive and quickly picked up the concept, making for a well-finished job.

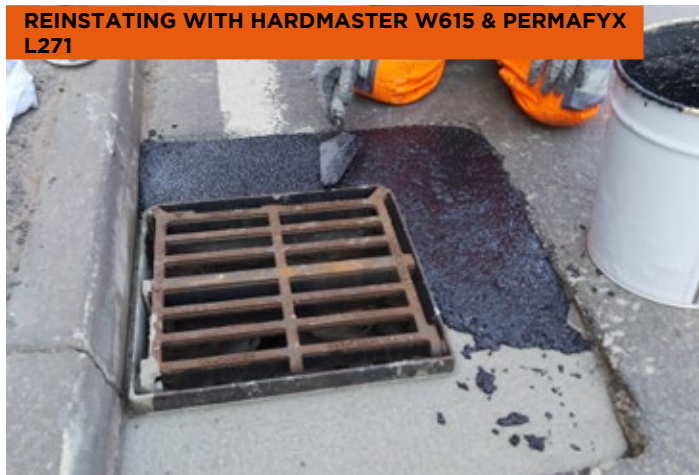
REINSTATING WITH HARDMASTER W615 & PERMAFYX L271

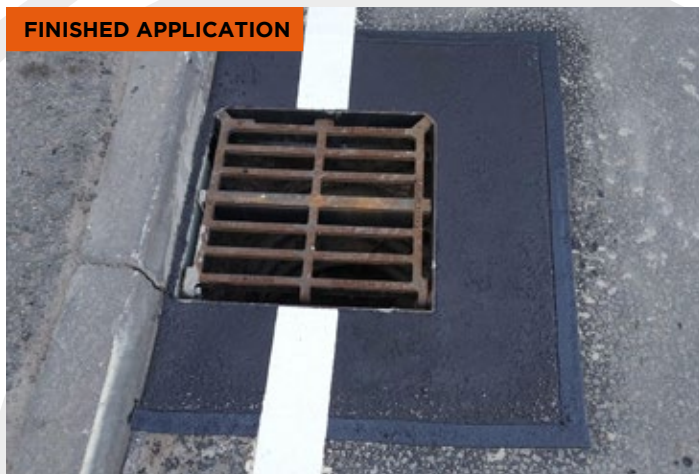
FINISHED APPLICATION
