# PERMAFYX L272 CASE STUDY

## TFL HYDROBLAST SCARRING REPAIR

TfL, Blackfairs Road, London, SE1 8BF

Applied on 19<sup>th</sup> February 2020

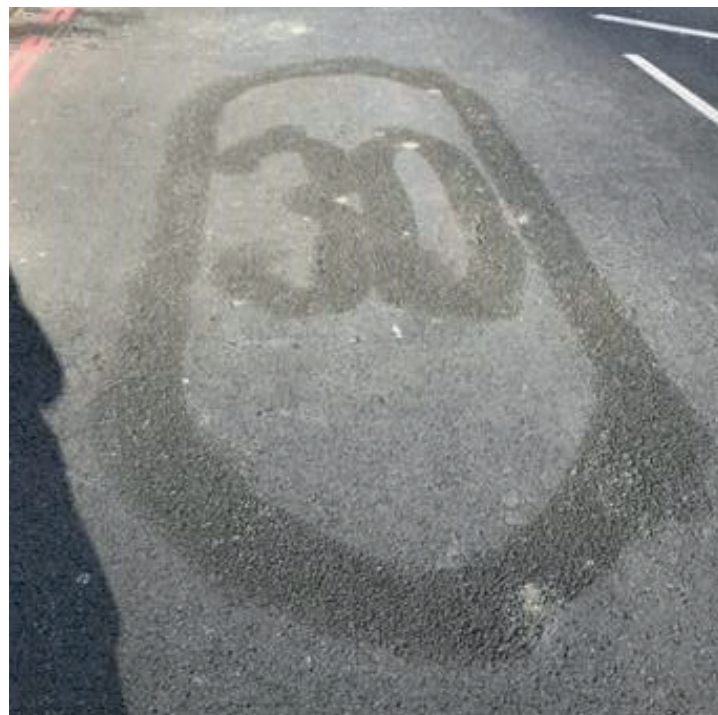
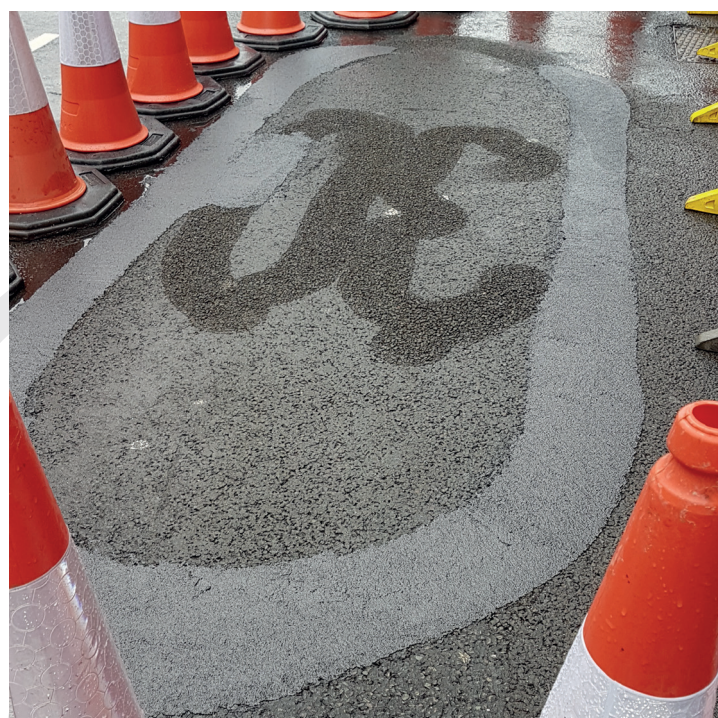
During construction works, a temporary 30MPH roundel had been installed onto a new asphalt surface adjacent to the office building used by Transport for London highways engineers. The thermoplastic roundel was subsequently removed using hydroblasting technology, which resulted in damage to the surface texture. The TfL team identified the need to apply something across the exposed aggregates, and approached Meon for their recommendations.

The Meon technical team concluded this was a scenario that could be addressed using the PermaFyx L272 system. The system was mixed with bauxite aggregate to help bulk it out and increase the SRV rating of the finished surface. Application was satisfactorily completed on a dried surface without any masking requirement, minimal traffic management and virtually zero carbon emissions.

PermaFyx L272 MMA Surface Repair with 0.9-1.4mm aggregate.
