Test Report

Durability confirmation of a magnetic lightbar for highspeed and braking tests.

Type : Mega-Flash 360 Lightbar

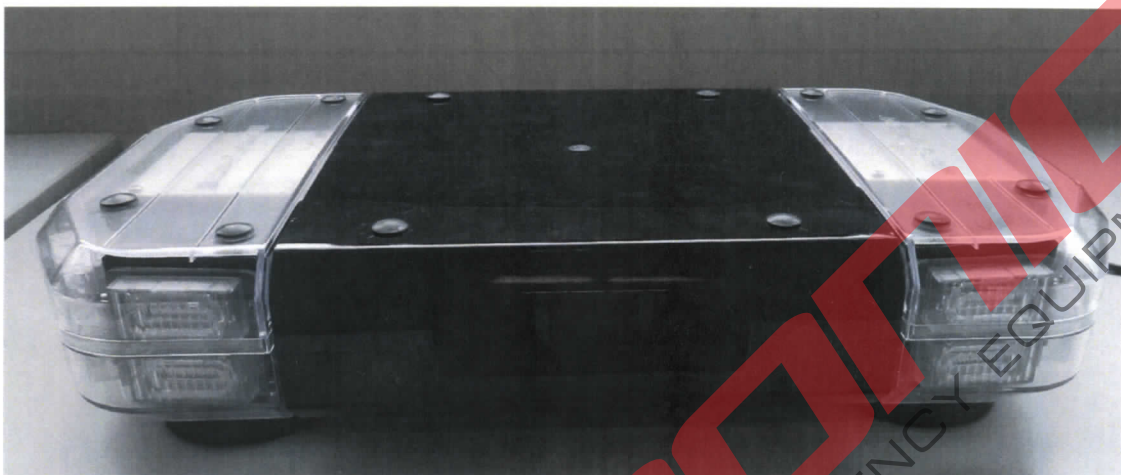
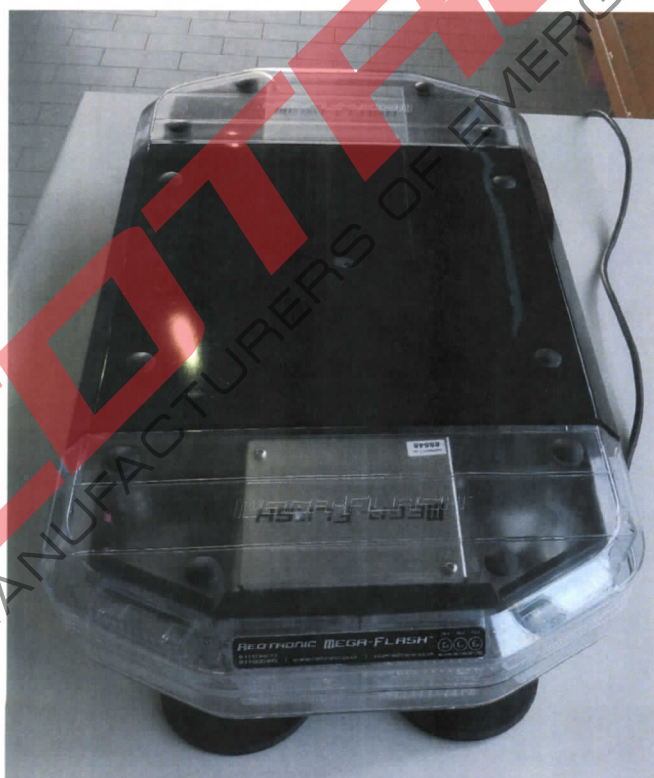
Mega-Flash 360 Lightbar (front view, side view)

Dimensions

Length : 545 mm

Width : 305 mm

Hight : 120 mm

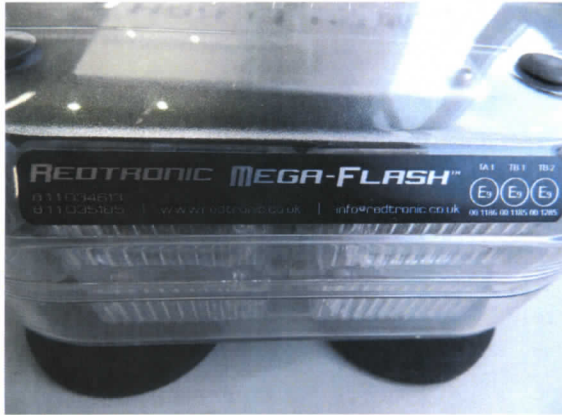
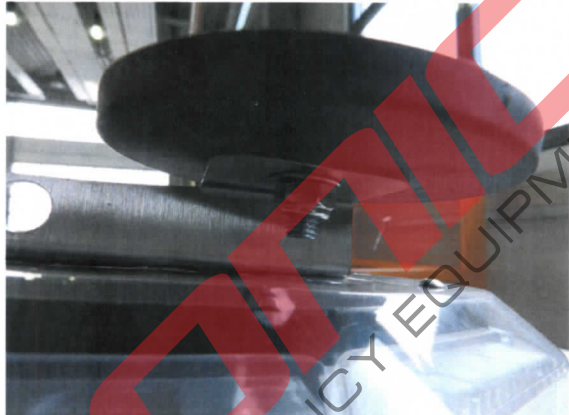
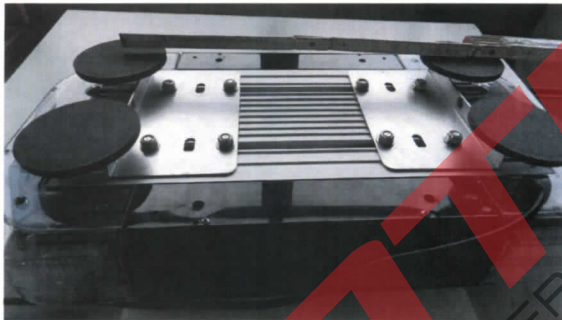
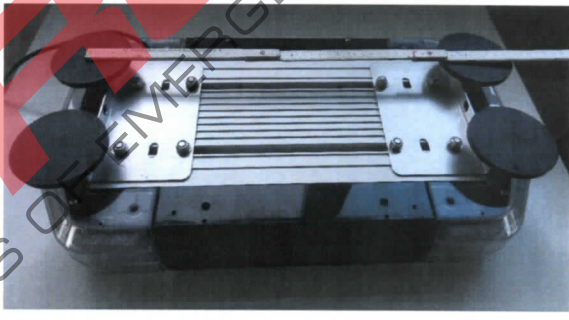
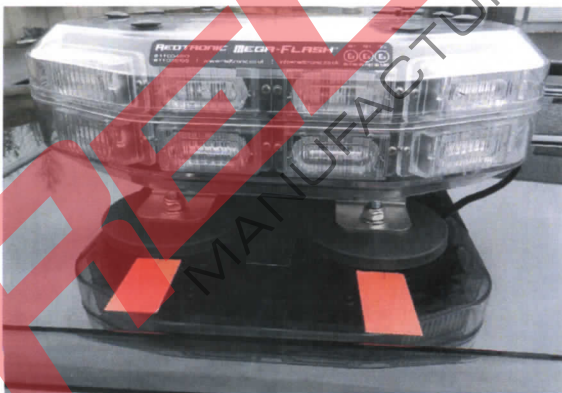
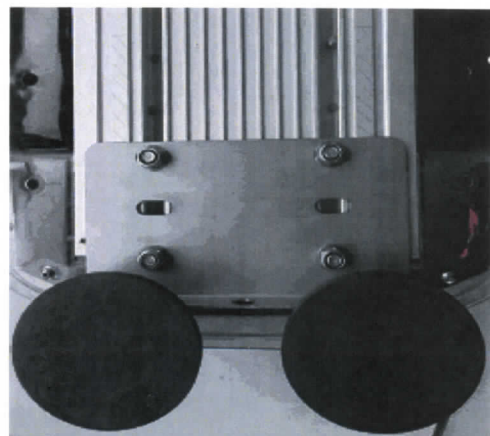
Details

Number of magnetic foots : 4
Diameter magnetic foots : 87 mm
Height magentic foots : 8 mm
Remark : A double tilted steel (wall thickness 2mm) is fixed below the lightbar with 4 self locking nuts. Two of this parts are fixed, therefore is the lateral distance adjustable. On each of this parts are two magnetic foots fixed mounted. The foots are not movable, but because of the construction and strong magnetic force, are small movements possible.

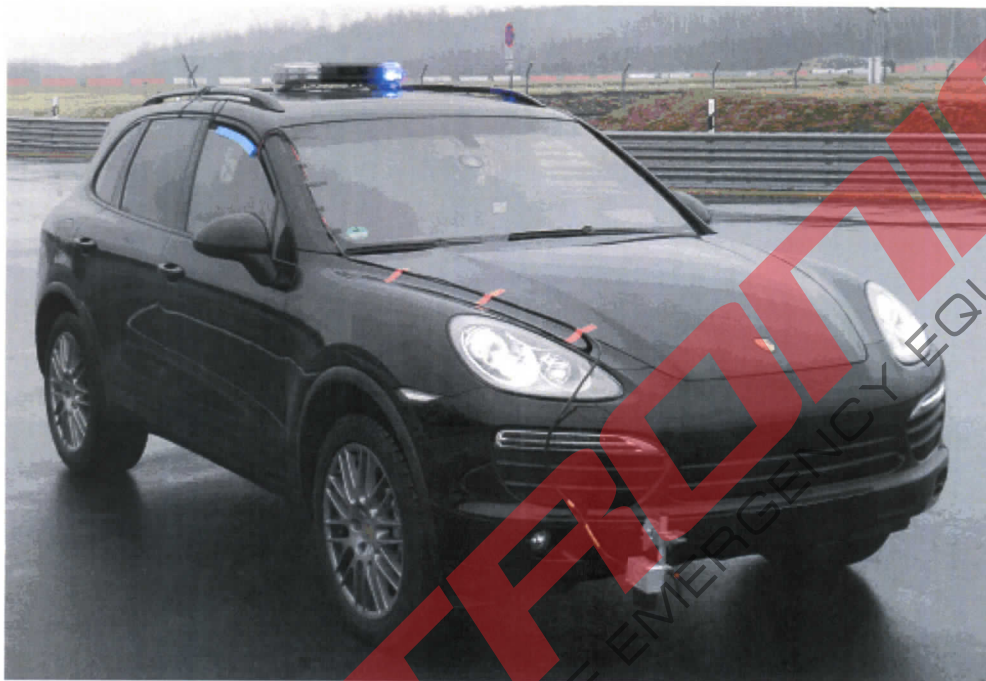
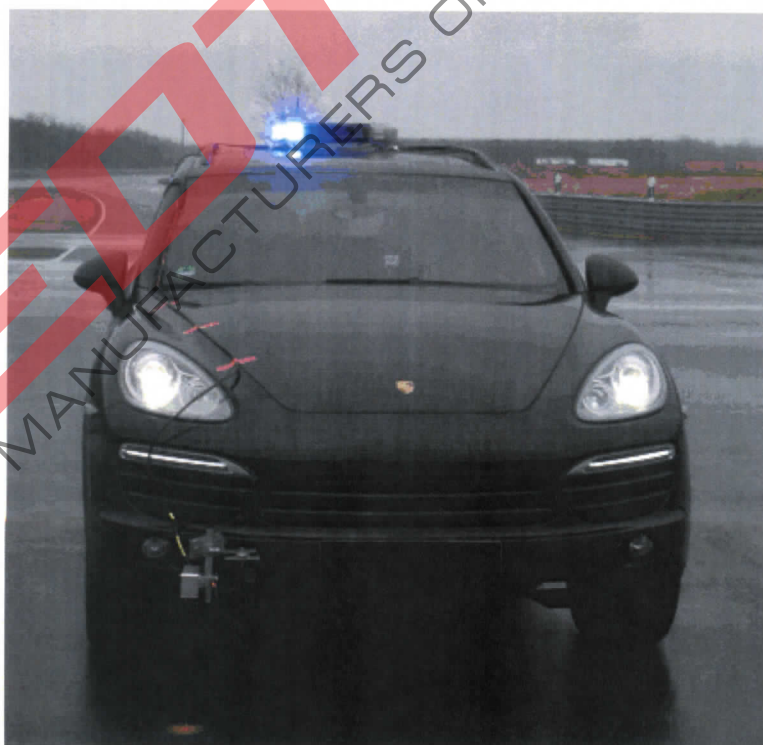
Test Vehicle

1.1.1 Name of manufacturer : Porsche
1.1.2 Type : 92A
1.1.3 Trade name : Cayenne S
1.1.4 Vehicle class : M1G
1.1.4 Engine power : 294 kW / 6500 min⁻¹

The Redtronic lightbar type "Mega-Flash 360 lightbar" was mounted at a dry and clean roof of the test vehicle. Easy installation with magnetic foots. Afterwards was checked if all four foots are in contact with the roof. Further the lightbar was secured by a strap on each side. This was made just for safety reasons, the strap was not tighten! For checking any movements of the lightbar at the roof, there made some stripes next to the magnetic foots.

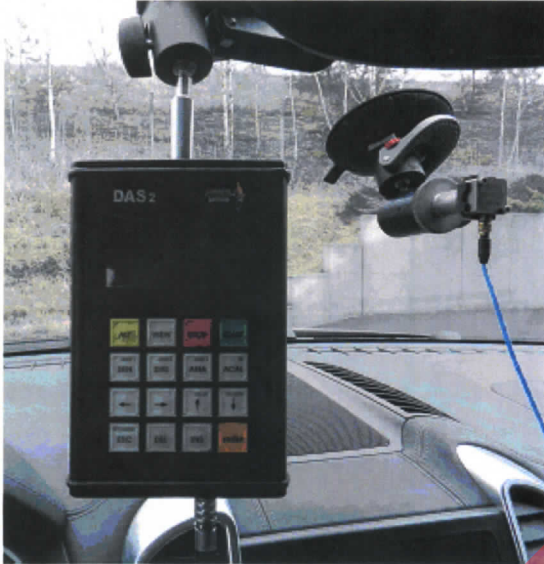
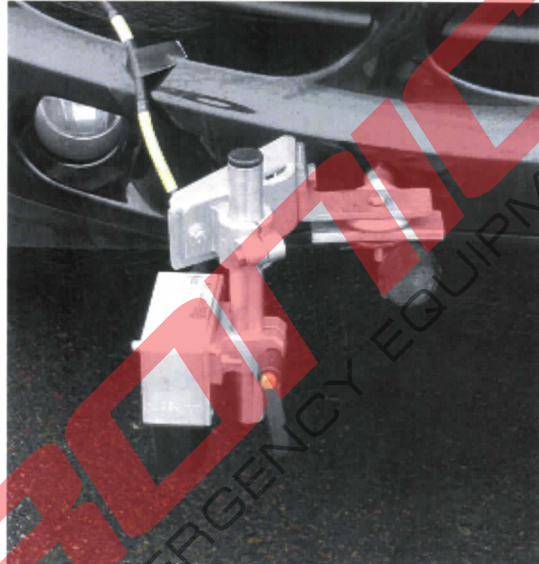
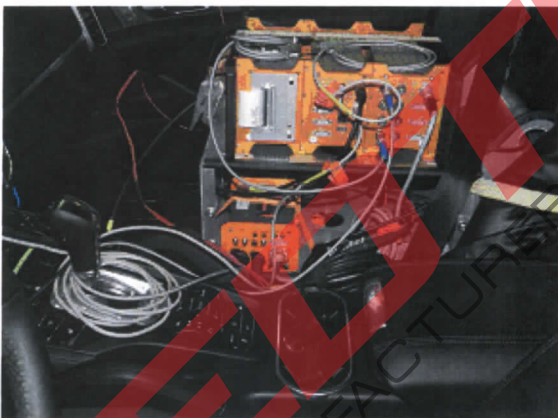
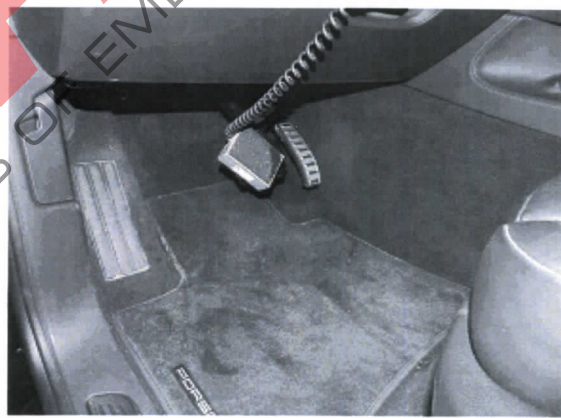
1.2 Measuring and testing equipment : Measuring and evaluation system
Speed sensor
Footpedal sensor
DecelARATION sensor
Scale
Measuring tape
