REDTRONIC IP69K

Certificate No: RED-202201

TEST CERTIFICATE

Company : Redtronic Ltd
Address : Unit 1-9, Wellington Business Park, Quebec Street, Elland, HX5 9BX,
United Kingdom
Sample Name : Tornado Microbar
Date Tested : 3rd February 2022

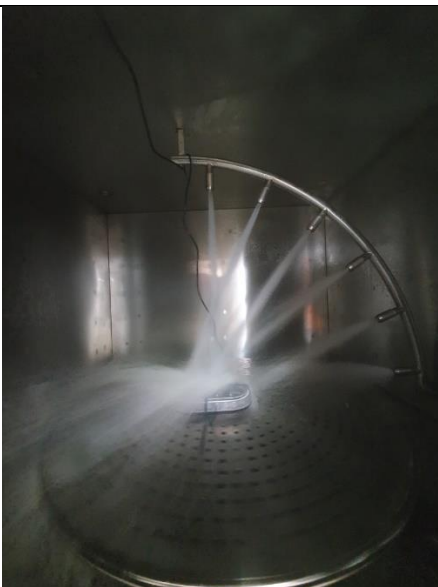
SETUP

Distance of the Nozzle to the specimen:	100 to 150mm
Water flow rate:	15l / min
Water pressure:	100 bar
Water temperature:	80°C
Speed test table:	5 U / min
Spray angle:	0°, 30°, 60°, 90°
Number of cycles:	1
Test Conditions:	The specimen is not in electrical operation.

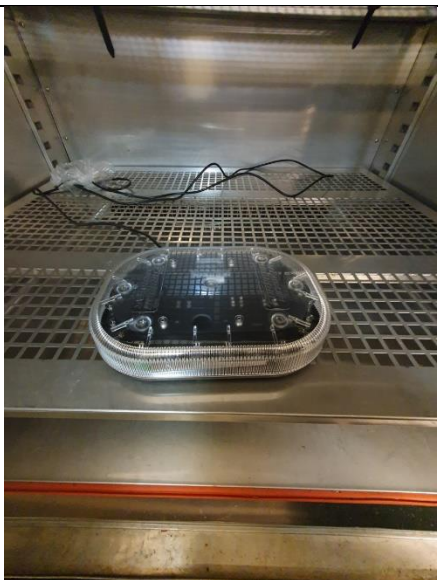
AFTER TESTING

After testing, visual inspection showed no water permeated into the unit.

Comments: Device passed IPX9K test with no negative reaction. The microbar worked both at beginning of test cycle, during and after test cycle complete.

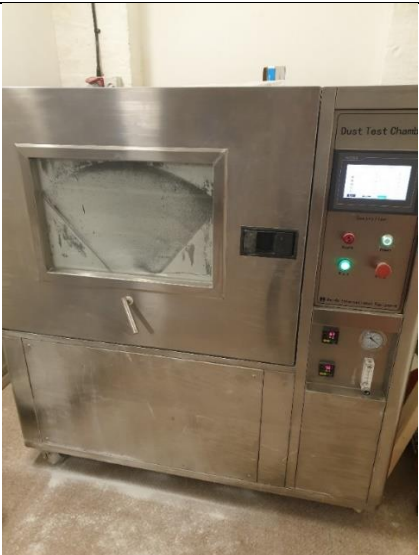
SETUP

After testing, visual inspection showed no dust particle permeated into the unit.

AFTER TESTING	
Comments: Device passed IP6X test with no negative reaction. The Microbar worked both at the beginning of the test cycle and after the test was complete. There was no ingress of dust within the Microbar enclosure.	
Conclusion: Device passed IP69K test with no negative ingress effects.

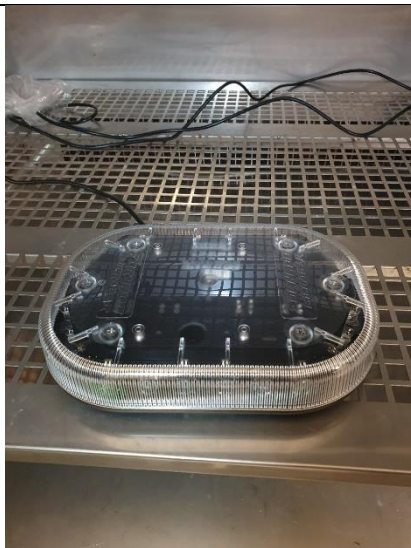
SETUP

Section of test:	Parameters:
Preconditioning	$55^{\circ}\text{C} \pm 2\text{ K}$ 20% RH for 24h
Initial measurements	Visual Inspection of specimen
Conditioning	$\pm 2\text{ K}$ tolerance
Test cycle	$25^{\circ}\text{C} \pm 2\text{ K}$ 93 $\pm 3\%$ RH at start of test then follow BS EN 60068-2

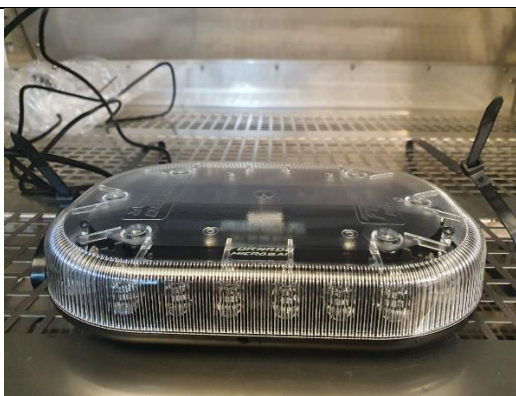
AFTER TESTING

After testing, visual inspection showed no water permeated into the unit. And no effect had been caused by the heat cycle.

Comments: Device passed test with no negative reaction. The Microbar worked both at beginning of test cycle and after the test was complete.
