REDTRONIC ENVIRONMENTAL TEST CERTIFICATE

Company : Redtronic Ltd
Address : Unit 1-9, Wellington Business Park, Quebec Street, Elland, HX5 9BX,
United Kingdom
Sample Name : Tornado X Duo XT2M-047-BBL42
Date Tested : 19/12/23

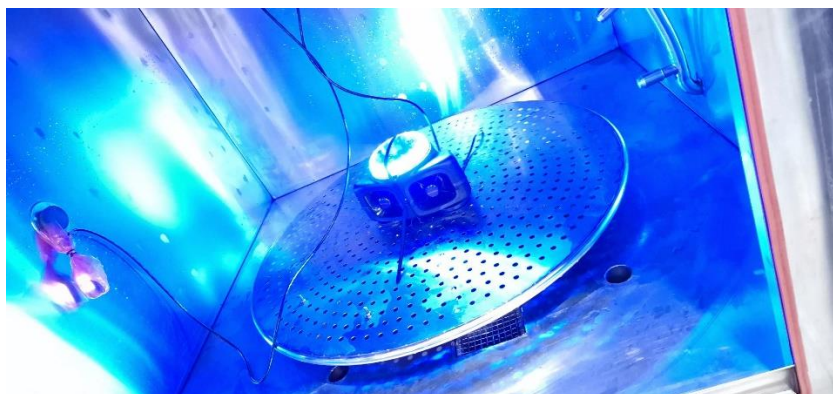
SETUP

Distance of the Nozzle to the specimen:	100 to 150mm
Water flow rate:	15l / min
Water pressure:	100 bar
Water temperature:	80°C
Speed test table:	5 U / min
Spray angle:	0°, 30°, 60°, 90°
Number of cycles:	1
Test Conditions:	The specimen is periodically in electrical operation.

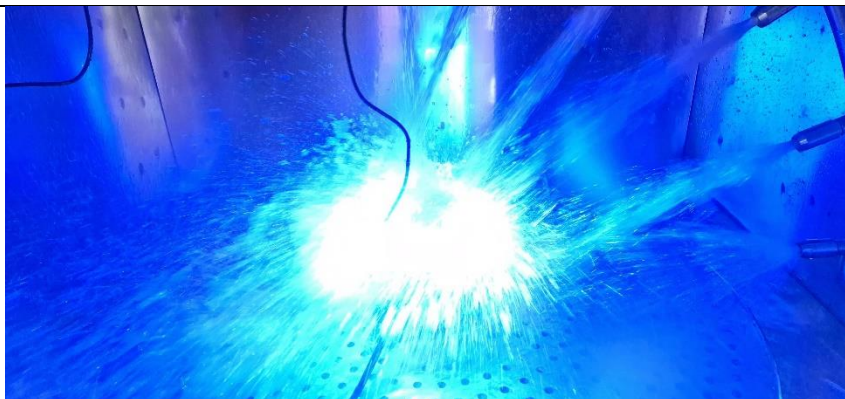
AFTER TESTING

Comments: The test caused no negative reaction. Lamp worked both at beginning of test cycle, during and after test cycle complete.

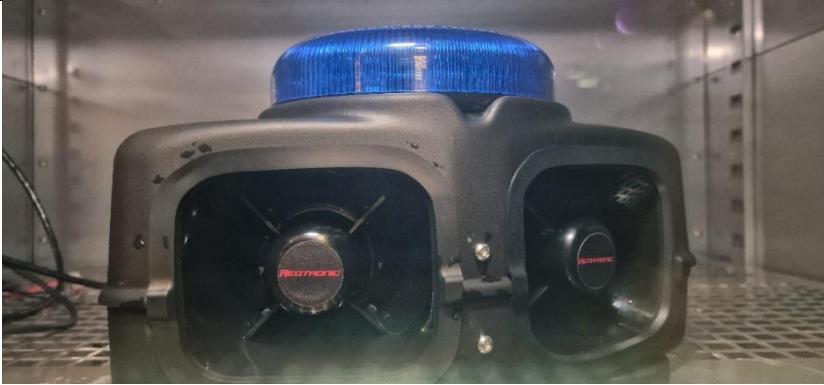
SETUP

Section of test:	Parameters:
Preconditioning	$55^{\circ}\text{C} \pm 2\text{ K}$ 20% RH for 24h
Initial measurements	Visual Inspection of specimen
Conditioning	$\pm 2\text{K}$ tolerance
Test cycle	$25^{\circ}\text{C} \pm 2\text{K}$ 93 $\pm 3\%$ RH at start of test the follow BS EN 60068-2

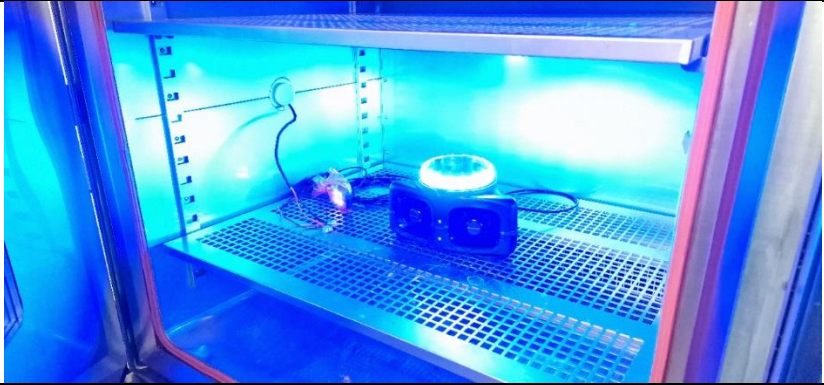
AFTER TESTING

After testing, A visual inspection showed only slight condensation build up due to the cold temp of the plastics which cleared naturally once the unit was beginning to warm back up to room temperature.

<p>Comments: Device passed test with no negative reaction. The unit worked both at beginning of test cycle and after testing was complete. A periodic function test was run during the testing procedure.</p>	
<p>Conclusion: The test ended with no negative effects.</p>
