IST SPORTS CORP.

O40 2<sup>ND</sup> STAGE / OCTOPUS

IST O-40  
Octopus

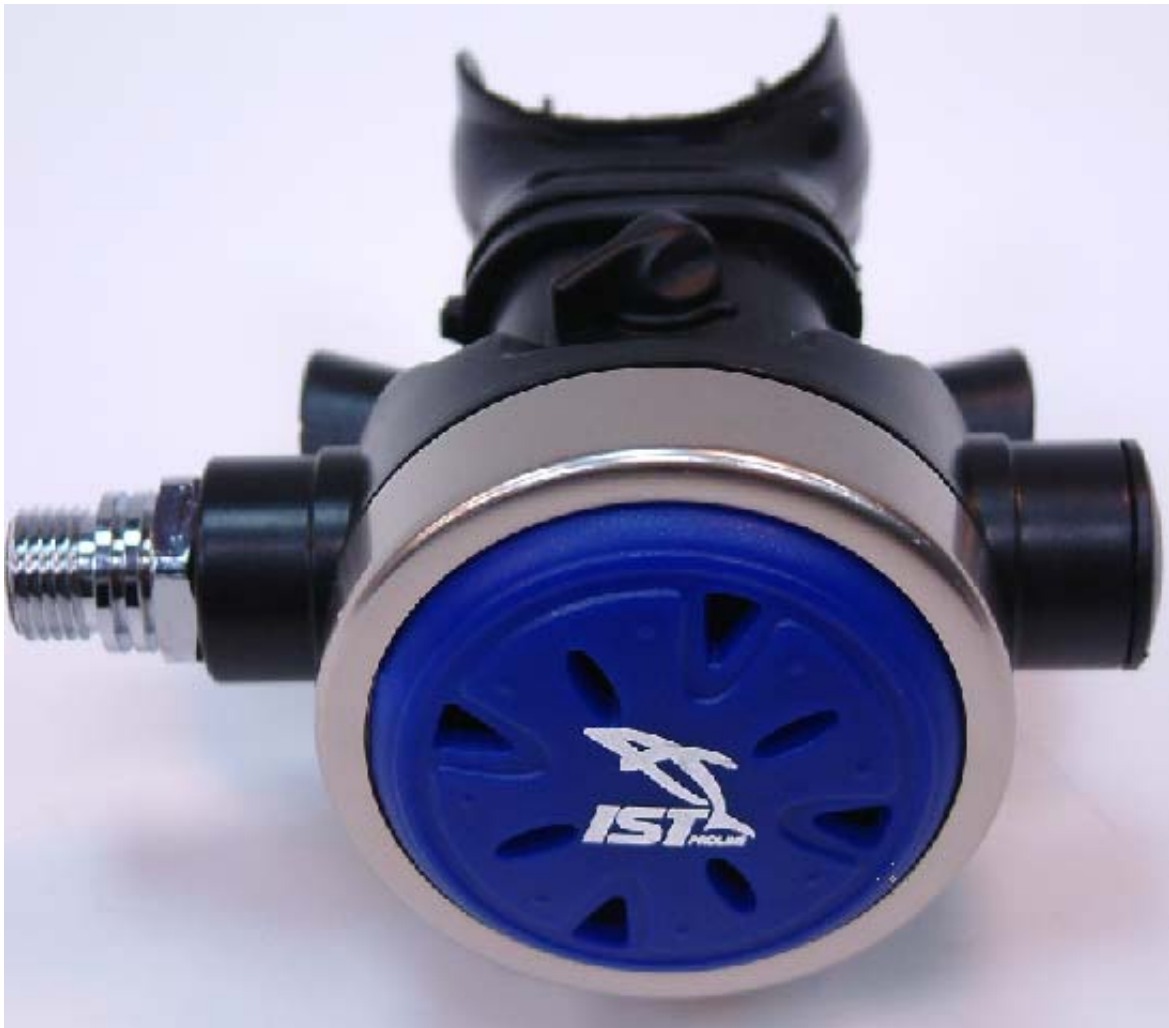
1	A-02-010-08	Side plug	14	C-02-010-04	Washer (thin)
2	O-AS568-015	O-ring	15	C-02-010-03	Brass valve housing
3	A-02-010-01	Main housing	16	B-02-010-01	Diaphragm
4	D-02-010-01	Spring	17	A-02-010-10	Diaphragm washer
5	C-02-010-02	Poppet	18	A-02-010-04	Bezel
6	A-02-010-07	LP seat	19	A-02-010-05	Purge cover
7	O-AS568-010	O-ring	20	P-02-010-02	Deflector cir-clip
8	A-02-010-08	Orifice	21	O-As568-010	O-ring
9	O-AS568-015	O-ring	22	A-02-010-09	Deflector knob
10	C-02-010-01	Orifice seat screw	23	A-02-010-02	Exhaust valve
11	C-02-010-06	Nut screw	24	A-02-010-03	Exhaust cover
12	C-02-010-05	Washer (thick)	25	A-02-010-12	Zip tie
13	S-02-010-01	Lever

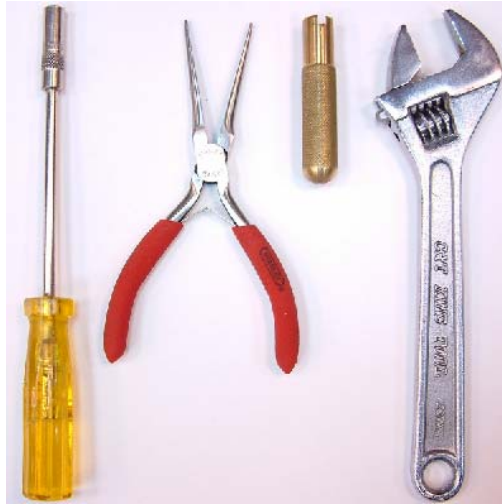
1. The tools shown above are the ones needed to perform the servicing operation of the O40 2<sup>nd</sup> stage / octopus: 6mm socket (with screw driver type handle), a pair of pliers, 4-slot 2<sup>nd</sup> stage tool and an adjustable spanner. If a certain tool(s) is difficult to obtain, appropriate improvisation can be considered, as long as there is no extraneous / unusual stress to cause damage to the 2<sup>nd</sup> stage.

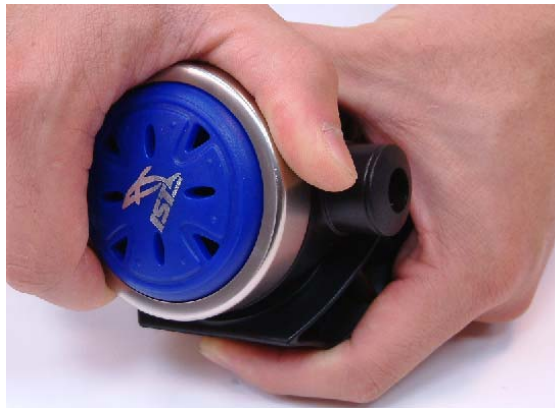
2. To remove, firstly, rotate counter-clock wise to remove the metal bezel (part 18) and purge cover (part 19).

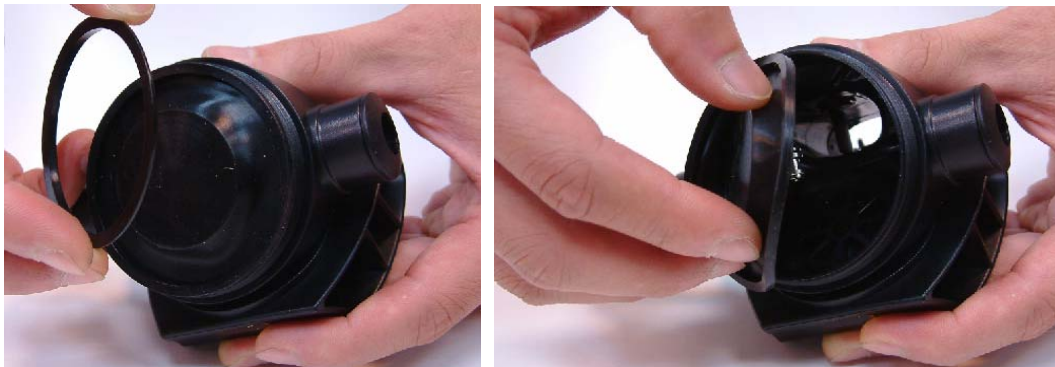
3. Remove the diaphragm washer (part 17) and then the diaphragm (part 16).

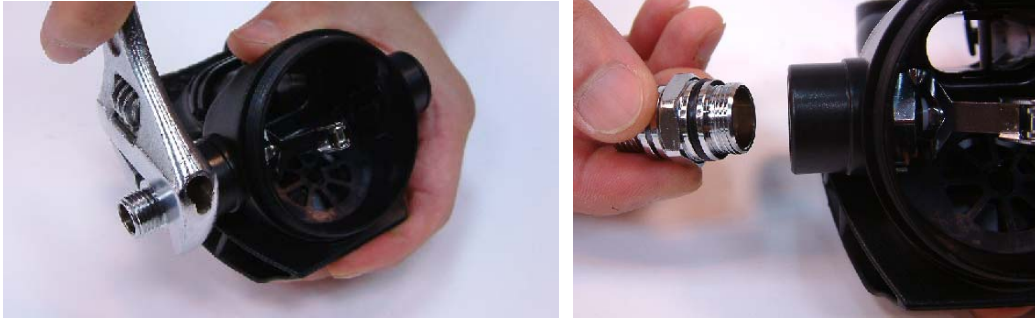
4. Use the adjustable spanner to loosen and remove the orifice seat screw (part 10).

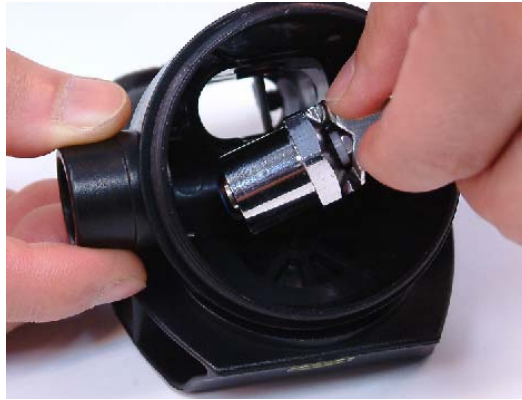
5. Take the lever and brass valve housing (containing part 4~6, 11~15) out of the main housing (part 3)

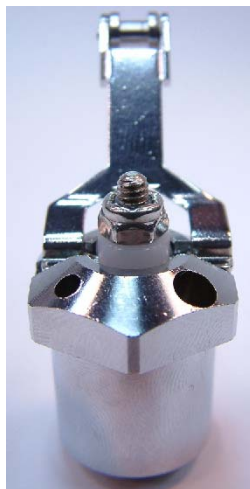
6. Count the number of threads of the poppet (part 5) that is exposed and use this information for reassembling.

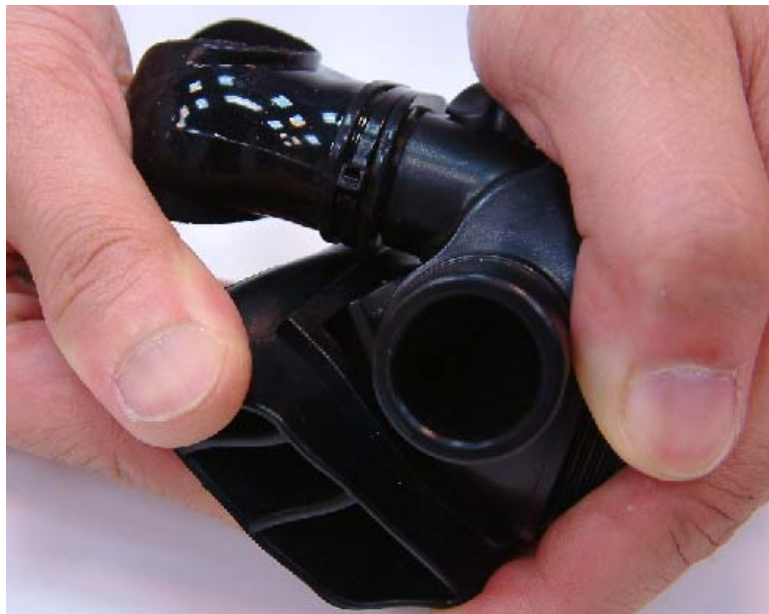
8. Should there be a need to remove the exhaust cover (part 24) for inspection / servicing of the exhaust valve (part 23), soak it in hot water until the material softens, then simply peel it away from the main housing (part 3).

To remove the exhaust valve, simply pull it off.

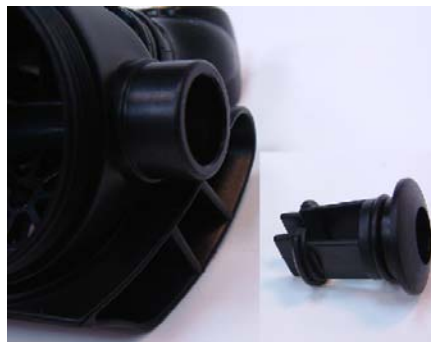
10. The side plug (part 1) can be removed simply by squeezing its two arms together.
11. Should it be necessary to replace the mouthpiece, simply cut off the zip tie (part 25) so the mouthpiece can be removed. Use a new zip tie after the replacement mouthpiece is in situ.
