INSTRUCTIONS for 2003-2011 FORD CROWN VICTORIA narrowed front control arms

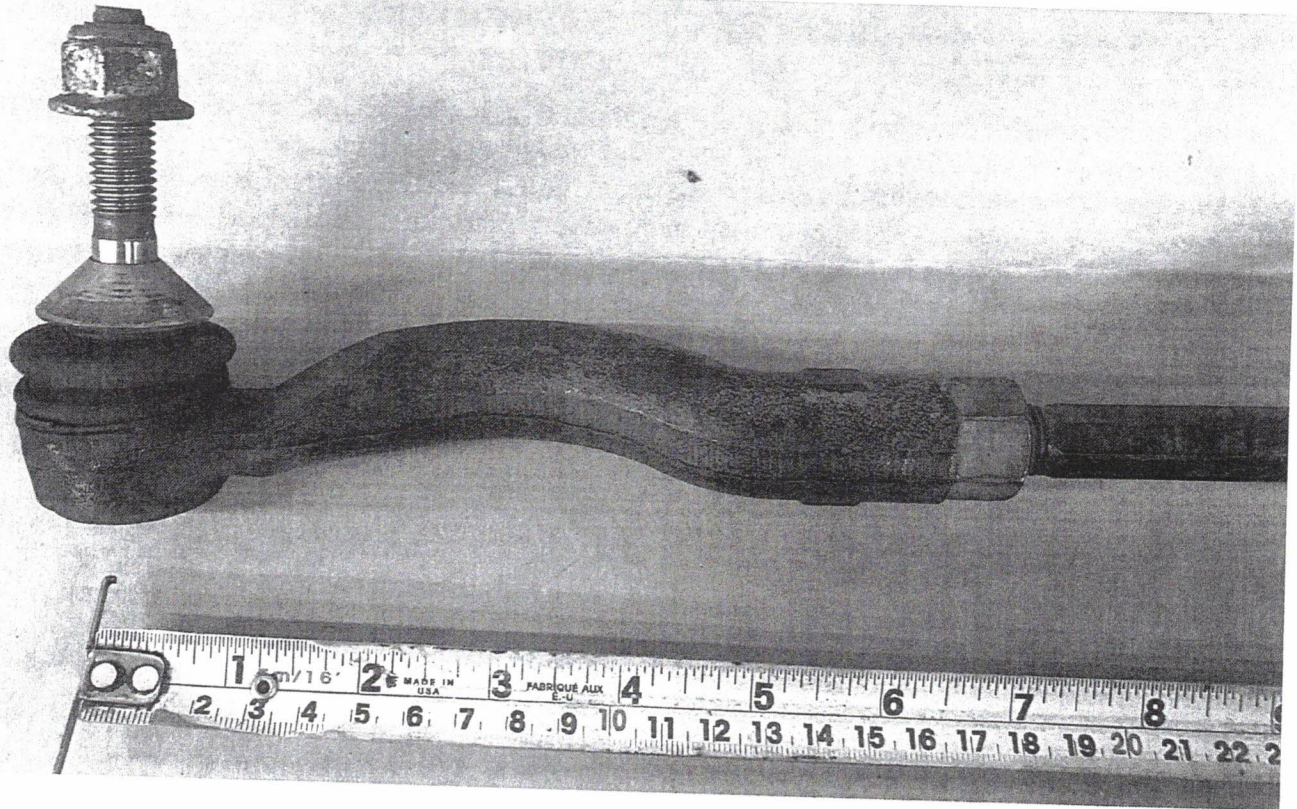
- 1) To prepare to install these arms, remove the original arms along with the coilover shock/spring package and the steering gear. To allow for the narrowed arms to work with the original rack and pinion steering we will be shortening the outer and inner tie rods per the photo below. Removing $\frac{3}{4}$ " from each allows the shorter length needed while maintaining plenty of thread engagement. It is helpful to measure the tie rod length prior to the cutting, and then roughly set the adjustment 1" shorter.
