Reliability Test Report

Report No.: SH-HS-ETR-2108002

<u>Sample Name</u>	: RBDM "Brick" Antennas		
<u>Sample Quantity</u>	: 10Pcs		
<u>Date Submitted</u>	: 2021.08.03		
<u>Test Period</u>	: 2021.08.03~2021.08.18		
<u>Test Request</u>	Test Conditions	Serial #	Qty
	1. Operating Temperature	4-6#	3Pcs
	2. Storage Temperature	7-9#	2Pcs
	3. Temperature Shock	10-12#	2Pcs
	4. Humidity	1-3#	3Pcs
<u>Test Method</u>	: RFMAX Standard		
	: Customer Request		√
<u>Test Result</u>	: Please refer to next page.		Pass
<u>Conclusion</u>	NA		
<u>Suggestion</u>	NA

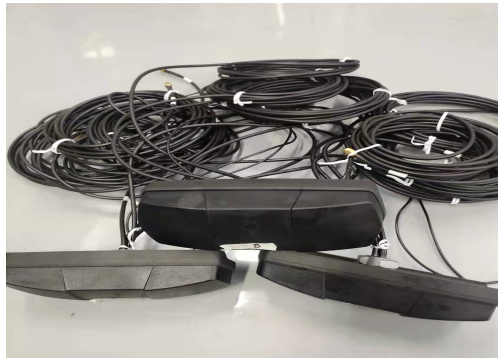
Fig.1: Appearance photos of the samples before test.

<u>Sample Name</u>	: RBDM "Brick" Antennas	
<u>Sample No.</u>	: 3Pcs	
<u>Test Ambient</u>	: Temperature: 24.0°C	
	: Humidity:45%RH	
<u>Sample Reception</u>	: Fig.1	
<u>Test Condition Setup</u>	'-40/+85 °C 1.Room Temperature to -40 degrees (2hours) 2.Storage for 2 hours at -40 degrees 3.-40 degrees to 85 degrees (2hours) 4.Storage for 2 hours at 85 degrees 5.85 degrees to -40 degrees (2hours) 6.Repeat from 2 to 5 for 5 times 7.-40 degrees increase to room temperature within 2 hours (Total 44 Hrs)	
<u>Test Process</u>	: Fig.2	
<u>Photos After Test</u>	: Fig.3	
<u>Test Result</u>	: Visual and RF test are ok before and after reliability testing.	
<u>Final Result</u>	: OK	√
	: NG	
<u>Confirmed by</u>	: Li xiaolu

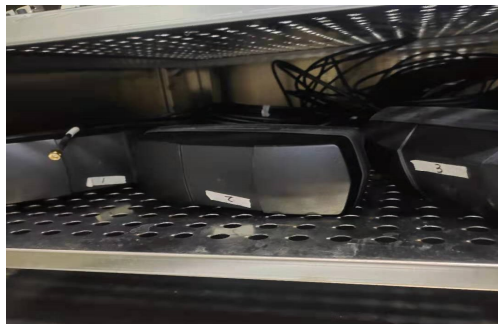
Fig.2: Photo of samples in test process.

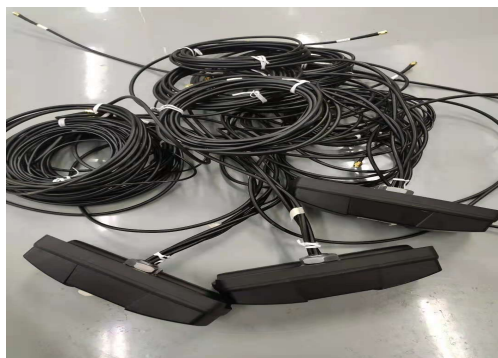
Fig.3: Appearance photos of the samples after test.

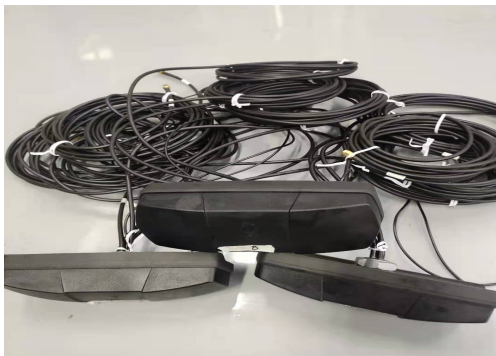
Fig.1: Appearance photos of the samples before test.

<u>Sample Name</u>	: RBDM "Brick" Antennas	
<u>Sample No.</u>	: 2Pcs	
<u>Test Ambient</u>	: Temperature: 24.0°C	
	: Humidity:45%RH	
<u>Sample Reception</u>	: Fig.1	
<u>Test Condition Setup</u>	'-40° to +85° C MIL-STD 810G Method 501.5 (high) Method 502.5 (low) 1.Room Temperature to -40 degrees within 2 hours 2.Storage for 24 hours at -40 degrees; 3.-40 degrees room temperature within 2 hours 4.Room Temperature to 85 degrees within 2 hours 5.Storage for 24 hours at 85 degrees; 6.85 degrees room temperature within 2 hours (Total 56 Hrs)	
<u>Test Process</u>	: Fig.2	
<u>Photos After Test</u>	: Fig.3	
<u>Test Result</u>	:Visual and RF test are ok before and after reliability testing.	
<u>Final Result</u>	: OK	√
	: NG	
<u>Confirmed by</u>	: Li xiaolu

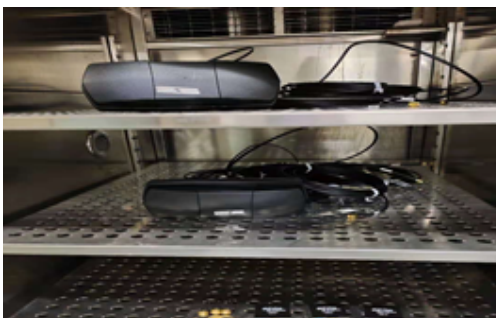
Fig.2: Photo of samples in test process.

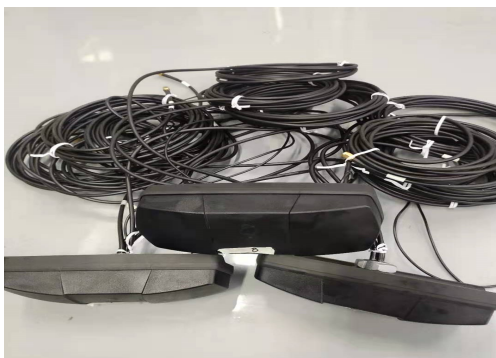
Fig.1: Appearance photos of the samples before test.

<u>Sample Name</u>	: RBDM "Brick" Antennas	
<u>Sample No.</u>	: 2Pcs	
<u>Test Ambient</u>	: Temperature: 24.0°C	
	: Humidity:45%RH	
<u>Sample Reception</u>	: Fig.1	
<u>Test Condition Setup</u>	'-40C for 1 hr to +85 C for 1 hr @ 15 deg.C/min rate of change; 3 cycles. MIL-STD 810G Method 503.5 (Total: 7 Hrs)	
<u>Test Process</u>	: Fig.2	
<u>Photos After Test</u>	: Fig.3	
<u>Test Result</u>	: Visual and RF test are ok before and after reliability testing.	
<u>Final Result</u>	: OK	√
	: NG	
<u>Confirmed by</u>	: Li xiaolu

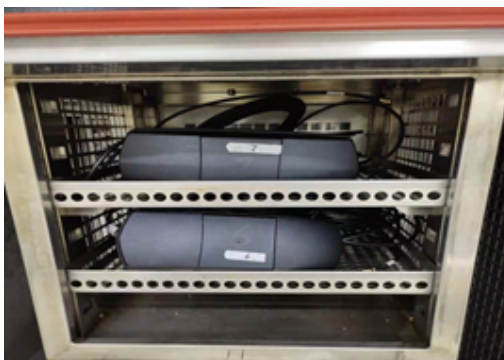
Fig.2: Photo of samples in test process.

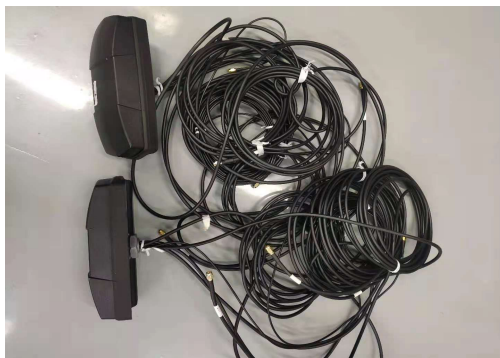
Fig.3: Appearance photos of the samples after test.

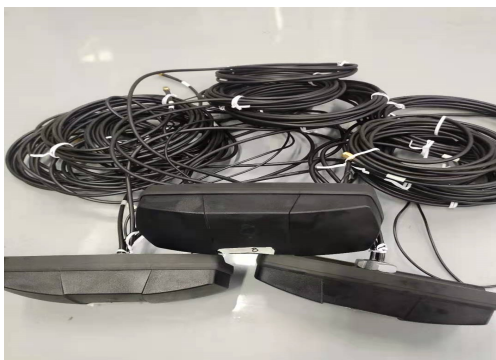
Fig.1: Appearance photos of the samples before test.

<u>Sample Name</u>	: RBDM "Brick" Antennas	
<u>Sample No.</u>	: 3Pcs	
<u>Test Ambient</u>	: Temperature: 24.0°C	
	: Humidity:45%RH	
<u>Sample Reception</u>	: Fig.1	
<u>Test Condition Setup</u>	'+30° @ 93% RH per IEC 68-2-56 mth Cb or MIL-STD 810G Method 507.5 +93% RH @ +30°C for 12 h and 55°C for 12h. in 6 cycles (= 6 days)	
<u>Test Process</u>	: Fig.2	
<u>Photos After Test</u>	: Fig.3	
<u>Test Result</u>	: Visual and RF test are ok before and after reliability testing.	
<u>Final Result</u>	: OK	√
	: NG

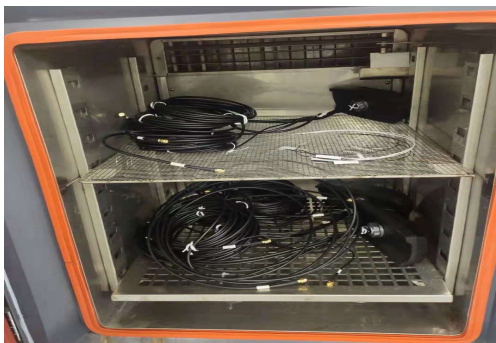
Fig.2: Photo of samples in test process.

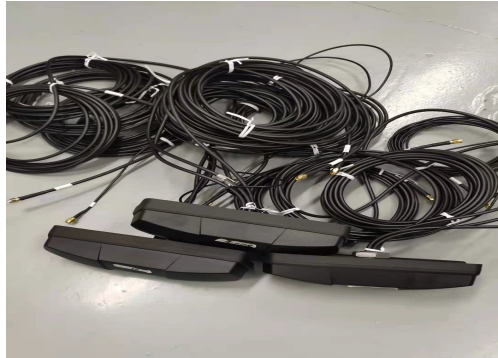
Fig.3: Appearance photos of the samples after test.
