TEST REPORT

Client: RFMAX
Address of client: 825 Bloomfield Ave, Verona, NJ 07044
Name of sample: Antenna
Model of sample: RBDM-G55WW-17-SSSRR-B
Number of samples: 2 pcs
Date for received: 2023/09/18
Test name: Change of temperature test、Vibration test
Date for test: 2023/09/18~2023/09/21

4. Test items

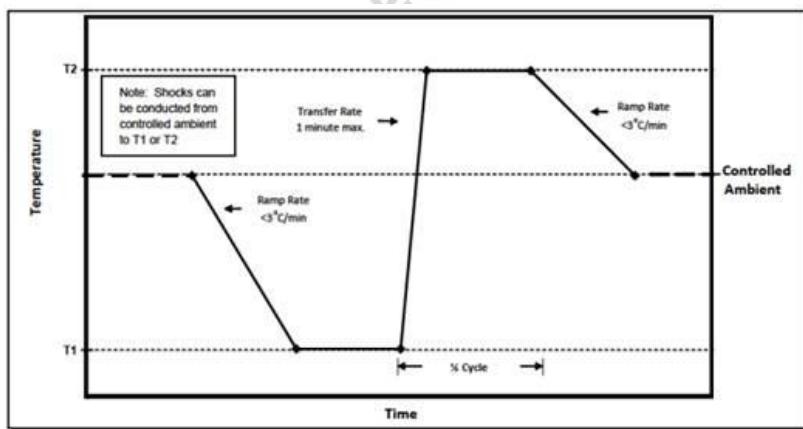
Figure 503.7-1. Single Shocks (1/2 cycle).

Low temperature	High temperature	Dwell time	Temperature change rate	Number of cycles
-40°C	85°C	60min	2°C/min	10

Test 1cycle time:32min+60min+63min+60min+31min=246min

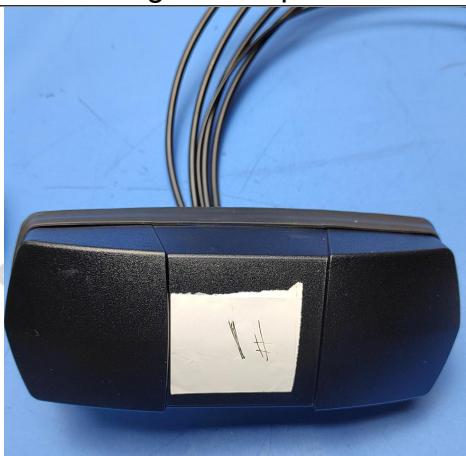
SN:1#

Photo after Change of temperature test

Test item:	Name of sample:	Model of sample:	SN:	Description of test results:
Change of temperature test	Antenna	RBDM-G55WW-17-SSSRR-B	1#~2#	--After testing, the appearance of the sample showed no significant changes, cracking, or deformation. -After the test, the sample function was checked to be normal.
Vibration test

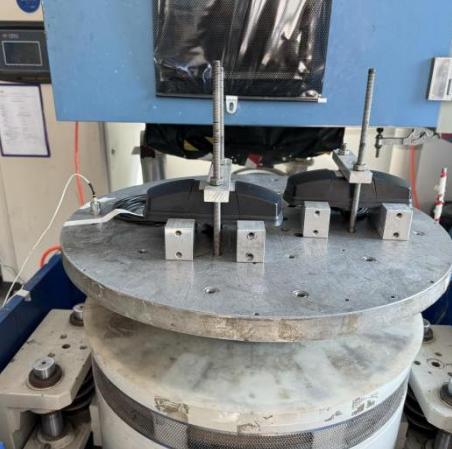
Z axis

Frequency(Hz)	Acceleration (g ² /Hz)	Slope (db)	Grms	Direction	Time
5	0.0101372	-	2.24	Z,X,Y/axis	40 Min /axis
500	0.0101372	-

Test setup photo

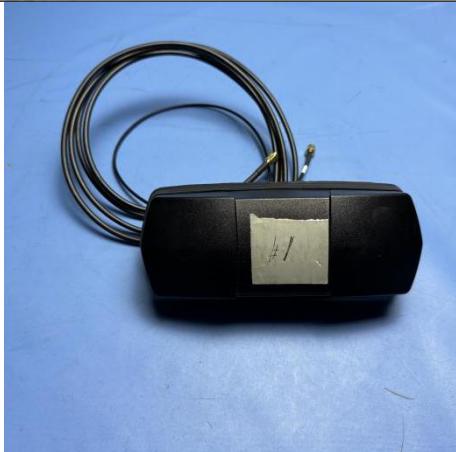
SN:1#

Photo after test for Vibration test

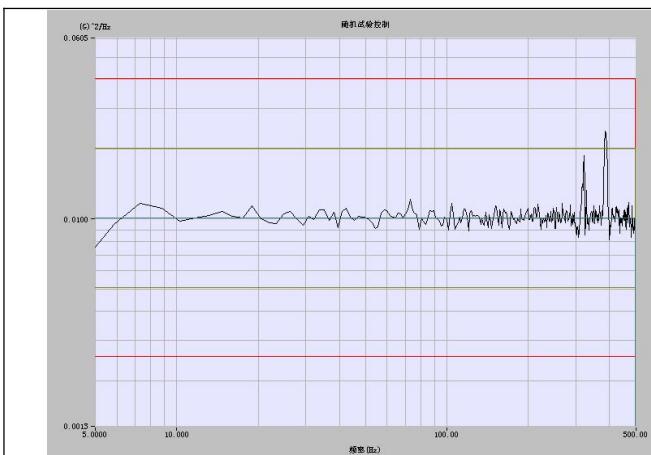
Z axis

Test curve
