Report No: 15877-1218-04627-MEME/2
Date of Report: 10 December 2018

Load Testing

One (01) piece of ST0281 Series Cavity Floor Box with 12mm Recess

Stainless Steel Section Assembly Revision 4 (R4) (Figure 2)

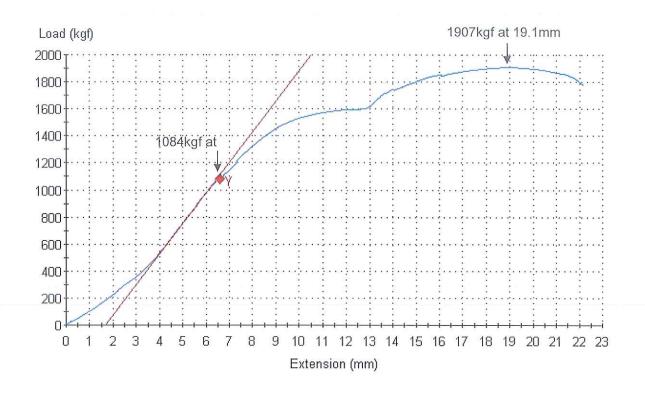
Figure 1: Load vs. Extension Curve

Sample Reference	ST0281 Series Cavity Floor Box with 12mm Recess Stainless Steel Section Assembly Revision 4 (R4)
Initial Deformation Load	1084 kgf
Extension at Initial Deformation Load	6.6mm
Maximum Applied Load	1907 kgf
Extension at Maximum Load	19.1mm
Mode of Failure	Figure 4 & 5

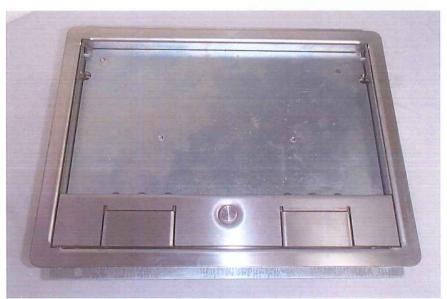
Figure 2: Received Sample

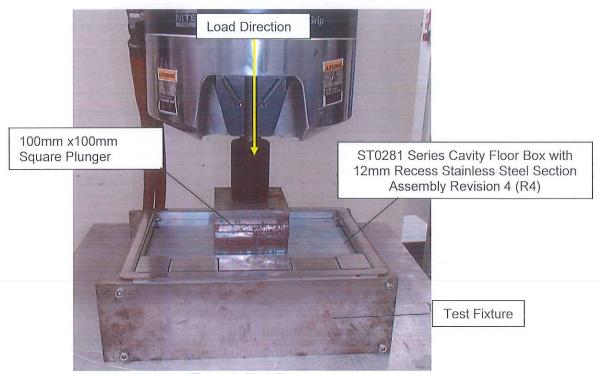
Figure 3: Test Set-up

The ST0281 Series Cavity Floor Box with 12mm Recess Stainless Steel Section Assembly Revision 4 (R4) was mounted onto the test fixture. Using 100mm x100mm square point plunger loading at the centre of the box, subjected to a compression load until failure occurred. (Test set-up

shown in figure 3)

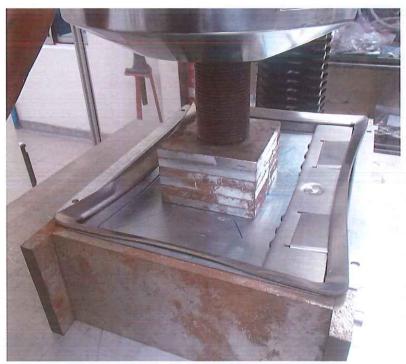
Figure 4: After Test

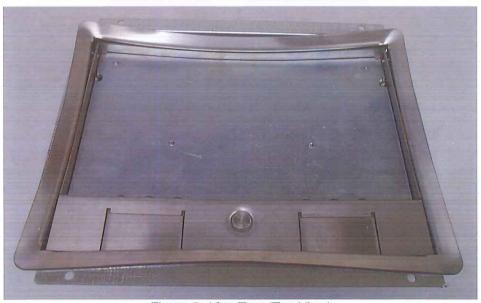
Figure 5: After Test (Top View)

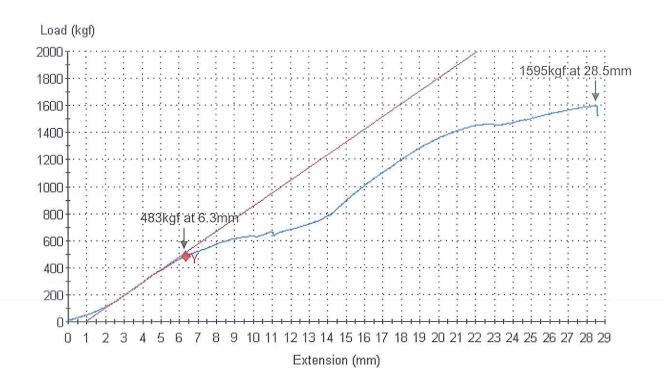
Figure 1: Load vs. Extension Curve

Sample Reference	ST0281 Series Cavity Floor Box with 6mm Recess ABS Lid Section Assembly
Initial Deformation Load	483 kgf
Extension at Initial Deformation Load	6.3mm
Maximum Applied Load	1595 kgf
Extension at Maximum Load	28.5mm
Mode of Failure	Figure 4 & 5

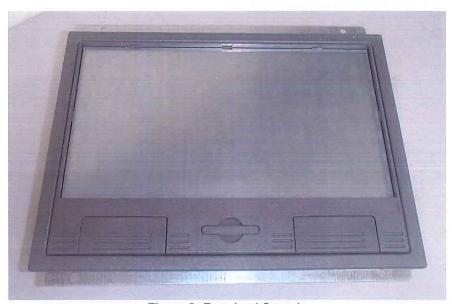
Figure 2: Received Sample

One (01) piece of ST0281 Series Cavity Floor Box with 6mm Recess ABS

Lid Section Assembly (Figure 2)

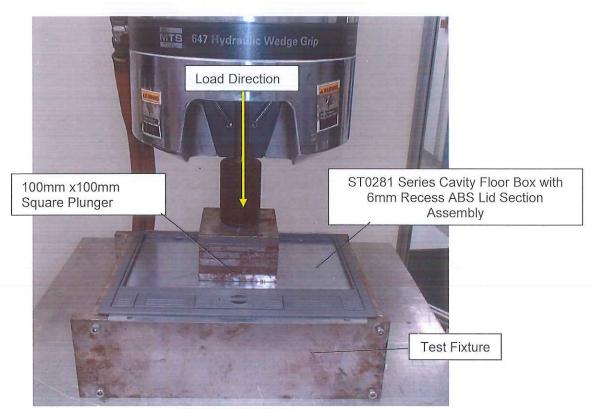
Figure 3: Test Set-up

The ST0281 Series Cavity Floor Box with 6mm Recess ABS Lid Section Assembly was mounted onto the test fixture. Using 100mm x100mm square point plunger loading at the centre of the box, subjected to a compression load until failure occurred. (Test set-up shown in figure 3)

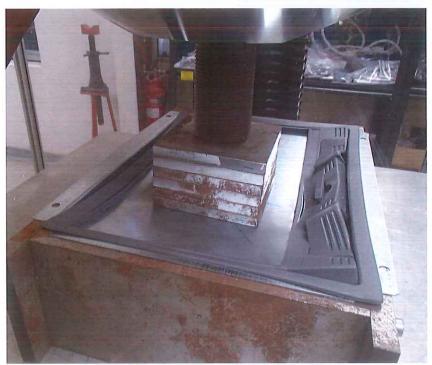
Figure 4: After Test

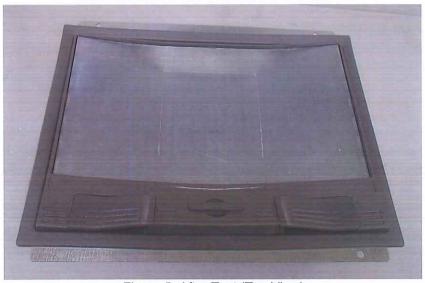
Figure 5: After Test (Top View)
