Report

Nr.: G 30 887-1

Material test of resistance to high pressure jetting – stationary jet test based on WIS 4-35-01, October 2008

HS-Rohrsystem

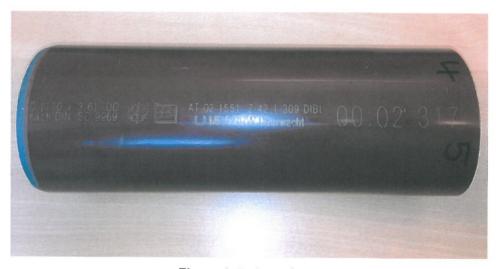
Figure 1: test specimen

Quantity of components	1	
Used In	Stationary jet test based on WIS 4-35-01 [1]	
Material	PVC-U	
Manufacturer	Funke Kunststoffe GmbH	
Product-Identification	HS-Rohrsystem	
Nominal diameter	DN/OD 110	
component length	0,30 m

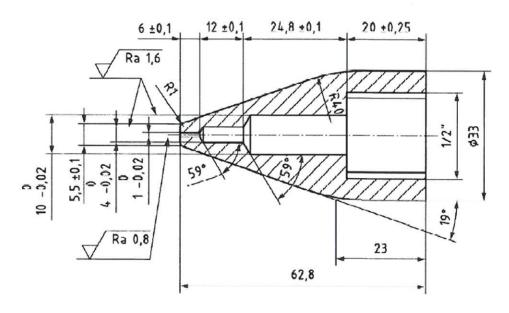
A stainless steel nozzle (see figure 2) is used for the stationary jet test mentioned above to comply with the tolerance ranges specified based on WIS 4-35-01, October 2008 [1].

Figure 2: design drawing of the nozzle Ø 1,0 mm based on WIS 4-35-01, October 2008 [1]

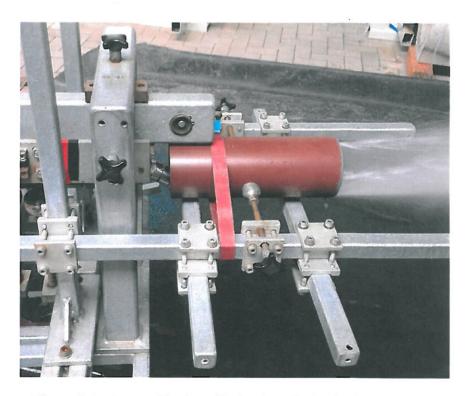
The material test has been carried out on the 17th of April 2014 at the iro GmbH Oldenburg research department. The interior surface of the test assembly (see figure 3) has been inspected prior to testing. No imperfections have been located. The test assembly was placed into the rig and adjusted to level.

Figure 2: test assembly placed in the rig at the iro GmbH Oldenburg

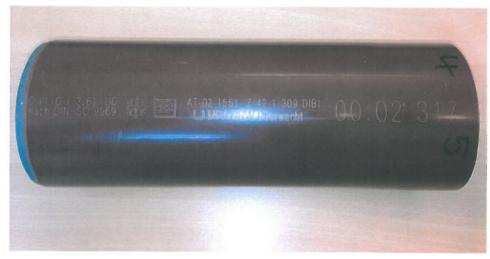
Figure 1: test assembly

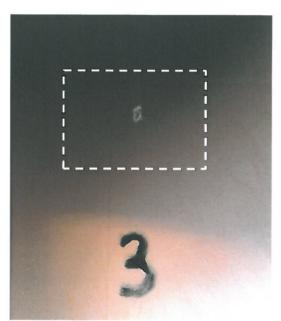
Figure 4: checkpoint 3 after testing

- The inner surface of the test piece was, however, in the area of the checkpoint to be evaluated during the test attacked not penetrated.
