CERTIFICATION TEST REPORT

**CERTIFICATION TEST REPORT 15038-1
OF
MECHANICAL STRENGTH TESTS
ON
CLEATS (4 1/2, 6 and 8 INCH)
FOR
ACCON MARINE, INC.**

ACCON MARINE, INC.
13665 AUTOMOBILE BLVD.
CLEARWATER, FL 34622

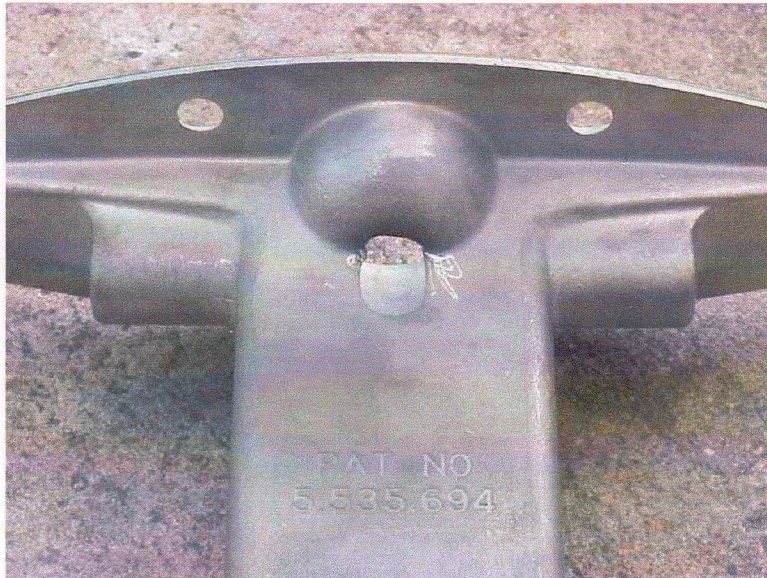
Figure 1. Photo showing typical “absence” of retaining pin due to vertical pull failure in 6 inch cleat.

The first failure mode (and the most common failure) was the failure of the retaining pin that normally prevents the pop-up portion of the cleat from coming completely disconnected from the casing. These graphs (i.e. 4 ½ inch, Sample 1, 2, 5, and 6) are slightly rounded near the maximum load value. This is due to the fact that the retaining pin holds its strength without deforming until the maximum strength of the pin is reached. Once the maximum load is reached, the pin starts deforming (this is where the rounded portion of the curve occurs). The ultimate failure is then related to a combination of both the strength of the pin as well as its elongation.

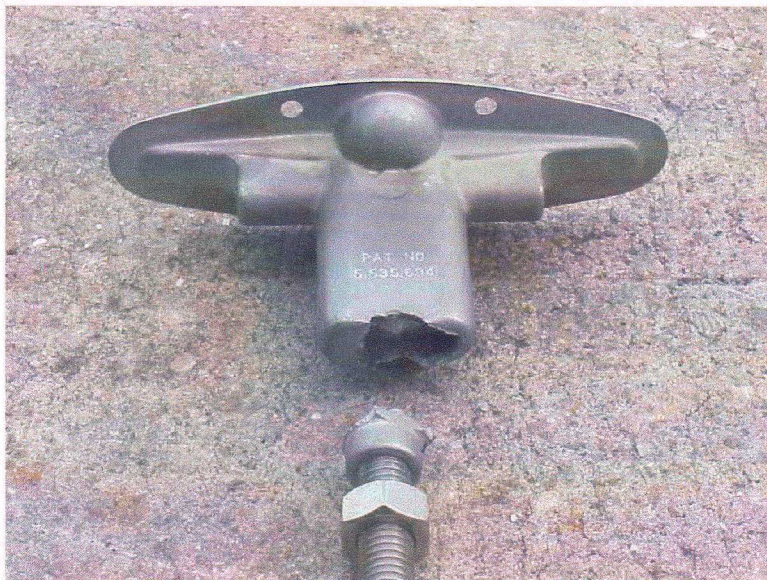
Figure 2. Photo showing typical Cleat Case Failure and remaining part left on threaded bolt. Note at top center of the 4 ½ inch cleat the first indications that the retaining pin is about to fail (small circle in metal).

The second failure mode is when the back portion of the cleat casing is completely torn out and the remaining piece stays attached to the threads of the mounting bolt (i.e. 4 ½ inch, Sample 3 and 4). These graphs show virtually no deformation and only a sudden release of the load when the part ultimately fails.
