Mill of Plunton, Kirkcudbrightshire: Historic Environment Assessment & Survey

Appraisal

issued 17th December 2021

RATHMELL  
ARCHAEOLOGY LTD

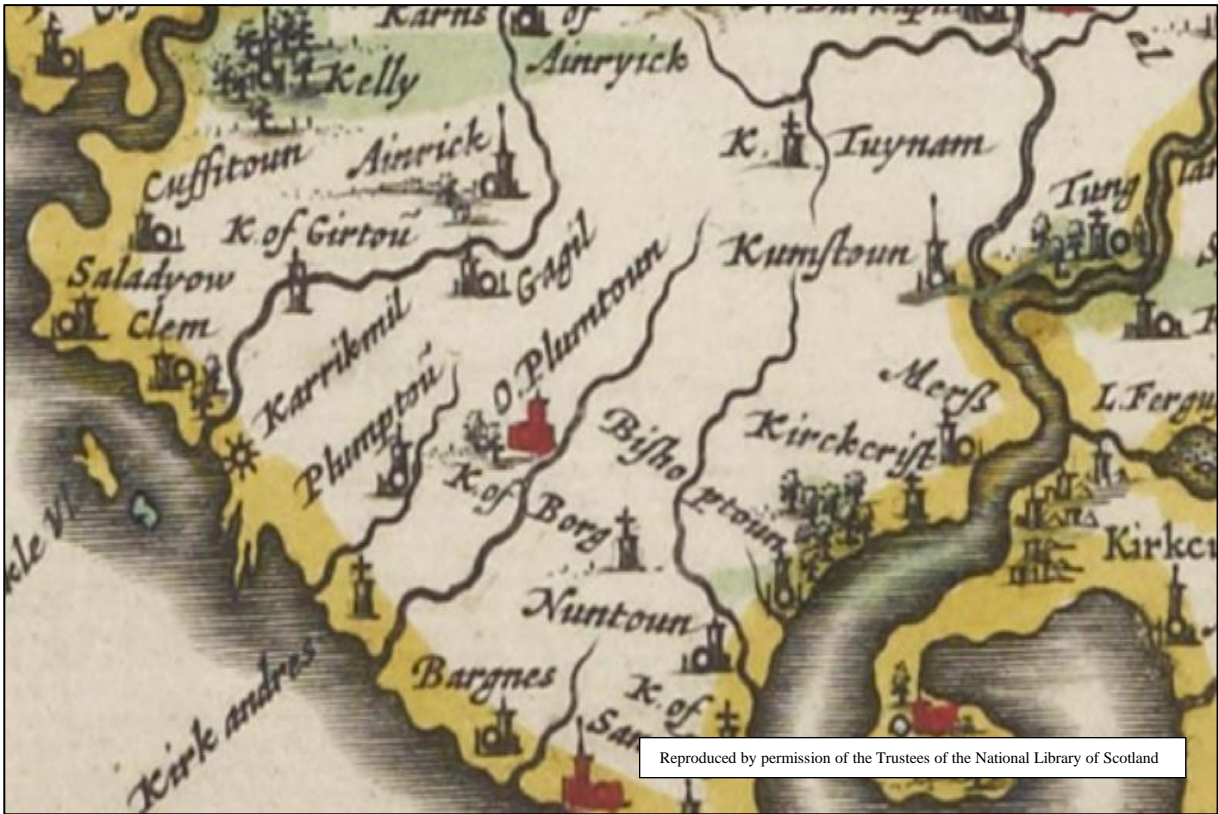
Figure 1a: Extract from Blaeu 1596-1673, Gallovidia, vernacule Galloway.

28. Blaeu's map (1596 – 1673) (Figure 1a) is the first map to give any indication of the existence of the assessment area. On the map 'Plunton' is spelt *Plumtoun*, with what appears to be the Pulwhirrin Burn (although this is not made clear on the map) distinctly shown on the plan as running through the area .

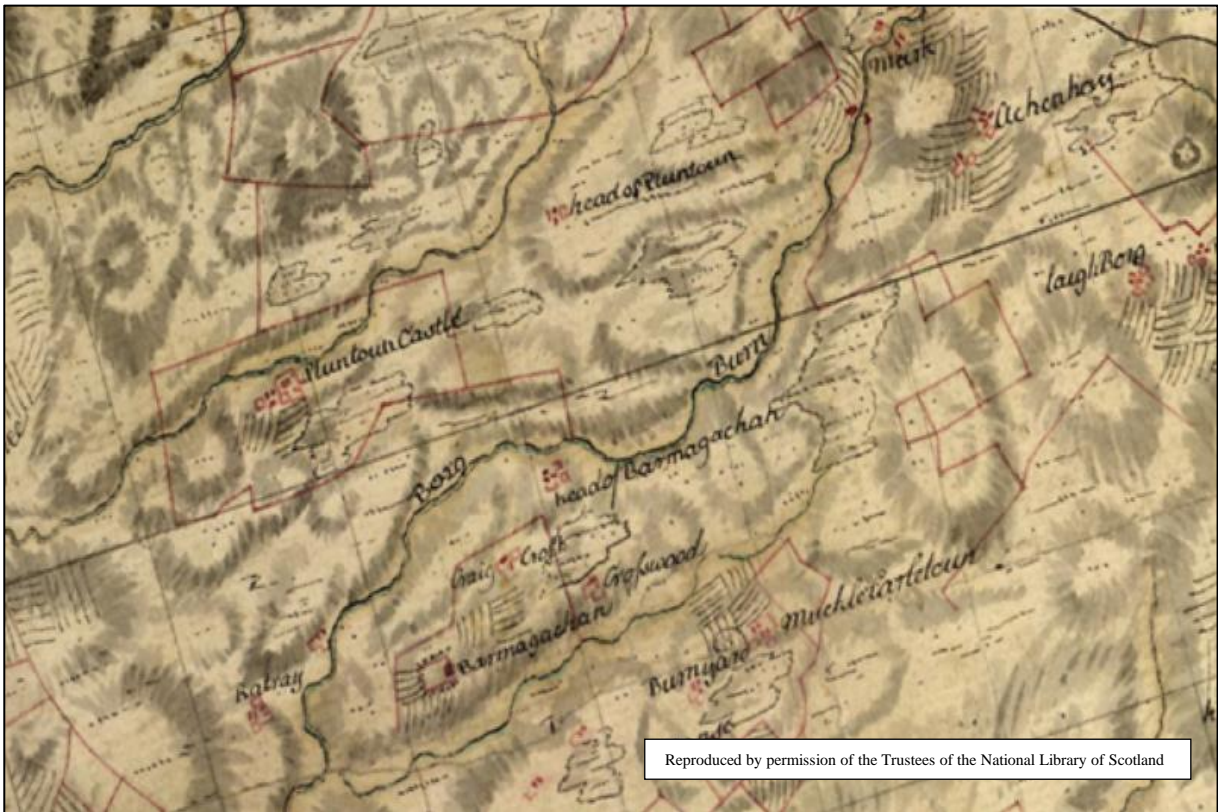
Figure 1b: Extract from Roy 1752-5, Military Survey of Scotland (Lowlands)

29. The first available mapping that provides any level of detail within the assessment area is Roy's *Military Survey of Scotland (Lowlands)* (1752-5) (Figure 1b). The assessment area is depicted as cultivated land with a possible farmstead named "Head of Plunton". The settlement of Plunton is to the north of Borgue and is located on the burn that runs to Kirkandrews Bay. Woodland is scarce at this time and the land appears to be divided into fields by this time. Mill of Plunton falls under the parish Borgue which is derived from the Gaelic word *burg* which signifies *little hill*, which describes the general appearance of the landscape which is said to have a very uneven surface.

30. Roy mentions a number of small farmsteads within the vicinity of the assessment area: Barmagachan, Craig Croft, Burnyard, Ratray and Crofswood. There is evidence of the widespread use of enclosures that are drawn in red on the map. Based on this evidence, Roy's red lines indicate that there are enclosures in the southern area of the assessment area and possibly the northern.

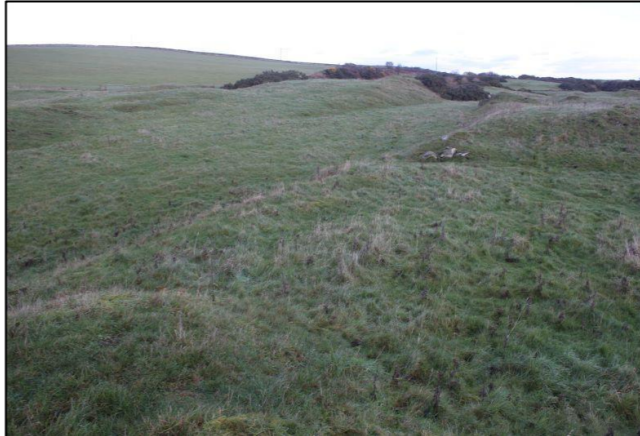
S14	Mill of Plunton Field Bank	N/a	<p><i>Desk Based Assessment</i> A rectangular enclosure abuts the southwest side of farmstead (S3) farmstead. on the 1st edition Ordnance Survey. It is also visible on LiDAR. It is not shown on any other historical or modern mapping.</p> <p><i>Walkover</i> An 'L' shaped bank was visible during the survey. The bank was truncated by a track and exists partially covered by gorse. The bank runs for a total of 42.7m in length and 1.75m in width.</p>	NT 62595 51273

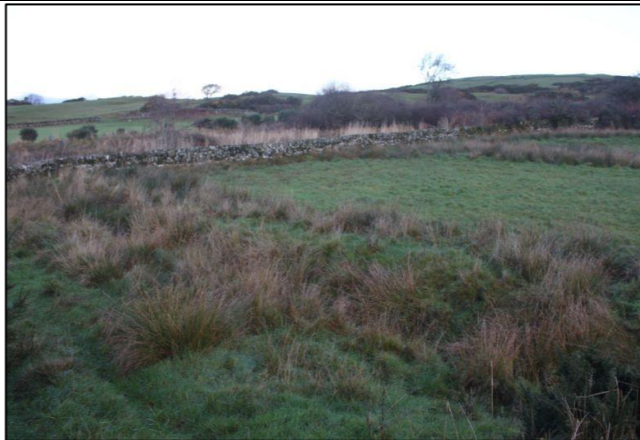
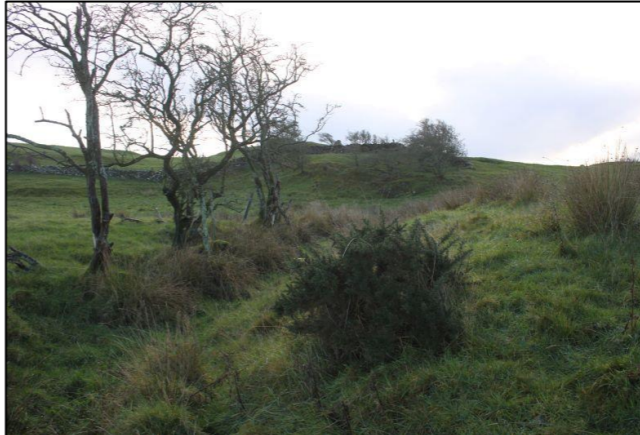
S15	Corsewood Drum Field Bank	N/a	<p><i>Desk Based Assessment</i> A field enclosure boundary running from north to south identified on the 1st edition Ordnance Survey. It is not visible on any other historical or modern mapping. It is not visible on aerial or LiDAR.</p> <p><i>Walkover</i> The bank is partially covered by tussocks of grass and damaged through the planting of three trees upon it and the creation of a track passing through it. There is a possible fence line that runs along the side of the bank.</p>	NT 62280 51162 NT 62310 51092

57. Corsewood Drum Field Boundary **S15** was first spotted on the 1st Ordnance Survey (1854) but was not identified during the field walkover. The feature is likely to have been destroyed through later land use. It does not contribute to historic landscape character. It has been ascribed Other significance and **no action** is recommended.

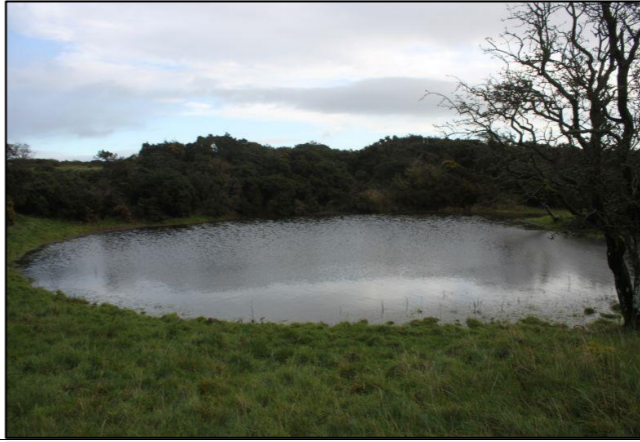
42. Corsewood Drum Pond or quarry (possible) **S16** was identified as a regularly-shaped, roughly circular, body of water. It is possible that this feature represents an old quarry or gravel pit now filled with water, although it could also potentially represent a custom-built pond created for agricultural purposes.

No	Site	HER Ref:	Description	NGR	Images from Site Inspection
S16	Corsewood Drum Pond Quarry (possible)	N/a	<p><i>Desk Based Assessment</i> A possible penannular enclosure was spotted on LiDAR. It measures 10m NW-SE by 12m transversely, with an opening to the east. This circular feature is also visible on the 1st edition Ordnance Survey but is not given a name or way of identifying it. It is not visible on any other historical or modern mapping.</p> <p><i>Walkover</i> A pool of water currently occupies this location, indicating a depression within the landscape, in a location comparable with the possible enclosure. The feature may represent an unmarked quarry or gravel pit which has become flooded.</p>	NT 62318 50838

58. Corsewood Drum pond and quarry (possible) **S16** was identified on LiDAR. It is not mentioned on any historical mapping and is possibly a waterfilled quarry or gravel pit. It does not contribute to historic landscape character. It has been ascribed Other significance and **no action** is recommended.

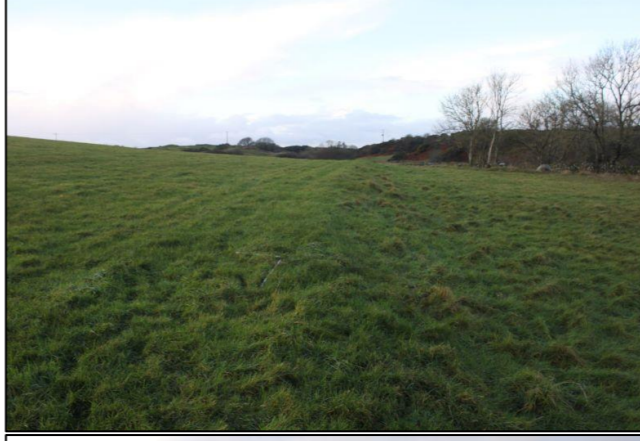
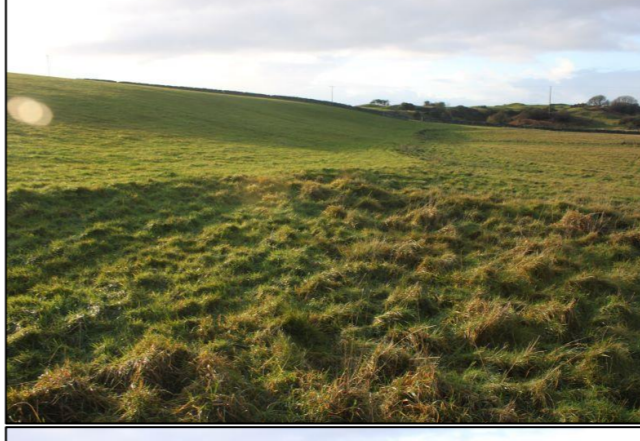
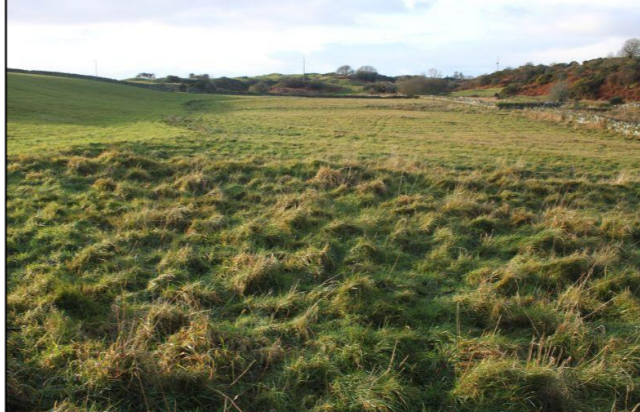
43. Field boundary **S17** was first identified on the walkover survey. It lies near **S18** clearance cairn which is perhaps related to the use of the field now represented by **S17**.

S17	Corsewood Drum Field Banks	N/a	<p><i>Desk Based Assessment</i> -</p> <p><i>Walkover</i> Possible field turf banks were found on walkover survey. All three banks consisted of turf and grass. S17.1 measured 90m in length and 1m in width. S17.2 measured 17m in length and 1.1m in width. S17.3 measured 30m in length and 1m in width.</p>	<p>S17.1 NT 62142 51061 NT 62057 51019</p> <p>S17.2 NT 62024 51022 NT 62037 51009</p> <p>S17.3 NT 62011 50990 NT 62021 51019</p>

59. Corsewood Drum Field Banks **S17** it is not visible on LiDAR or aerial photography. It is not mentioned on any historical mapping. It has been ascribed Other significance and **no action** is recommended.

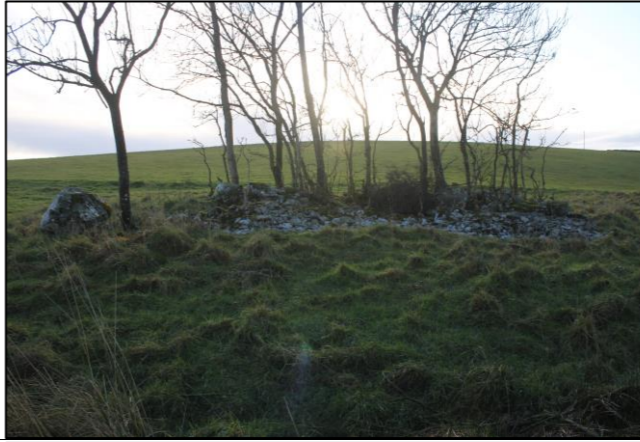
No	Site	HER Ref:	Description	NGR	Images from Site Inspection
S18	Corsewood Drum Clearance Cairn	N/a:	<p><i>Desk Based Assessment</i> -</p> <p><i>Walkover</i> A clearance cairn was found on the walkover survey consisting of hand sized stones covered in moss and trees growing out of it. Possibly connected to the field banks S17. It measures 4.9m SW to NE and 2.3m NW to SE.</p>	NT 62042 51026

60. Corsewood Drum Clearance Cairn **S18**, is partially visible on LiDAR. It is not mentioned on the 1st or 2nd edition Ordnance Survey maps. It does not contribute to the historical character of the landscape. It has been ascribed Other significance and **no action** is recommended.

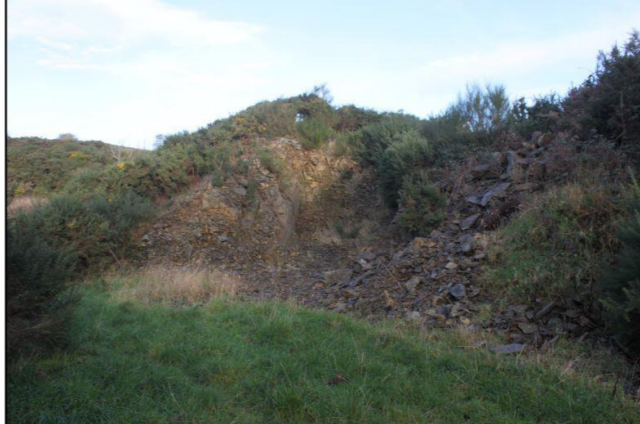
S19	Mill of Plunton Quarry	N/a	<p><i>Desk Based Assessment</i> -</p> <p><i>Walkover</i> A quarry was discovered out on the field walkover filled with large to medium stones and patches of gorse growing in it. It measured 7.6m W – E and 10.3 N – S.</p>	NT 62606 51525

44. Quarry **S19** was also identified on the walkover survey, located near **S12** and consisting of piles of sub-angular large stones almost obscured by gorse. Their exposed and irregular character suggested a modern date for these features.
45. One block of rig (Rig Block A) was identified on the walkover and its presence confirmed by LiDAR imagery. It was located in an area of grazed pasture where visible traces of rig and furrow cultivation could be identified in the field.
