# Identifying Your Rear Road Hub Page 1

Please use this document to identify your American Classic rear road hub. There are 4 different rear road hubs:

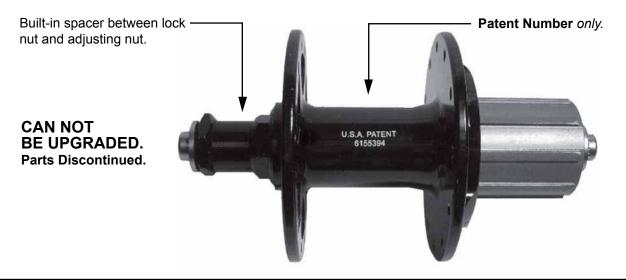
### RD205 - 15mm Hub (Old Style)

Please use the below image to identify if you have an older RD205 15mm rear road hub. If your hub has any of the following features, it can not be upgraded with new parts and is **discontinued and out of stock**. We are not rebuilding wheels with the 15mm hubs. 15mm hubs are not Campagnolo 11 speed or Shimano 11 speed compatible.

This hub uses four 15267 fully sealed bearings. Two in the hub shell and two in the freehub body. Ceramic bearing upgrade is not available.

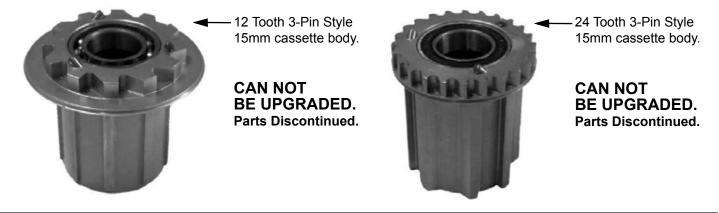
**3-Pin Style Cassette Bodies:** These hubs and parts have been **discontinued and out of stock**.
