THUREN FABRICATION 2014-2023 REAR COILS W/ SWAY BAR CONNECTING LINKS

These Instructions Are Applicable To The Following Trucks:

- 2014 - 2023 Ram 2500
- 2014 - 2023 Power Wagon

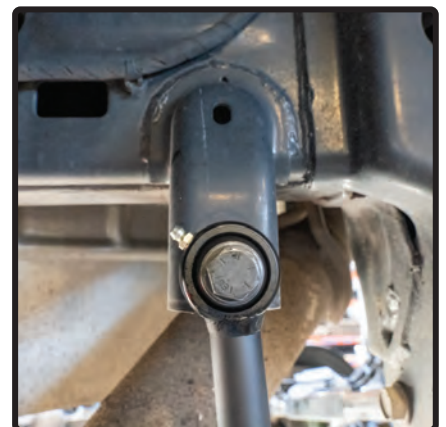
Image 1

- Before installing links, check that provided hardware slides through all mounts smoothly. It may be necessary to open up mount holes with a 1/2" drill bit for proper fitment.
- Install Sway Bar End Links on the outside of Sway Bar and Frame mounts to avoid possible damage to Zerk Fittings. Zerk Fittings should be facing Forward and Upward. (*image 1*)
- The Flange of the sleeve mounts against the Frame and Sway Bar.
- Install bolts with flange head against the center ball
- Torque Sway Bar Links Nuts to 100 Ft/Lbs.
- Once truck is back on ground at ride height, loosen Track Bar bolts and re-torque to 140 ft / lbs
- Apply Torque Stripe and/or Paint Marker to all hardware for quick visual verification of Torque Specifications.
- Recheck all hardware after 500 miles.
