# EXTRUSION PERFORMANCE FLUIDS - CRUCIAL IN MAINTAINING WATER-COOLED EXTRUDER EFFICIENCIES

Peter E. Greenlimb, Ph.D., Chemagineering Corporation, Rolling Meadows, IL

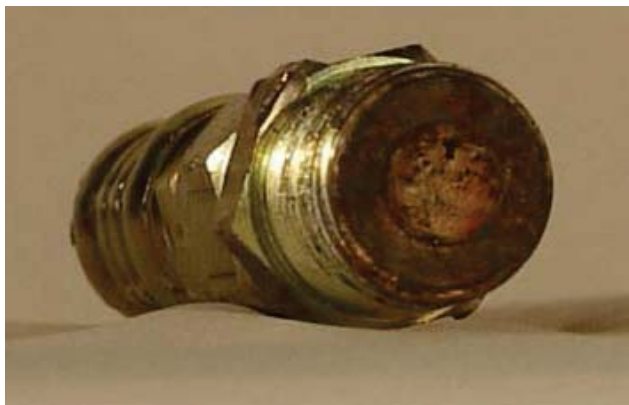
Figure 2. Plugged extruder 3/8 inch zone inlet coupling.

In most water-cooled extruders using distilled or softened waters as the heat transfer fluid, component corrosion is the most frequently encountered water-related issue. As system corrosion continues the corrosion products that are formed foul narrow water passages, deposit on heat transfer surfaces, impede zone valve operations, and accelerate corrosion due to their physically abrasive action on softer metal surfaces such as those of brass and copper. In the pitting corrosion of mild steel it has been estimated that the volume of iron oxide corrosion products produced is approximately seventeen times the volume of the metal lost. A  $\frac{3}{8}$ " diameter stainless steel zone inlet coupling plugged with corrosion and mineral deposits illustrates the severity of this issue in water-cooled extrusion equipment (Figures 1 and 2, respectively).

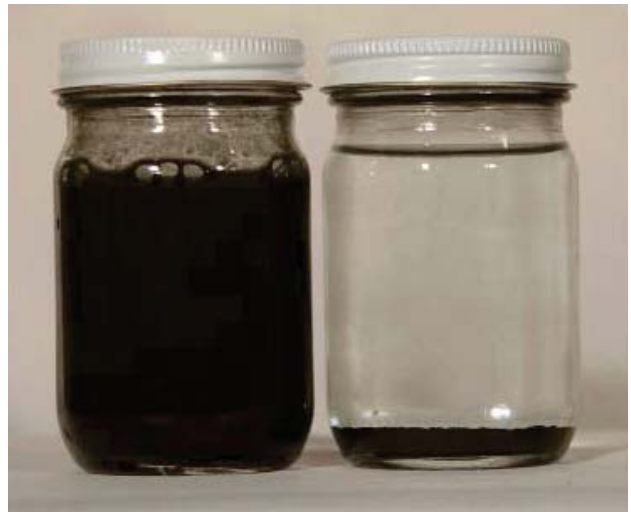
Figure 3. Demineralized water extruder barrel coolant.

**Case Study I.** A large specialty chemical manufacturer operated two Werner and Pfleiderer twin 91.8-mm diameter screw water-cooled extruders in the manufacturer of thin fibers of grafted thermoplastic polyolefin heat-seal coatings for use as adhesives. Each extruder had twelve zones with the fifth zone reaching the highest operational temperature of approximately 580°F. Initially demineralized water was utilized as the zone coolant (Figure 3), often being supplied to the zones at temperatures between 165 to 185°F from the system's water reservoir tank.

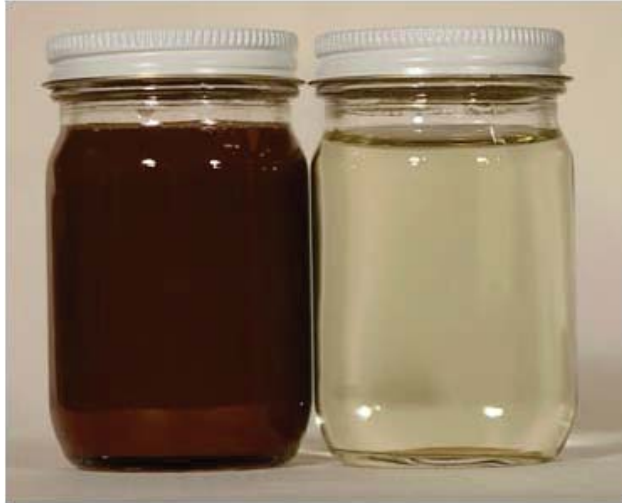
Figure 5. Fouled extrusion system distilled water coolant (left) and one maintained with EPF (right).

To restore these systems to optimum operating condition, each extruder cooling water system was thoroughly cleaned and flushed with a proprietary organic-based chemical descaler, followed by several flushes with tap water, and concluding with at least one high-purity water flush. After each system was cleaned following this procedure, it was charged with Extrusion Performance Fluid, a water-based, all-organic corrosion and deposit inhibition coolant. Typical 'before-and-after' coolant clarity is illustrated in Figure 5.

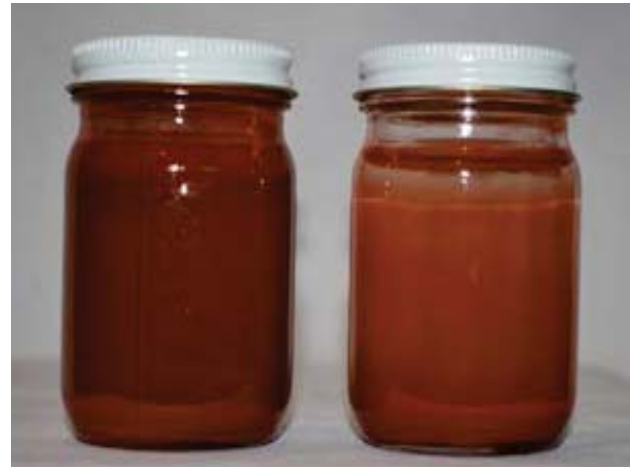
Figure 6. Initial extruder reservoir tank samples.

Four of the five extrusion lines were restored by following the recommended chemical cleaning procedure briefly described previously. Due to the design of the fifth extruder's reservoir tank, that system has not, as yet, been restored. During the restoration phase of the extrusion lines, each reservoir tank was found to contain approximately two inches of compacted corrosion product

debris. Each tank was manually cleaned and most of the system component parts (supply and return hoses, etc.) were replaced with manufacture-specified items. A sample of one of the original extruder coolants is illustrated in Figure 6. Analyses of the aqueous phase of that sample and its suspended solids are tabulated in Tables 4 and 5.
