KDSS Front Sway Bar Clamp Install

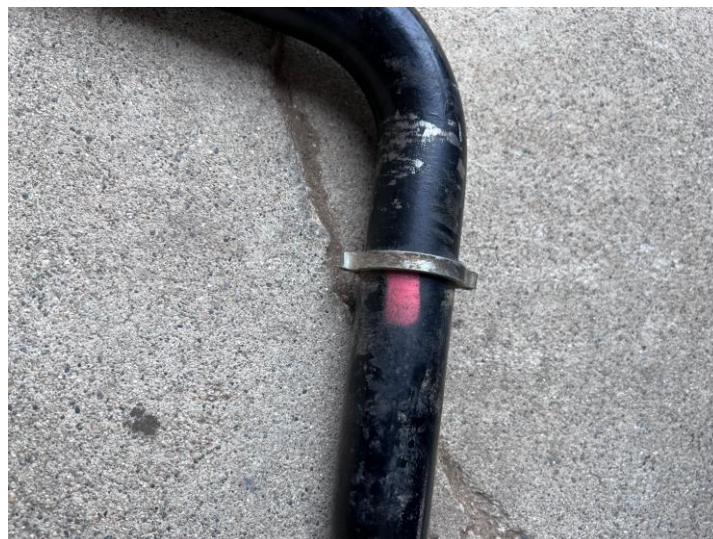
3. Prior to installation, it must be determined if the factory metal pressed on straps are in the proper location. This can be checked by looking under the sway bar. There is a pink spray-painted mark right up against the pressed-on metal strap (pictured below – note this is pictured off the vehicle and without the bushing/assembly in place). If there is no gap between the strap and the paint mark then it is in the correct location, if not, it needs to be adjusted.

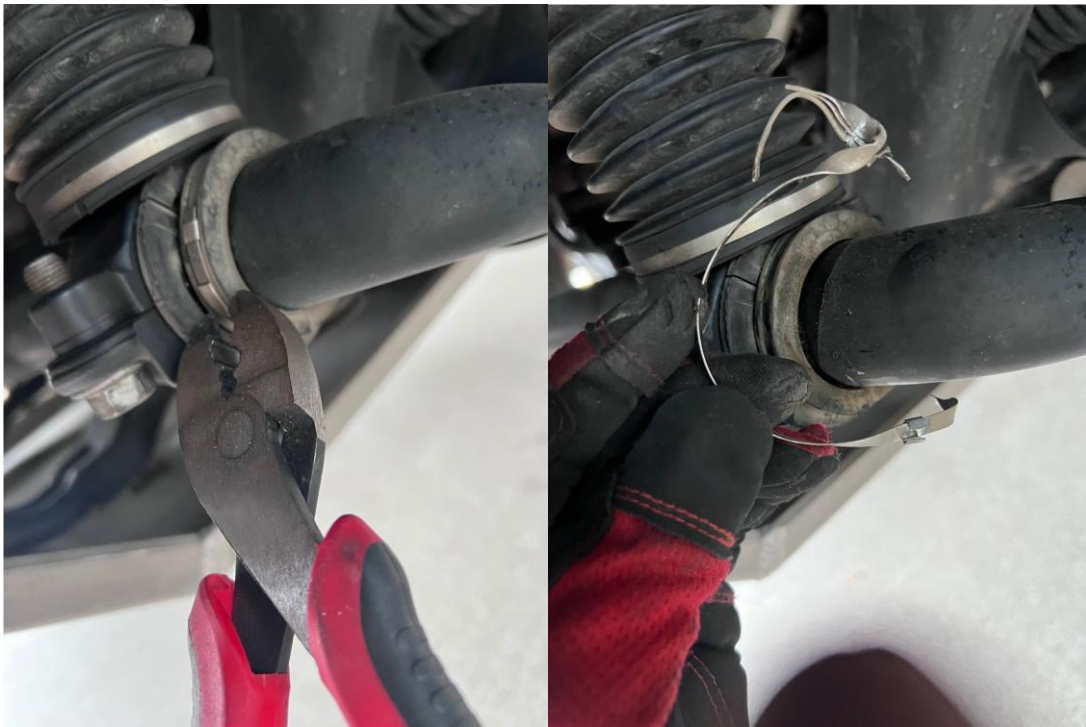
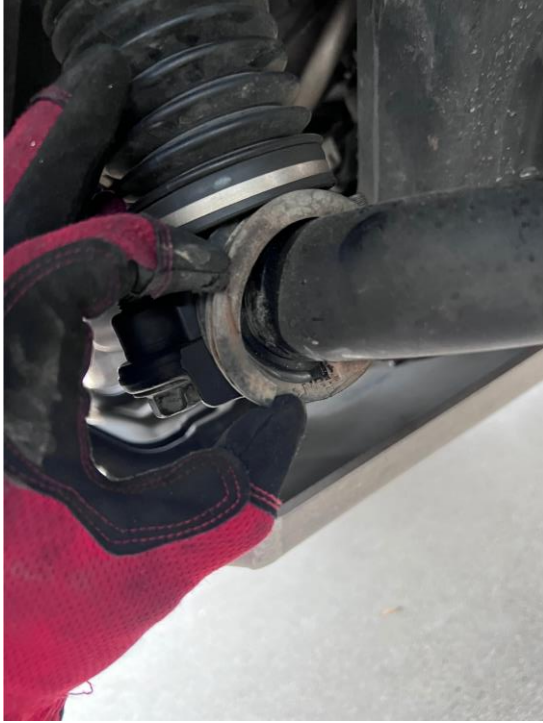
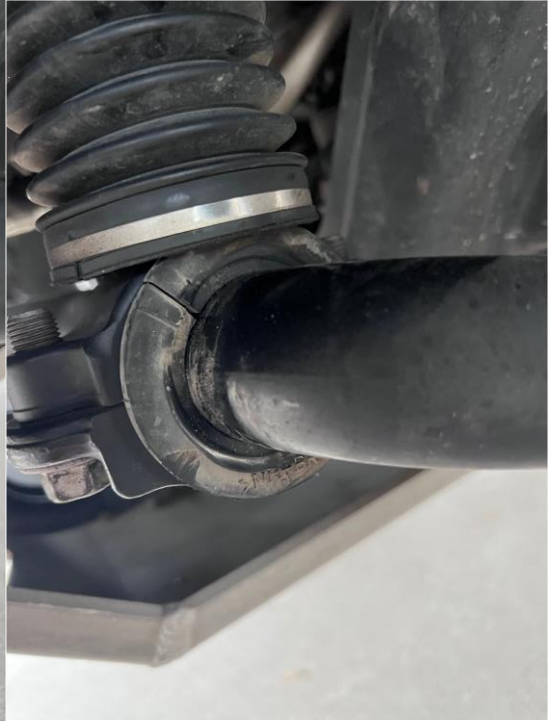
6. At the base of the KDSS shock, locate and remove the factory rubber strap that has a pressed on metal strap around by cutting it with a pair of snips and remove the rubber strap.

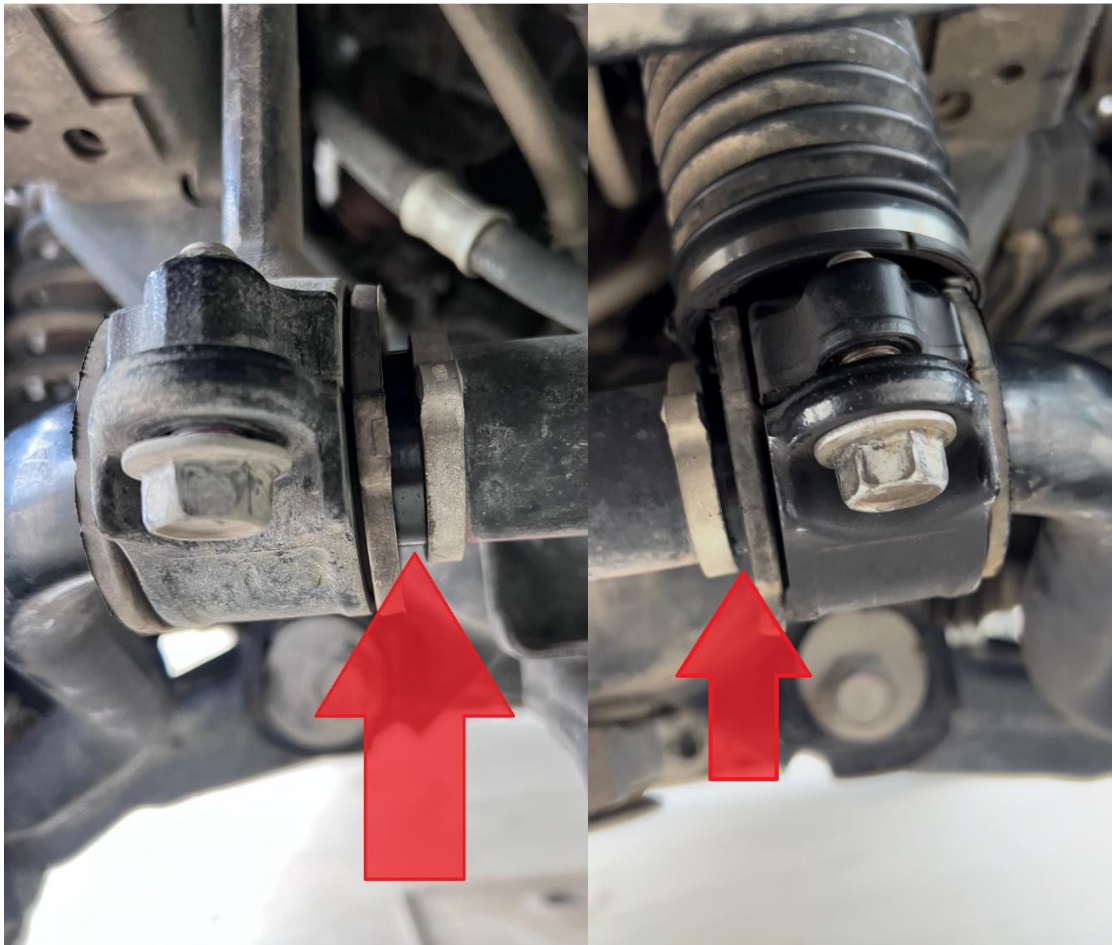
7. Determine if the sway bar has shifted to driver side or passenger side. This can easily be accomplished this by looking at the sway bar ends at the lower control arms and see which has more sticking out. In most cases the sway bar has moved towards the driver side. In either case, while the bolts are loose, the sway bar will need to be returned to the original position by physically moving it in direction it needs to go (kicking or pounding works well). Look at the sway bar ends again to determine if centered or close to it, primarily making sure that the pressed on metal straps are up against the hard link and KDSS shock bushing. If there is a gap between the KDSS shock and the inner pressed on strap, use a set of ratchet straps to pull the shock over (wrap around the lower boot of the shock and strap the other end to the frame for leverage). Note that if completing this extra step, make sure to tighten the bolts on the passenger side first so that the bar is held in place while repositioning the KDSS shock/mount.

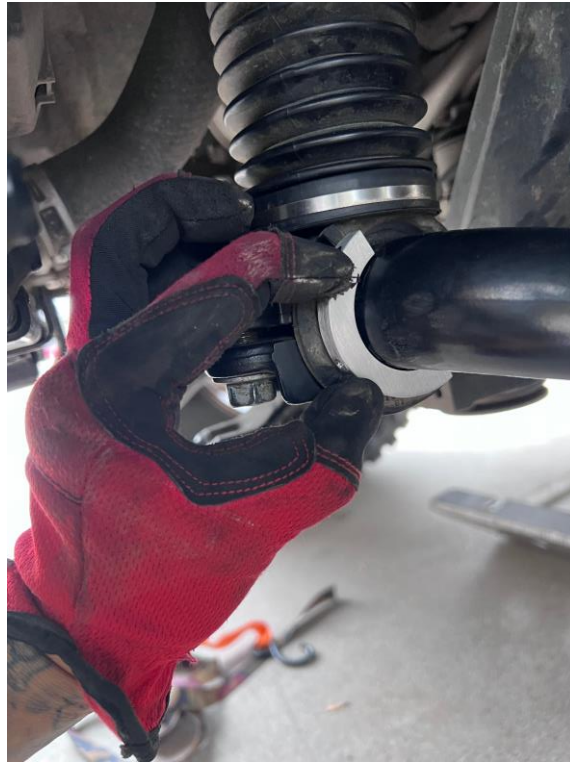
8. Starting with the driver side, and making sure that the KDSS shock mount is positioned against the inner metal strap, a divot must be marked and drilled to allow the set screw on the new clamp to be screwed into the sway bar. Start by removing the set screw from the clamp and position the clamp on the sway bar marking on the swaybar through the hole once in position – Note that the set screws best location is at the lower portion of the front half of the sway bar (pictured below) and make certain the clamp is flush against the KDSS shock mount bushing when making the mark (the bushing should not be swollen as the bolts should still be loose).

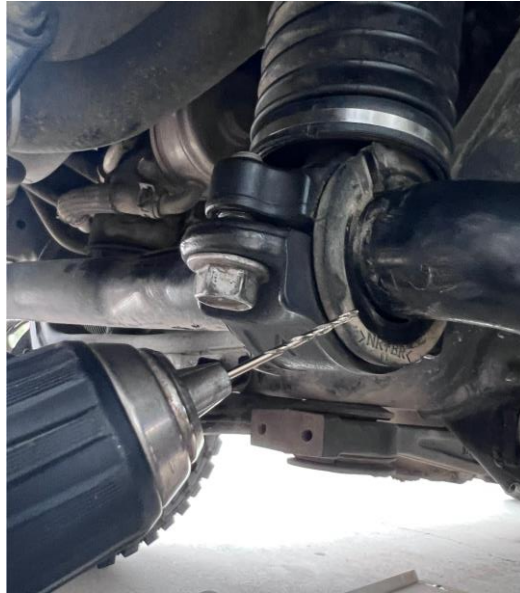
9. With the hole position marked, with a 5mm drill bit, drill approximately 1/8" into the sway bar.

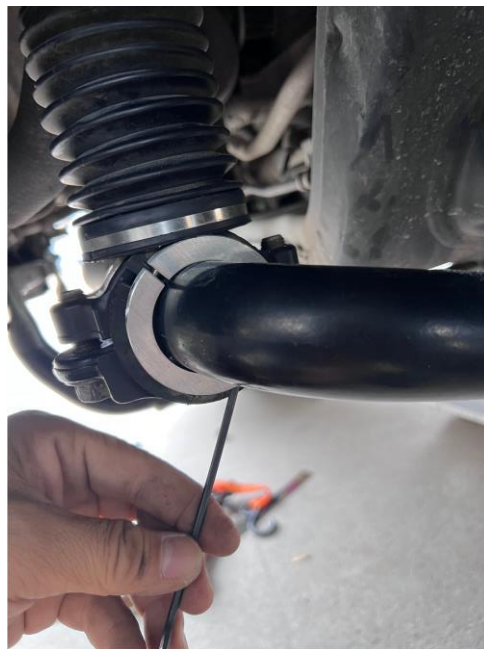
10. Place the front half of the strap with the set screw in its location along with the back half of the clamps, and start walking both bolts in evenly (back and forth) while making sure the front half is held in the location with set screw in the divot that was drilled. Note that backing off the set screw part way through the process can allow the bolts to be tightened further, but ensure the set screw is tightened again when complete. (Loctite can be used on the bolts and set screws if desired) ** If the back half of the new clamp will not sit flush against the KDSS shock mount, refer to 10a below **

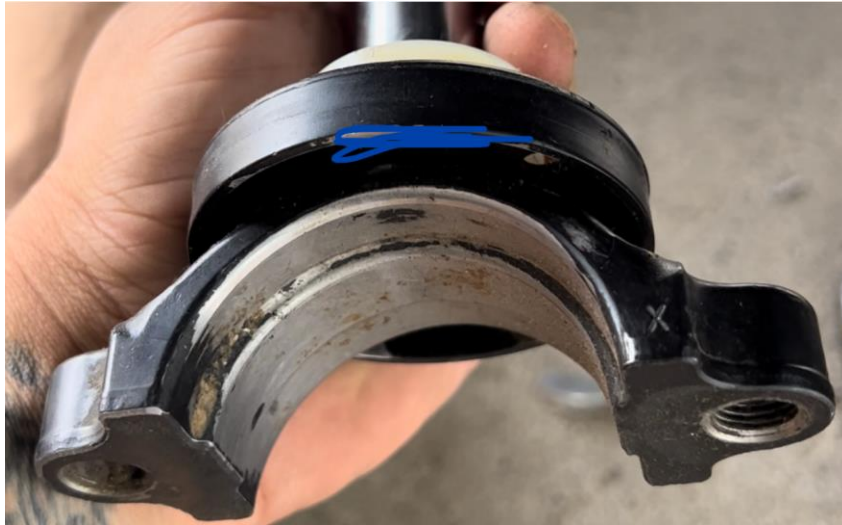
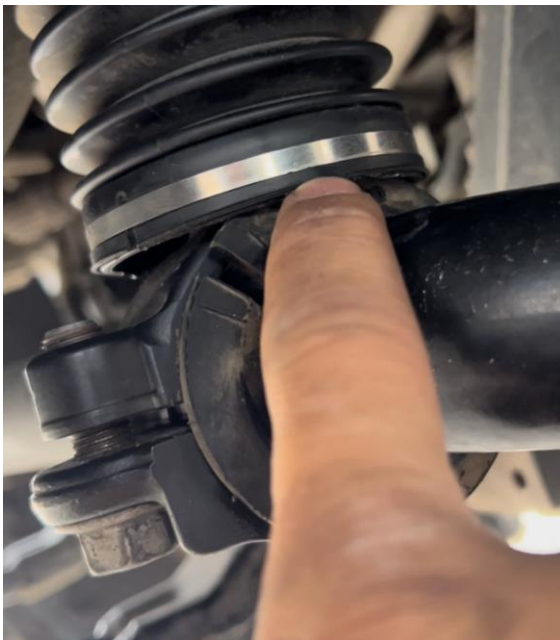
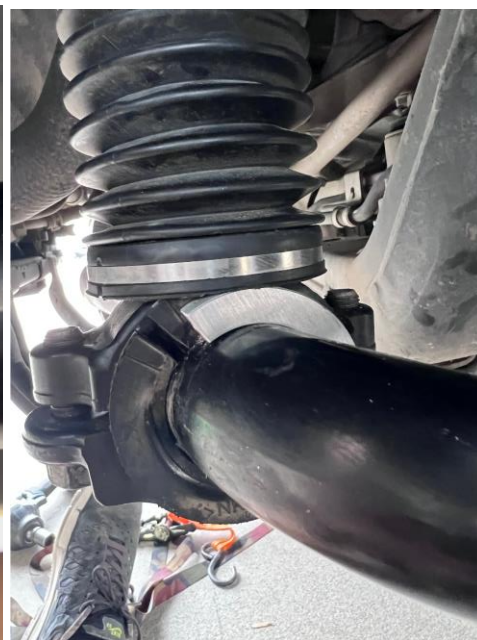
- a. If there is an issue getting the clamp flush to the KDSS shock mount, some models from 2018 and earlier may need a small clearance to the area below the KDSS shock boot strap to allow the clamp to sit flush. This will not affect the performance of the shock as only a small area under the boot needs to be modified. It is recommended that a Dremel with a small carbide bit is used to grind this portion. Below are pictures identifying the area – note that the shock does not need to be removed the picture is just an example.
