SDL-REBUILD-BNDL

SLIDING DOOR LATCH REBUILD KIT

1985-1991 Vanagon

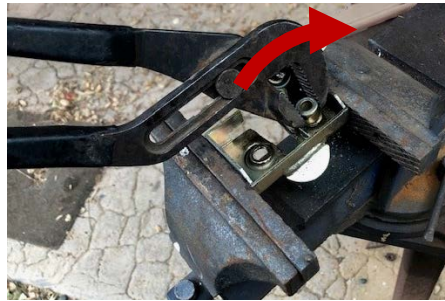
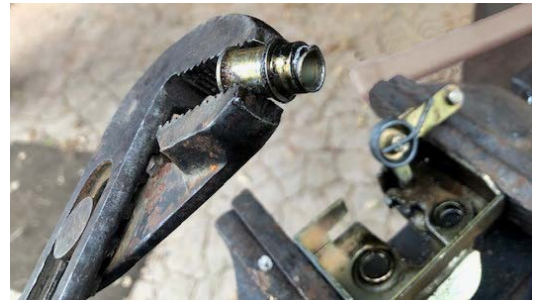
- 5) Remove the old latch springs and clean the latch *thoroughly* with a degreaser of your choice.
- 6) Removing the old posts requires breaking the thin rolled edge of the original post by either: prying out or drilling out the posts.
 - a. To pry out the old posts: place the latch body in a vice, then use pliers to pinch the top lip of the post and break out each post. Use the outer edge of the latch body for leverage.

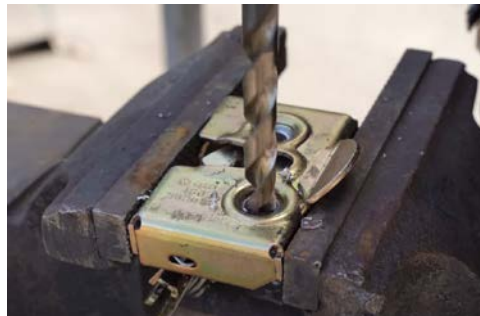
- b. If you have difficulty prying out the old posts: drill out each latch post from the back side of the latch. Start with a 3/8" drill bit, and slowly enlarge the hole until the posts drop out, using 25/64" and 13/32" drill bits if needed.

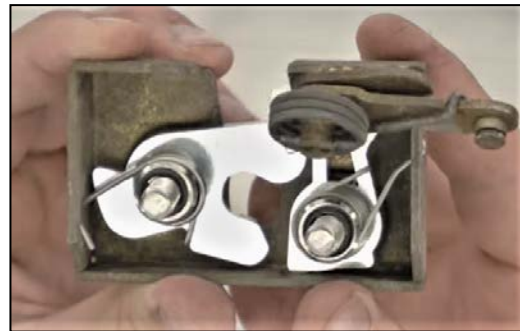
- 8) Assemble the latch using the rebuild kit. Start by stacking the latch over the new internal hex bolts, then stack each catch and a post onto the bolts. Press on and thread the supplied retaining washer onto each bolt and tighten the assembly. Tightening the retaining washers on each bolt now will make installing the latch to the door easier.
- 9) Install the new springs. These will install exactly the same as the factory springs.
- 10) Grease all moving parts thoroughly. We recommend [HHS-Plus Spray Grease \[GW Part #0893106\]](#), or a similar penetrating, high-pressure rated, lubricant.
Installation Note: **Serious Pinch Hazard.** Please be careful and exercise common sense while testing the latch catches when sprung.

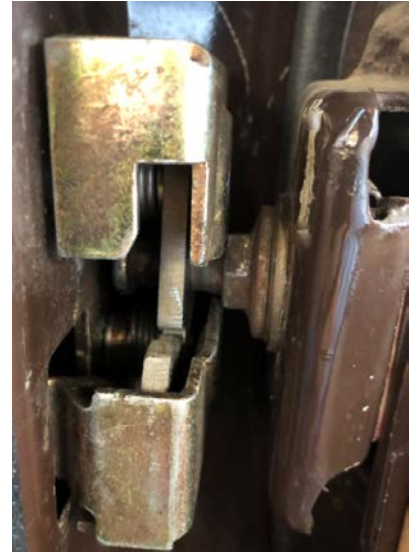
- 16)** The sliding door latches onto the pin that is threaded into the body below the C-Pillar. This pin position can be adjusted to ensure a better fit with the sliding door latch. Lightly loosening the pin threading will allow it to be moved within a 1" square. For some additional adjustability, a washer can also be added to space the pin further out from the door frame.
- 17)** When the door is closed, the latch catches should hold about halfway along the pin.

*In most cases, you should not need to adjust the pin location. Improperly adjusting the pin location can interfere with sliding door latch operation and cause premature wear on both the latch catches and/or the latch pin. Test out your sliding door latch prior to adjustment. Before loosening and adjusting the latch pin position, we **strongly** recommend marking your old pin position with a pencil or sharpie in order to track what adjustments you make.*
