3. Leakage from the back and side of the cover base

UPC Flushing ONLY

Leaking from the backside of the cover base

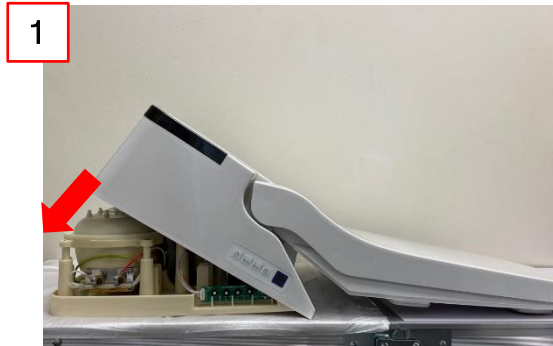
① Close the cover base in the arrow direction as above.

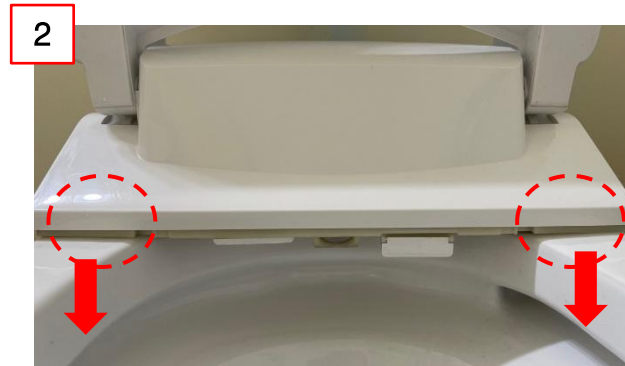
② Push down using your palms as above to hear clicks.
