HOW TO RESOLVE HEATED SEAT MALFUNCTIONING-BIDET TOILET

How to resolve heated seat malfunctioning

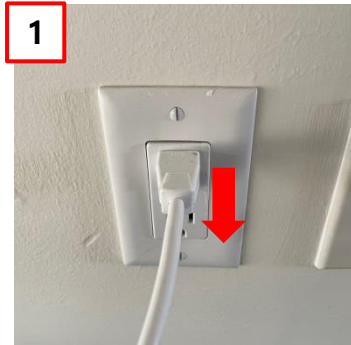
① Unplug the cord

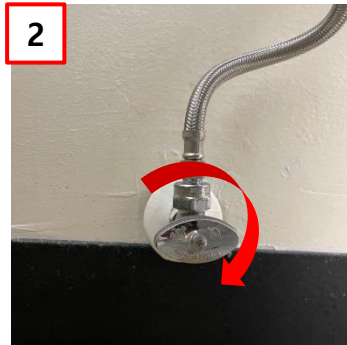
② Close the water valve clockwise

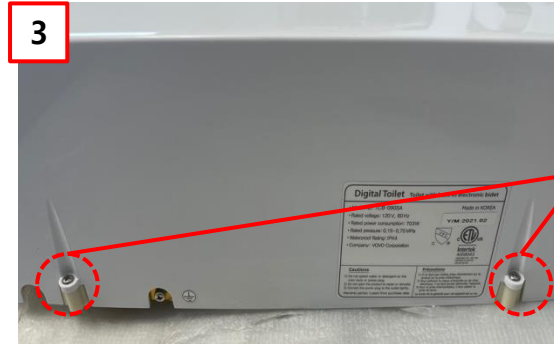
③ Unscrew the 2 screws at the back using a Philips head driver.

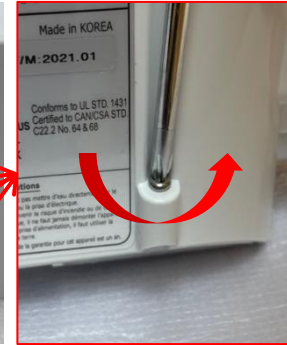
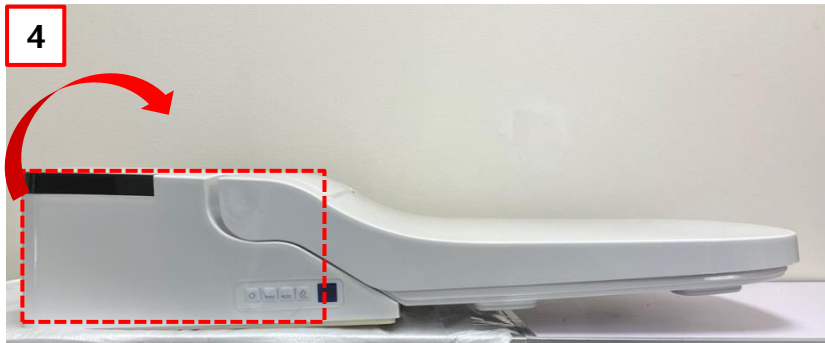
④ Detach the cover base by pulling it to the arrow direction as above.

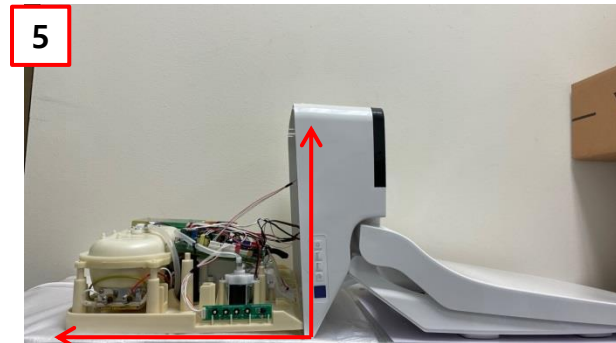
⑤ Make sure that the degree between the ground and the cover base is shown as in the above picture to avoid any wire damage.

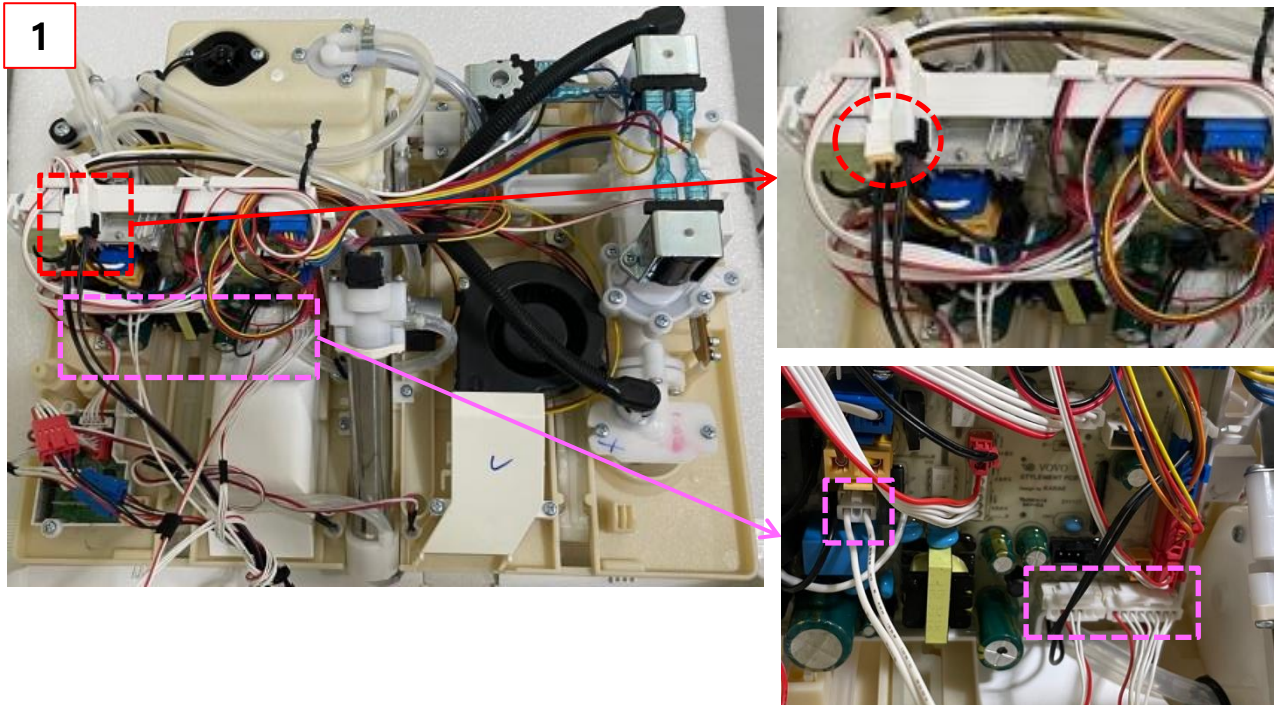
2. Check the seat harness

① Check the connection between MAIN PCB and the seat wire harness.

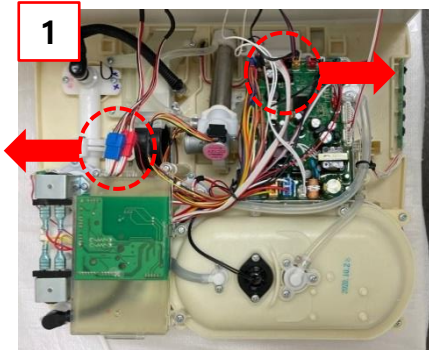
① Organize all the wires in the directions as above not to interfere the nozzle movement.

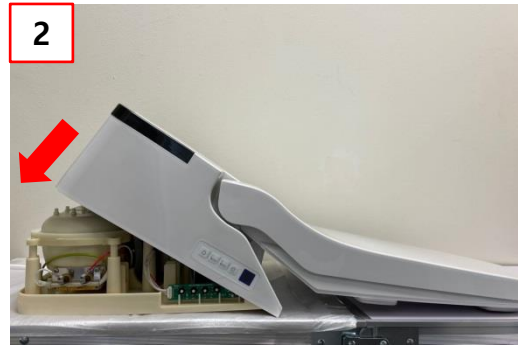
② Close the cover base in the arrow direction as above.

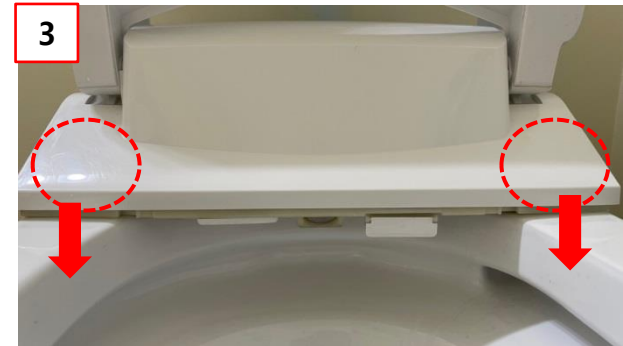
③ Push down using your palms as above to hear clicks.

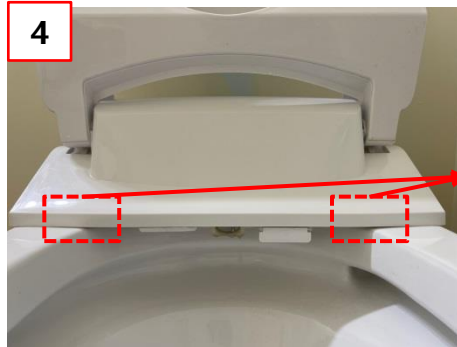
④ Check whether the cover base is assembled perfectly. If you heard clicks, it's perfectly done.

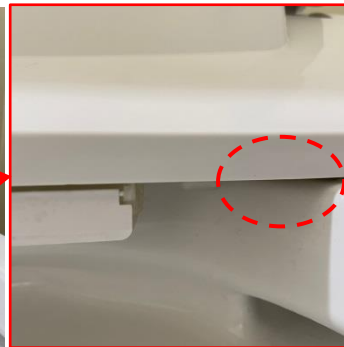
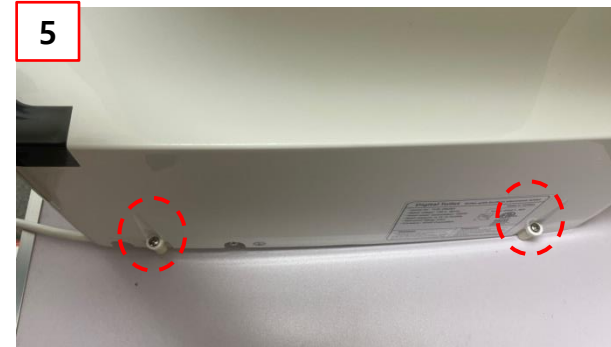
⑤ Screw the 2 screws back using a Phillips head driver.
