Choosing The Correct Tie Rod Ends for VWs With Ball Joint Spindles

Tie Rod Ends: What You Need to Know to Keep Your Classic VW On Rails!

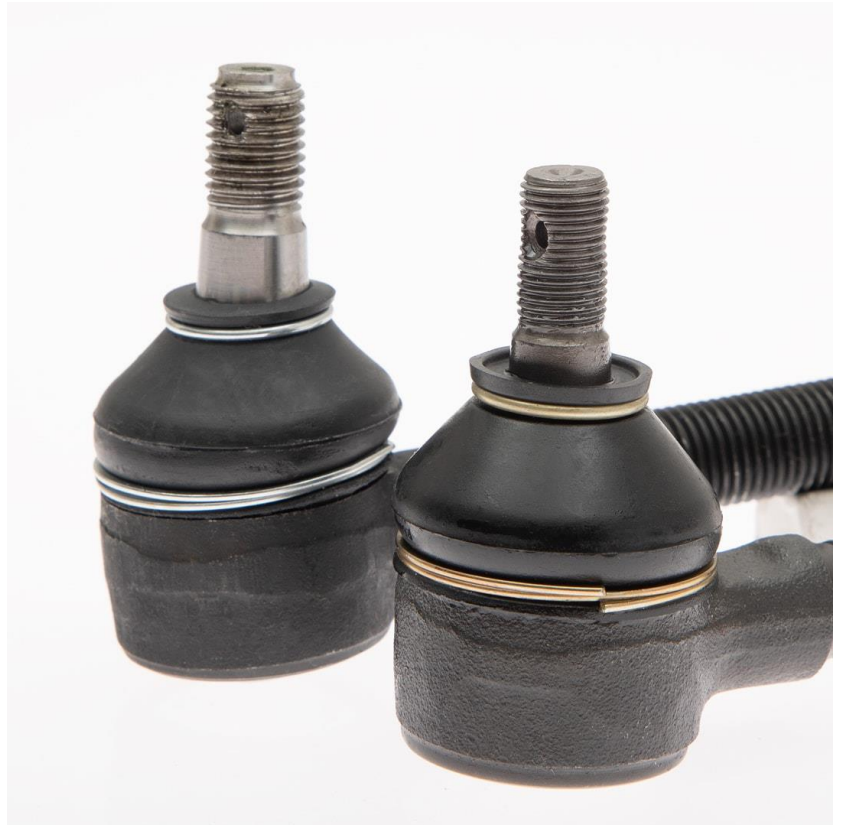
The image above shows the specific differences between the early and late model OE ball joint spindles found on the Bug & Ghia.

The ball joint front end was introduced on Bugs & Ghias with the 1966 model year. Both models used tie rod ends with a 10mm stud until the middle of 1968, when VW updated the spindle and tie rod ends to a 12mm stud.

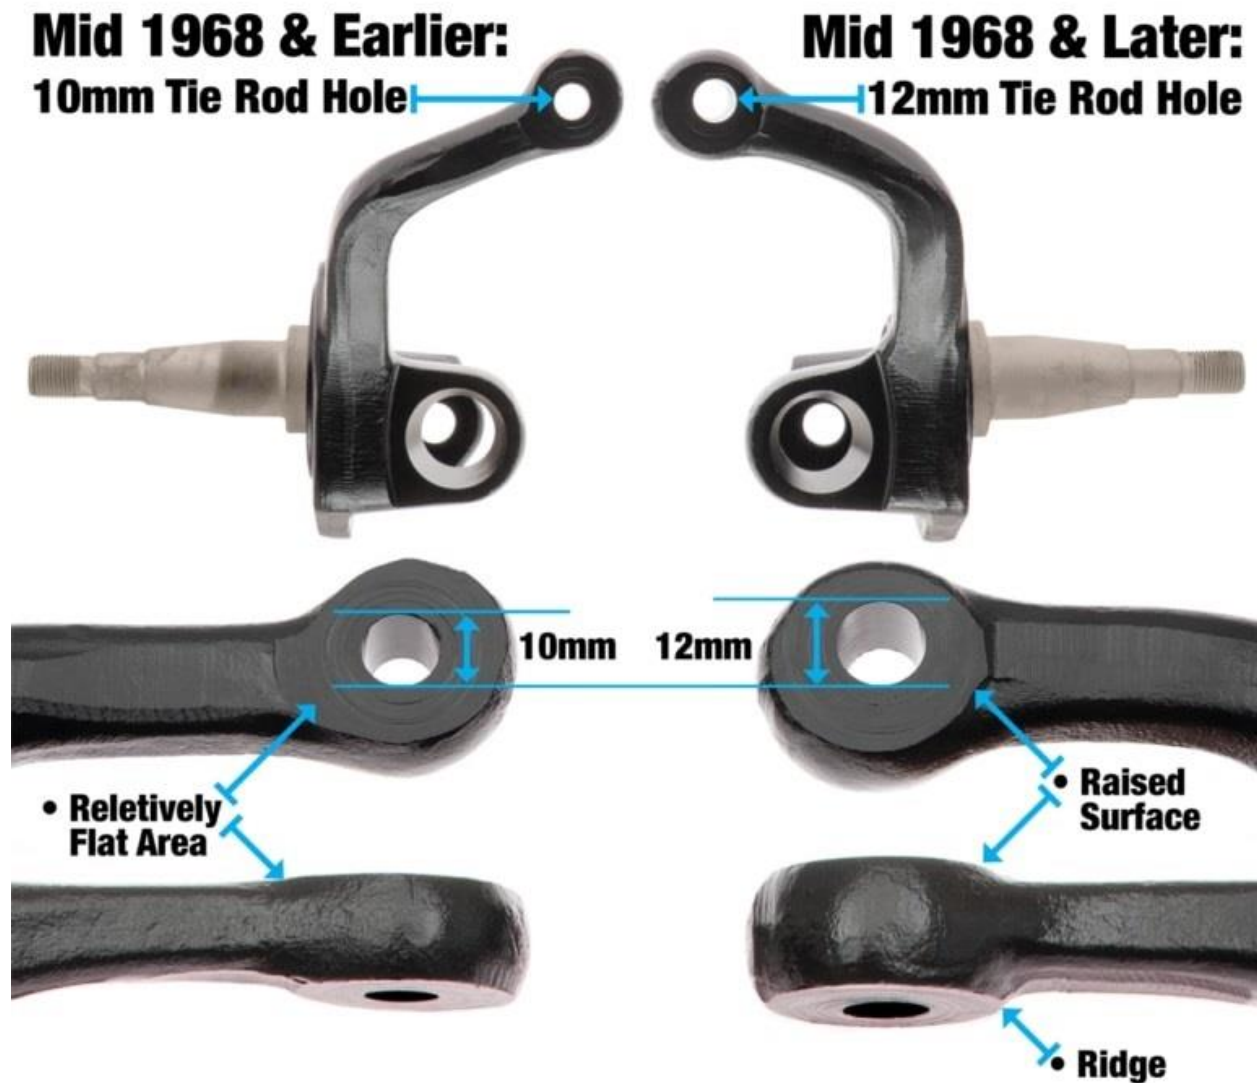
A Tale Of Two Spindles

A Tale of Two Spindles:

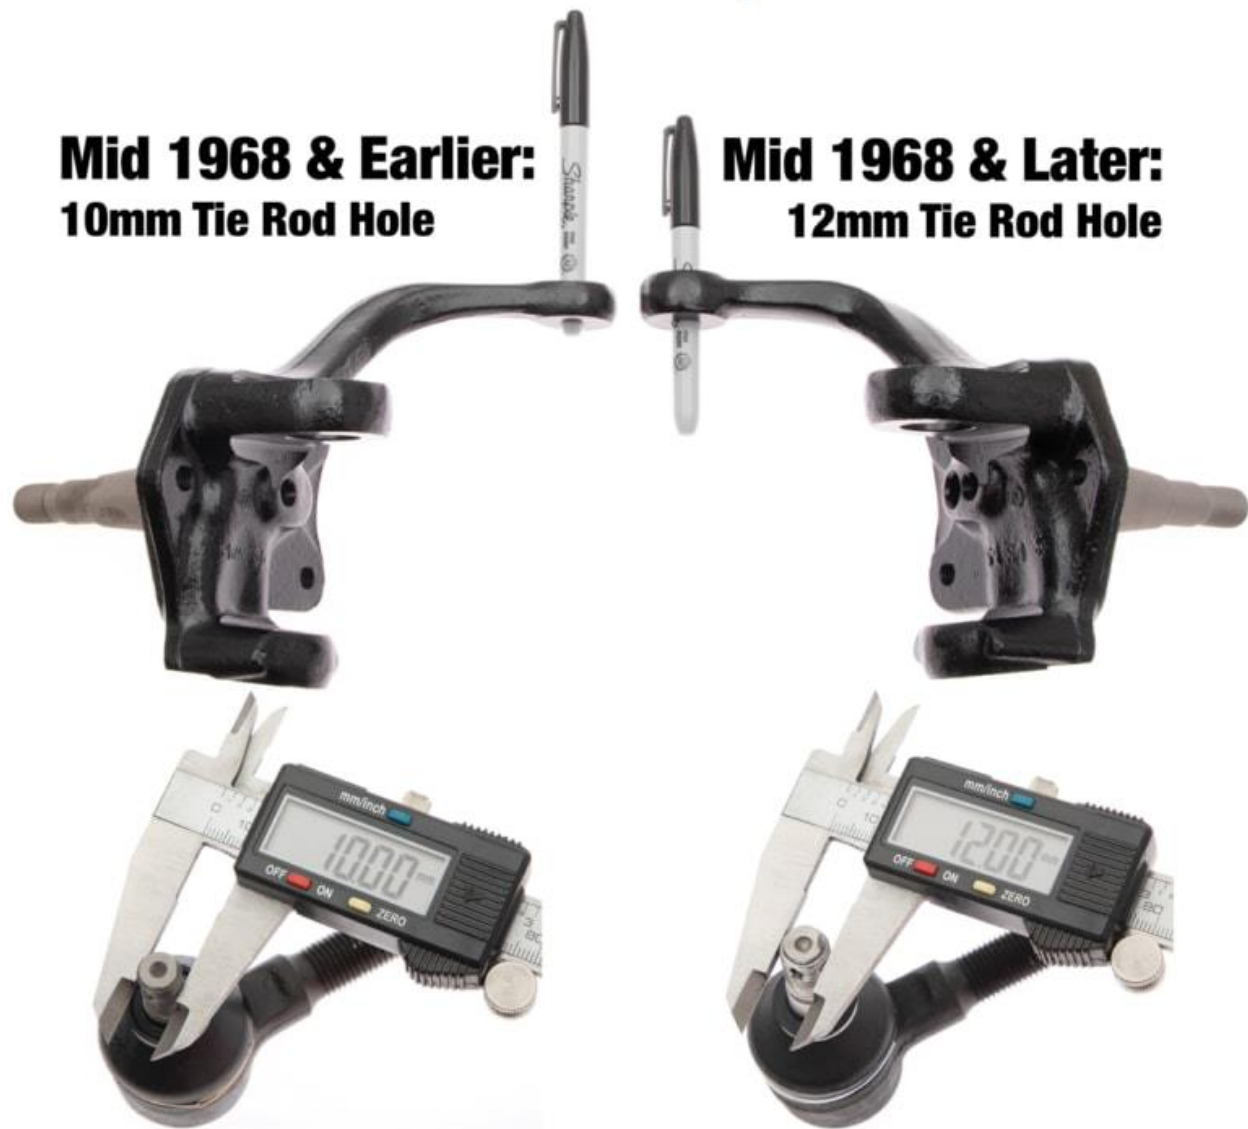
Take the Sharpie Test and the Truth will be Revealed!

The image below illustrates an easy test you can perform with the Sharpie you should have in your toolbox. The 10mm early model spindles (left) will only allow about $\frac{3}{8}$ " of the Sharpie to poke through the tie rod end hole, whereas the 12mm late model spindle will pass the Sharpie to the middle obscuring the logo on the pen. You can also use calipers to measure the threaded end of the ball joints currently on the car to determine which setup you have.
