Weld-i[®] 1000 Thermal Proof Test

Weld-i[®] 1000 Thermal Proof Test 10-10-12

This report covers the results of a thermal proof test performed on a Weldi 1000 system. The test simulated harsh thermal conditions found in common weld applications and validates system performance in high temperature environments.

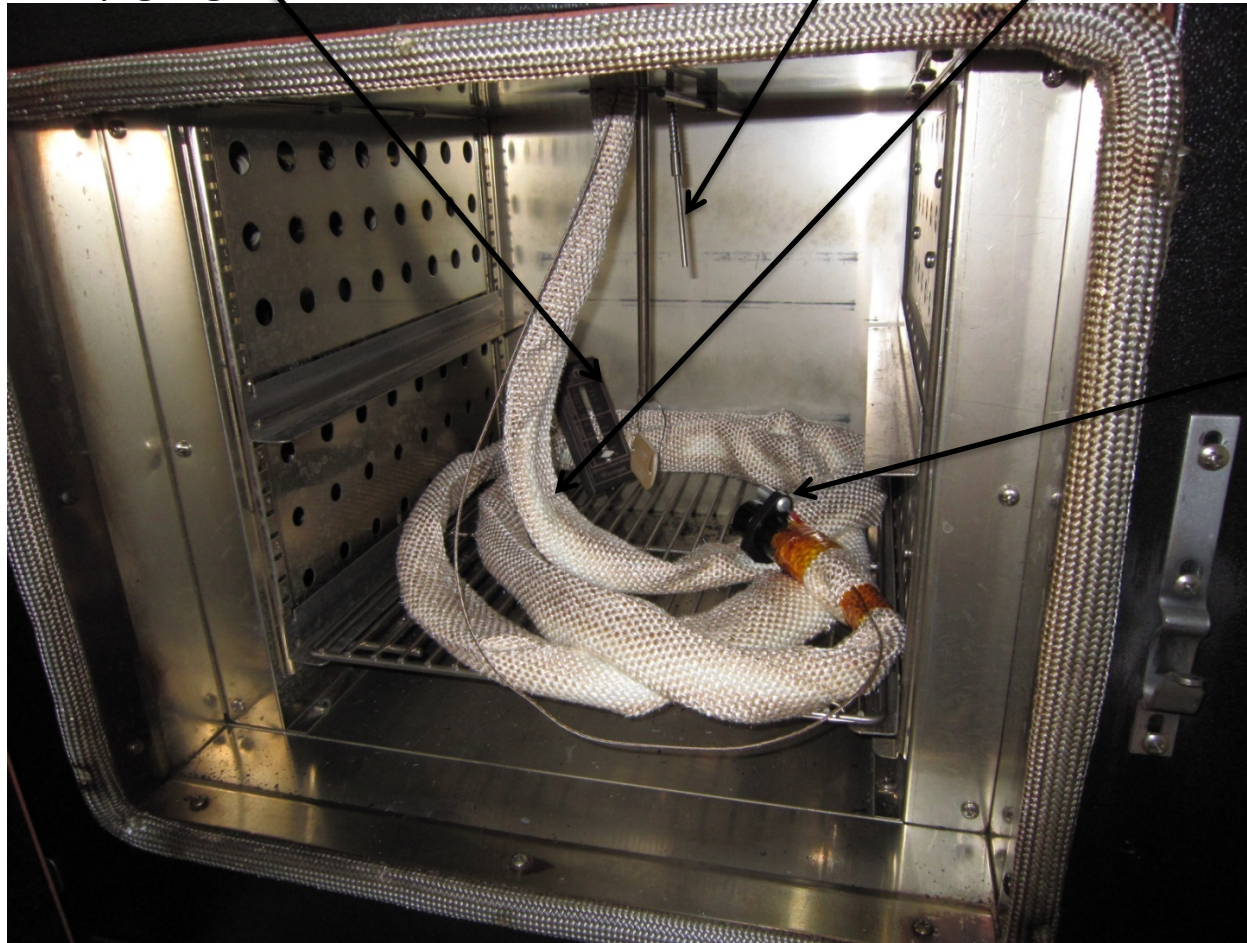
600F test Weld-i® 1000 - setup

Visual targets

Rotating tag & temp gauge

Fiberoptic light guide

Provide aux illumination

2.5 m umbilical in hot zone

Weld-i 1000
head

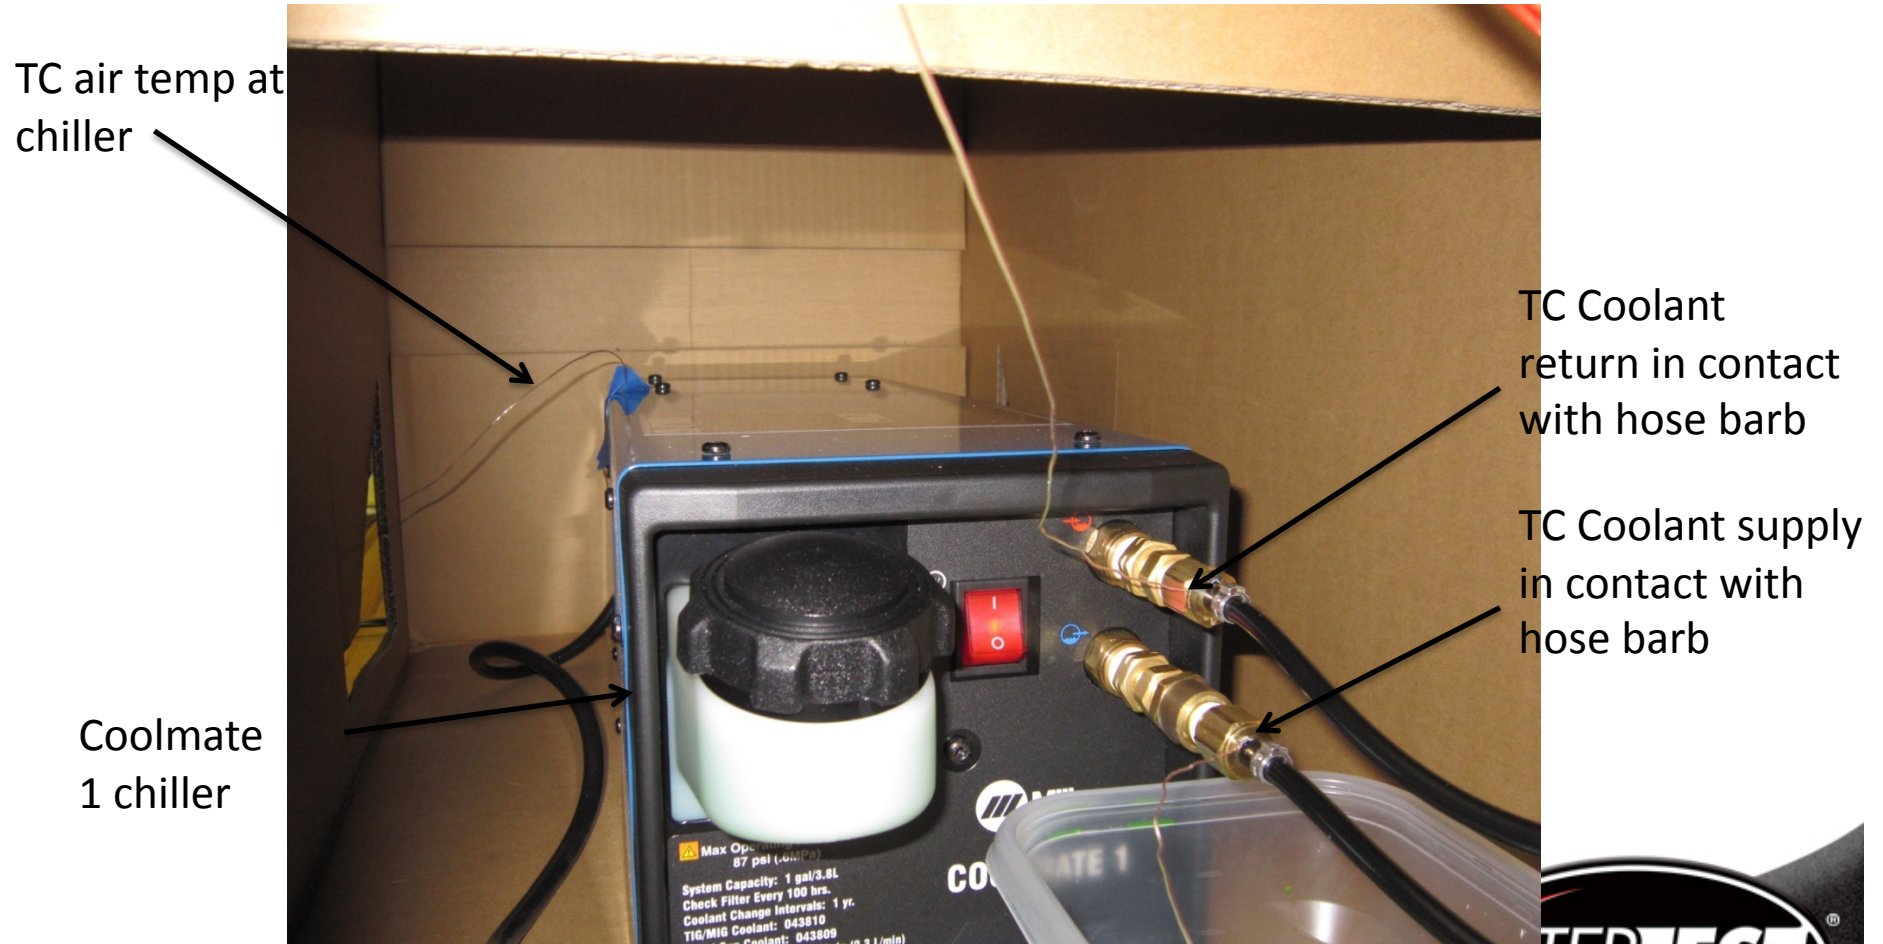
600F test Weld-i[®] 1000 – setup

Operated within enclosure to allow high ambient conditions

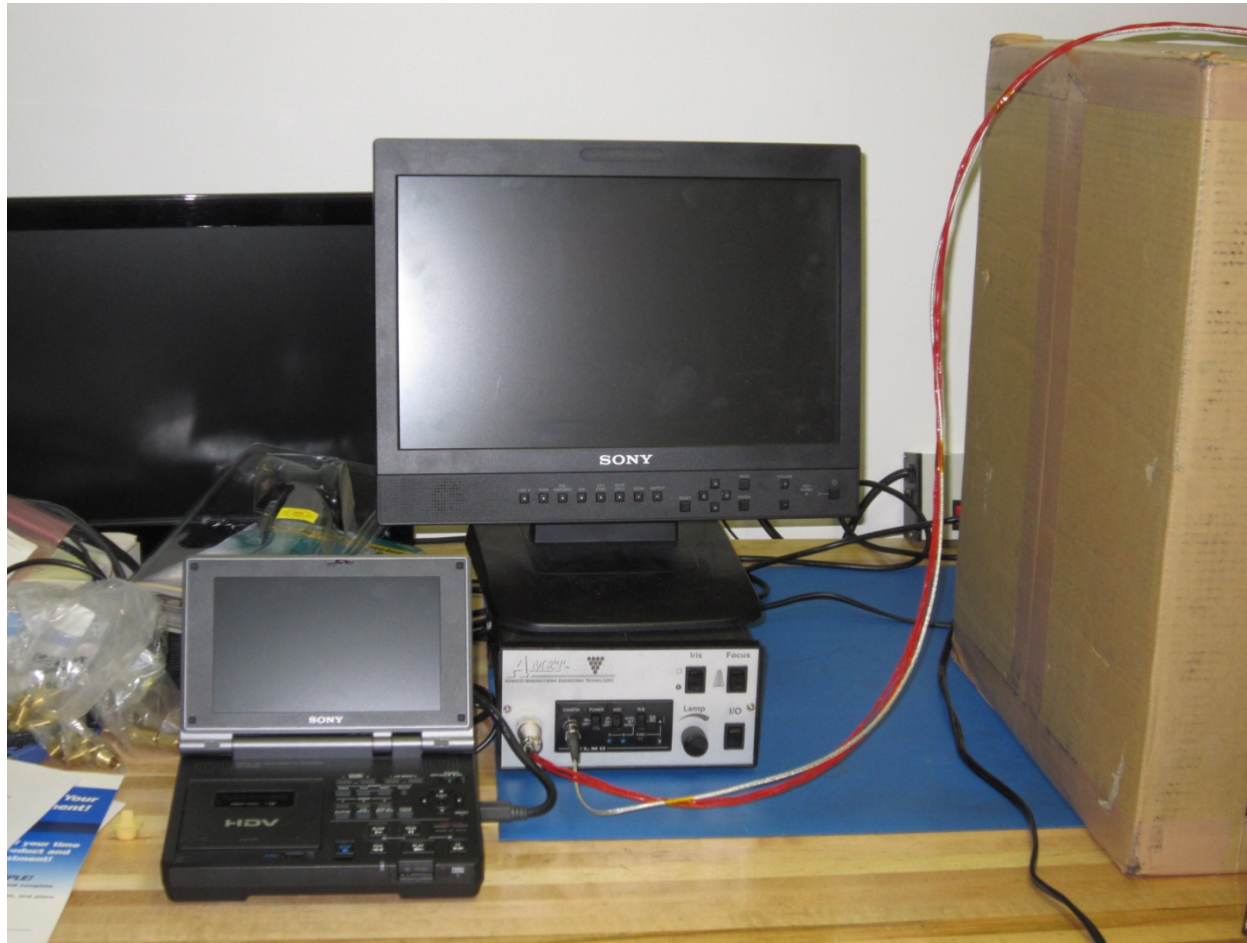
600F test Weld-i[®] 1000 – setup

Display, control unit & video recorder

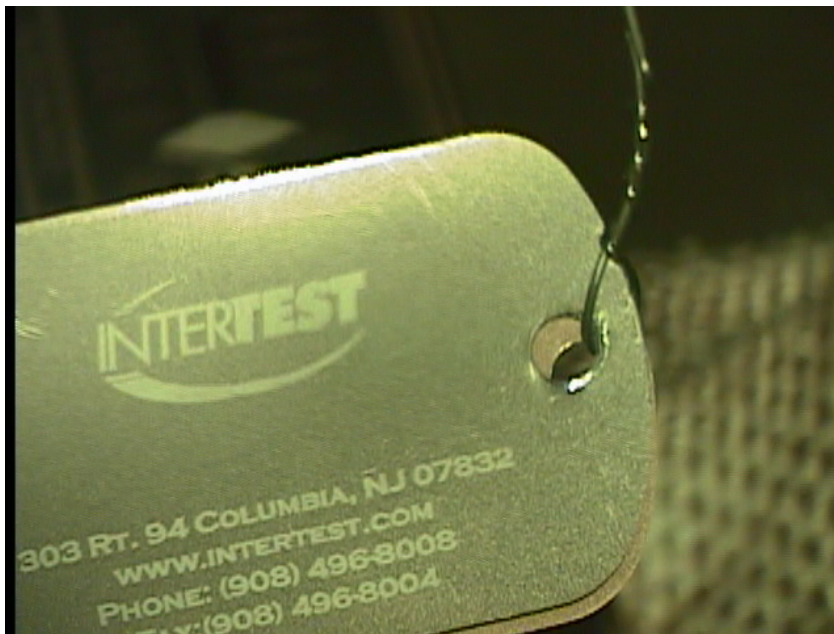
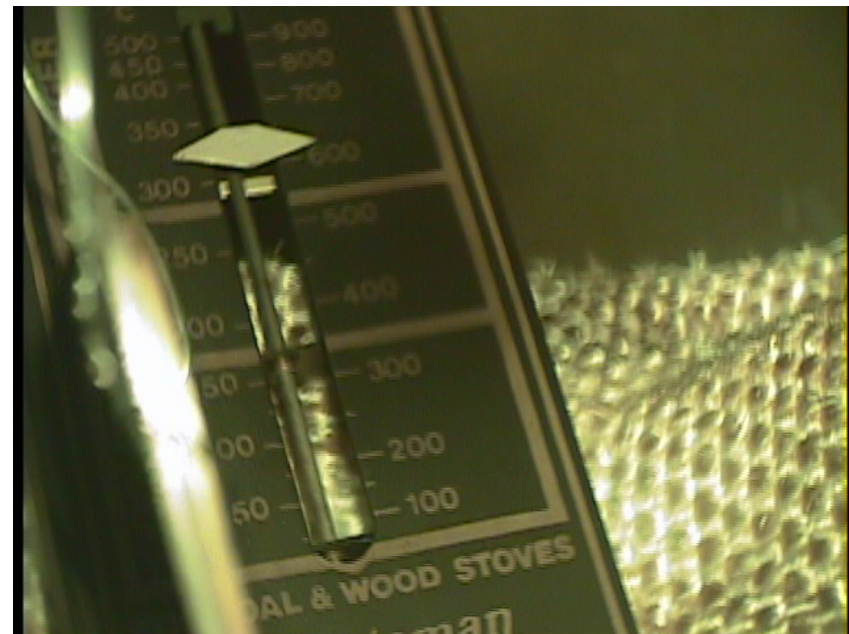
View from Weld-i® 1000 head at 600F focused on two targets in test oven
Left is rotating target in foreground
Right is temp gauge in background

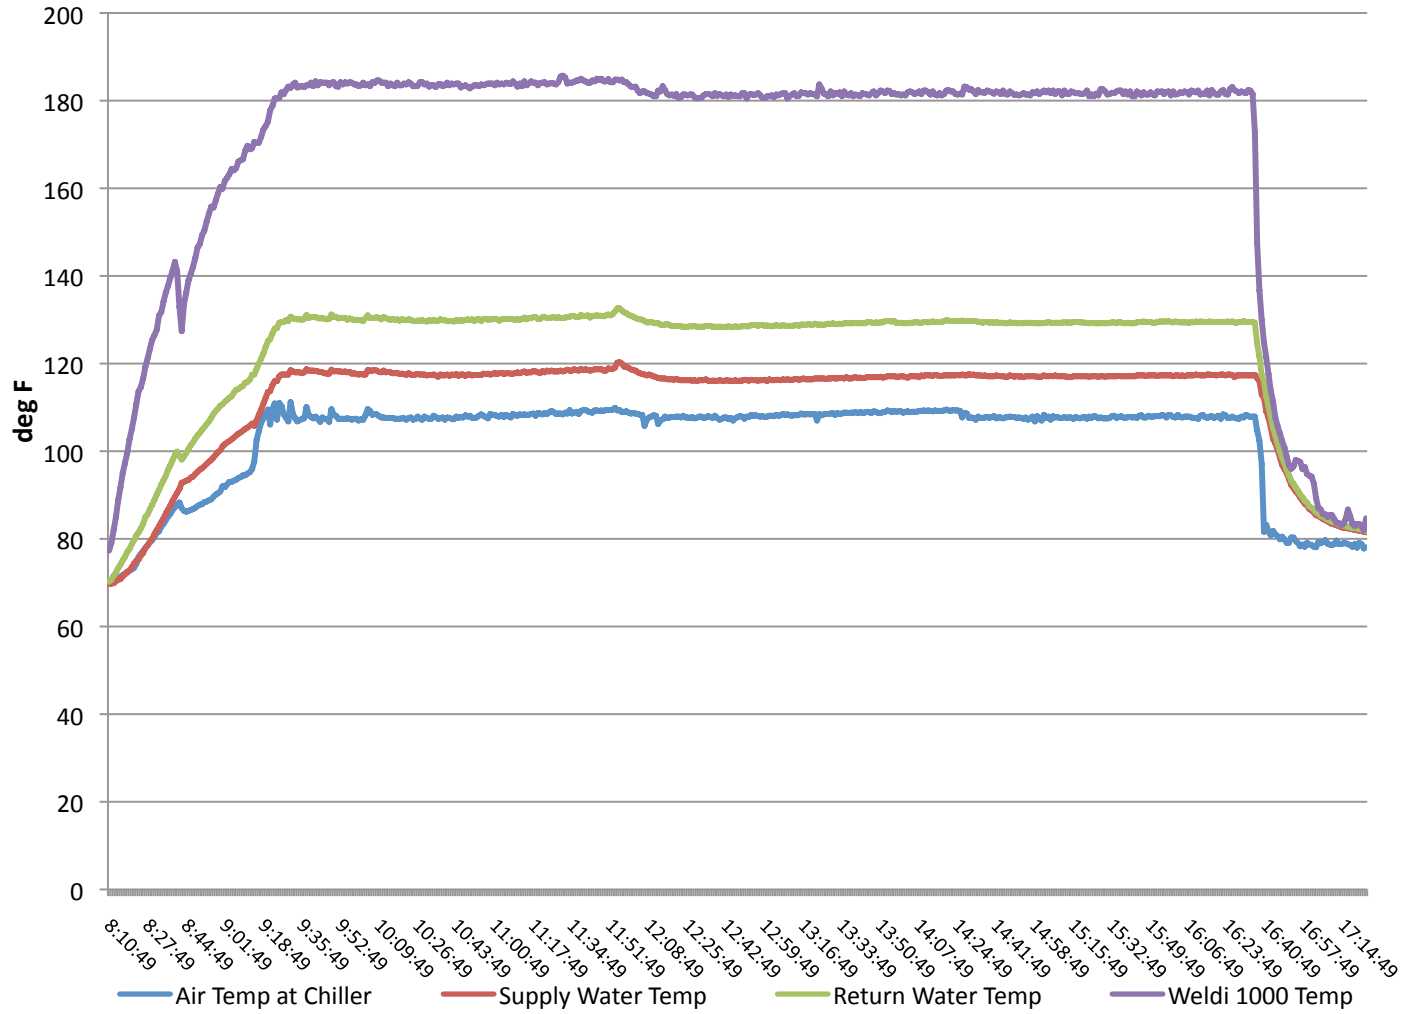
Weld-i® 1000: 600 deg F Test Data

- Weld-i® head + 2.5 m of umbilical operated in convective oven set at 600 F (315C) for 8 hrs
- Miller Coolmate 1 chiller with aluminum protecting antifreeze coolant operated in 107 F ambient conditions
- Direct plumbing of chiller supply and return ports to 3.5 m Weldi 1000 umbilical
- Coolant, Ethylene Glycol, supplied at .17 gpm and 40 psi
- Satisfactory performance of video, focus, iris, and light. Video on continuous throughout test. Focus, iris, and light checked for proper function on approx. 30 minute intervals throughout test.

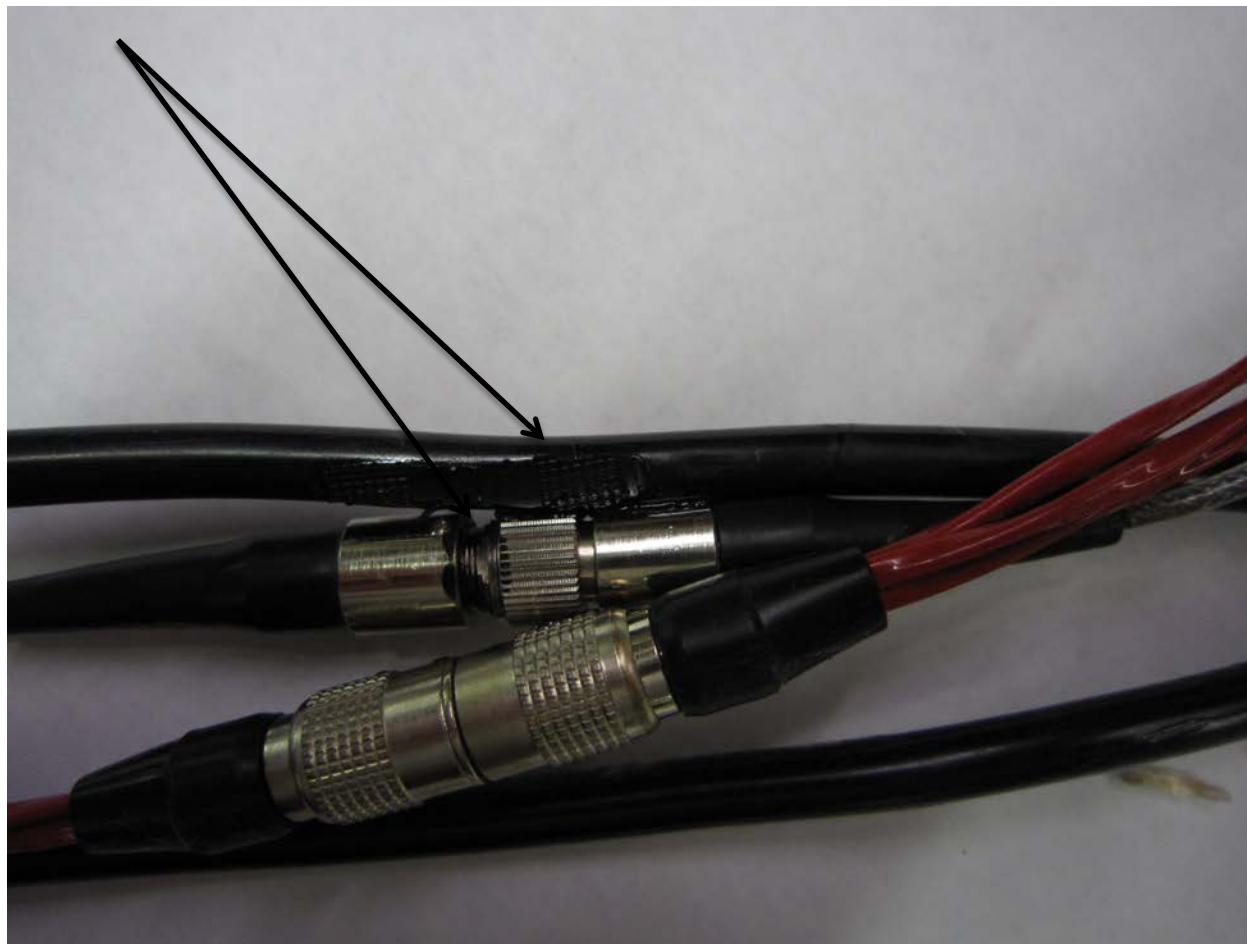
Tear Down Findings

Melting of plastic spacer on video cable interconnect

- On tear down inspection found localized melting of Teflon jacket on video cable. Teflon (PTFE) melts at 620 F (327 C). Suspect localized hot spot in oven, not considered to be a failure for proof of operation at 600 F
- On tear down inspection found melted plastic spacer at video cable interconnect. This part was replaced with metal component.
- On tear down found localized scar in tygon tubing. This was attributed to overheating during preliminary tests when there was momentary interrupt of coolant supply
