Hand Control Usage and Safety Assessment

Final Report
August 2001

**U.S. Department of Transportation Volpe
Transportation Systems Center**

**Automobile Safety Laboratory
University of Virginia**

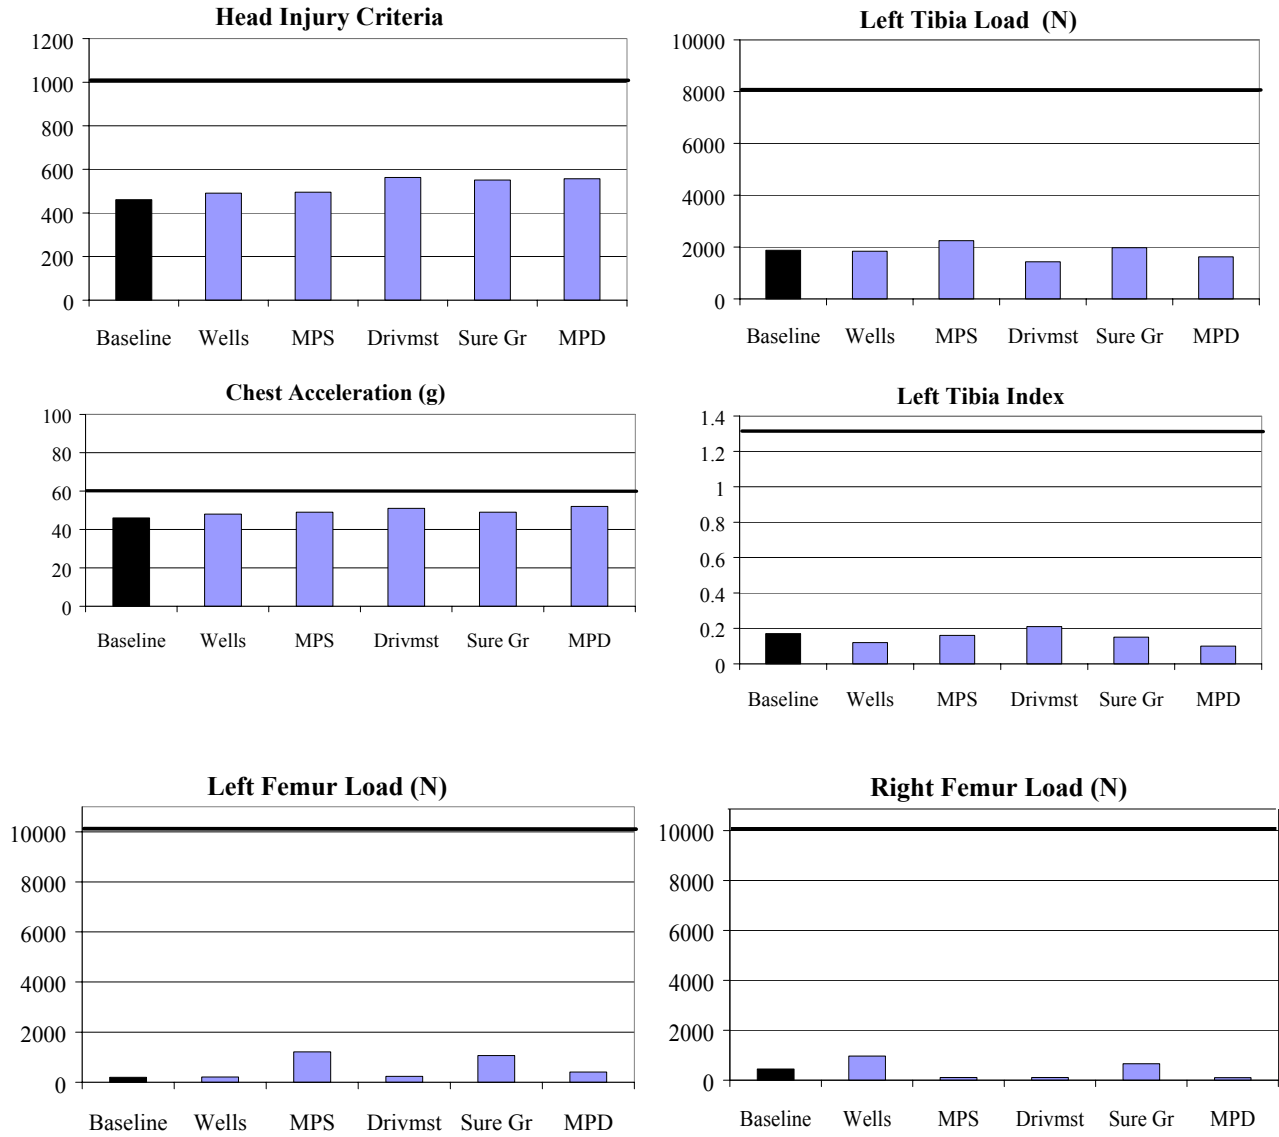
Figure 3. Injury criteria charts. The bold horizontal line indicates the injury threshold value.

We found that the hand controls and the knee bolster modifications necessary for their installation minimally affected crash safety. The most severe predicted injury was a moderate knee laceration. More generous radiuses on components mounted near the knees would reduce the risk and severity of lacerations. Injury criteria values such as HIC, chest g's, femur load, and the tibia index, were unaffected by the presence of the hand control (Fig 3). The results and conclusions of this study are based on a single crash condition. Hand controls and structurally compromised knee bolsters may perform differently in other crash environments. Modifications to the knee bolster structure should be avoided and, if possible, minimized in all cases.

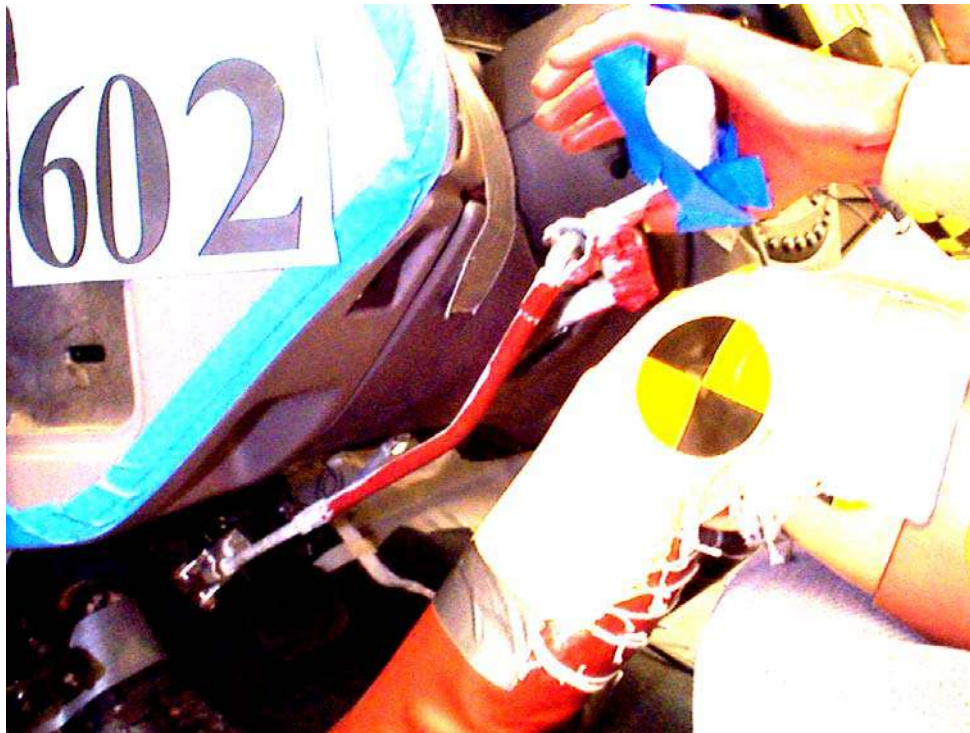
Figure 1. Typical hand control installation. MPS Monarch hand control pre-test 602.

Tests 600-605 were conducted to investigate the crash safety of commonly used hand controls. The tests included an initial baseline test conducted without a hand control (Table 1). Hand controls are devices used by people who are unable to operate the brake and accelerator pedals due to physical impairment. Hand controls typically are rod linkages attached at the lower end to the brake and accelerator pedals. The rods are supported by a bracket mounted underneath the steering column and terminate in a single handle positioned near the perimeter of the steering wheel. Pushing this handle pushes the brake pedal. Moving this handle back or down, or twisting the handle pushes the accelerator pedal (Fig. 1).

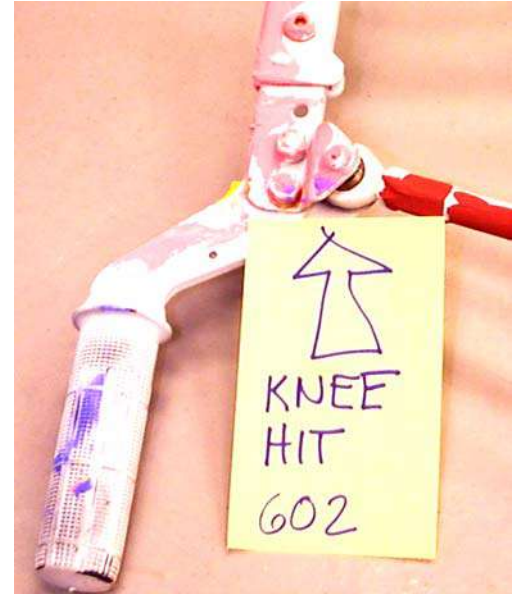
Figure 6. Edge of nut that caused knee cut on the underside of the hand control.

Figure 5. Knee cut in test 602 indicated by arrow.
