RV6 Performance Front Compliance Mount and Spherical Bushing Install Guide For 10th Generation Civic Type R FK8

This is an install guide written for the RV6 Performance front compliance mount and spherical bushing kit for the 10th generation 2017+ FK8 Civic Type R. This kit replaces the two chassis mounted rubber bushings on both left and right front lower control arms with solid bearings. The components referenced here are specific to the 10th generation Civic Type R, but RV6 Performance does offer respective parts for non-Type R models. This kit is aimed to remove all the play and slop around the front suspension and provide a clean, crisp and responsive feel when turning. Note that when moving from compliant rubber bushings to solid bearings an increase in NVH can be expected.

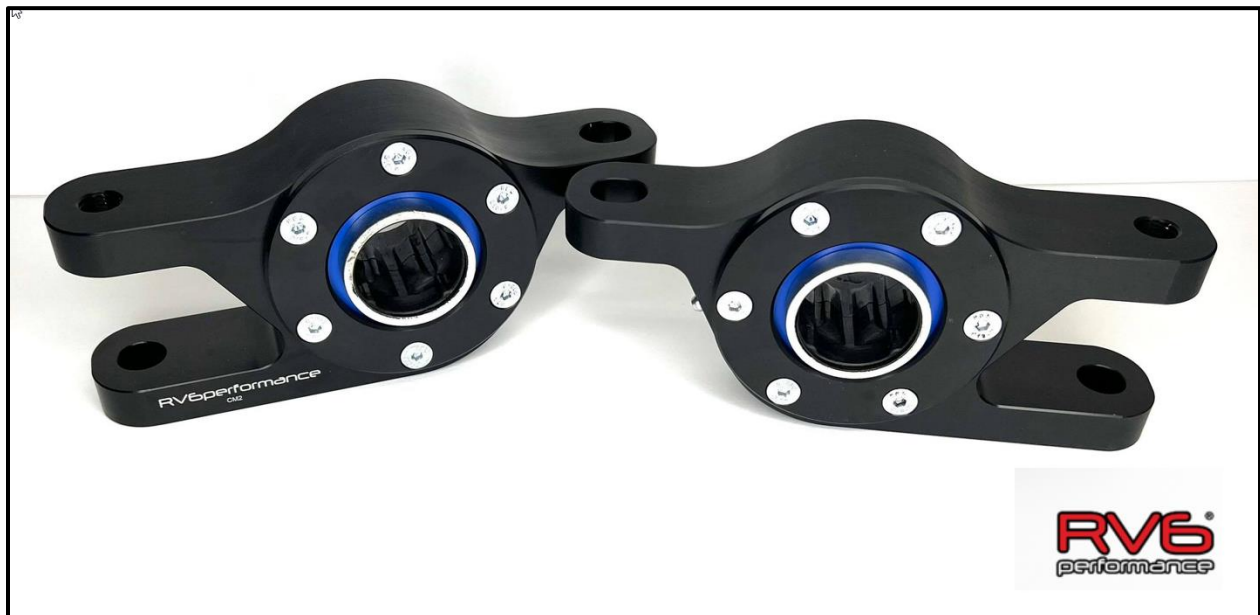
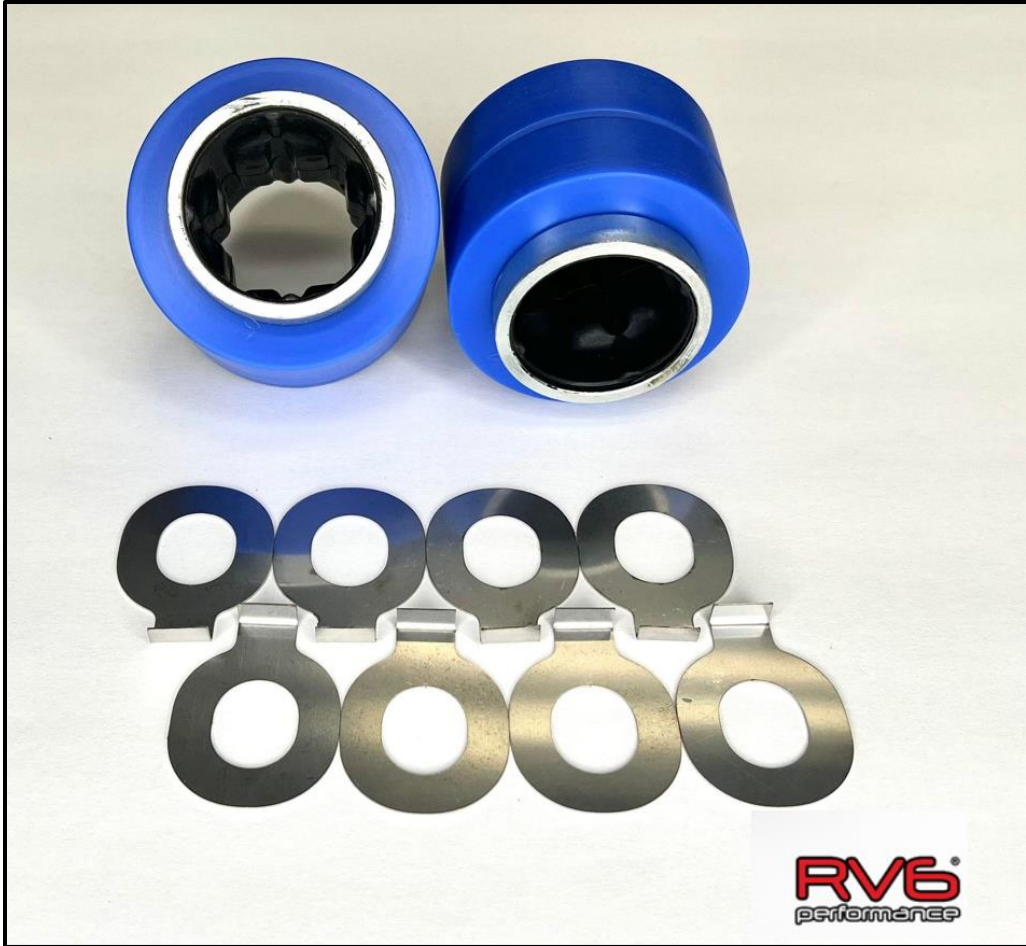
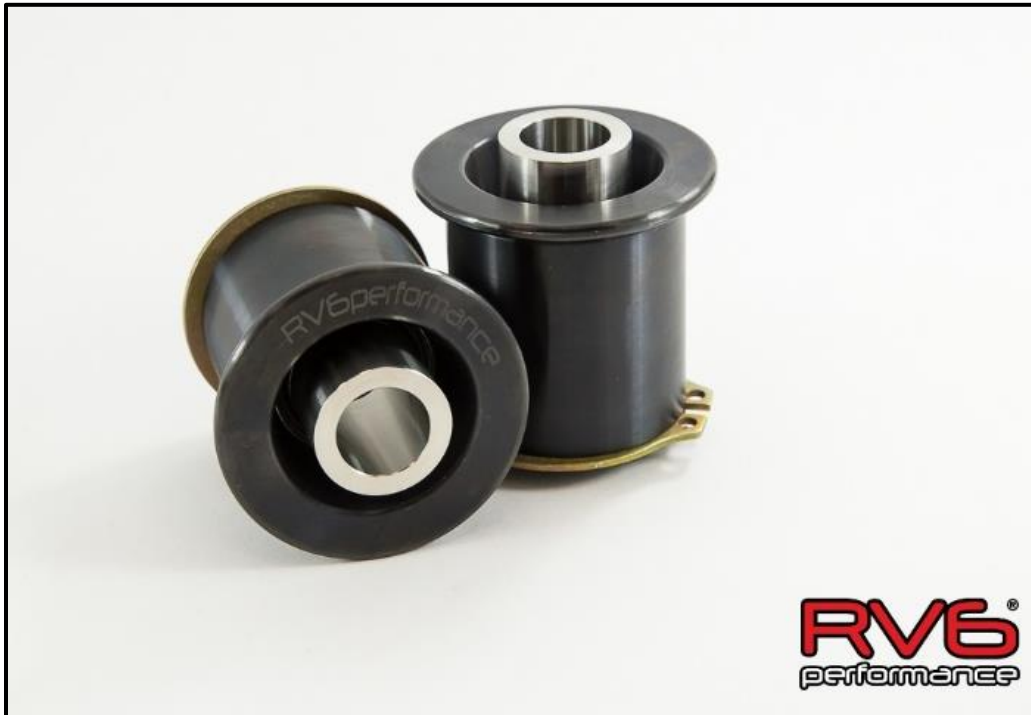
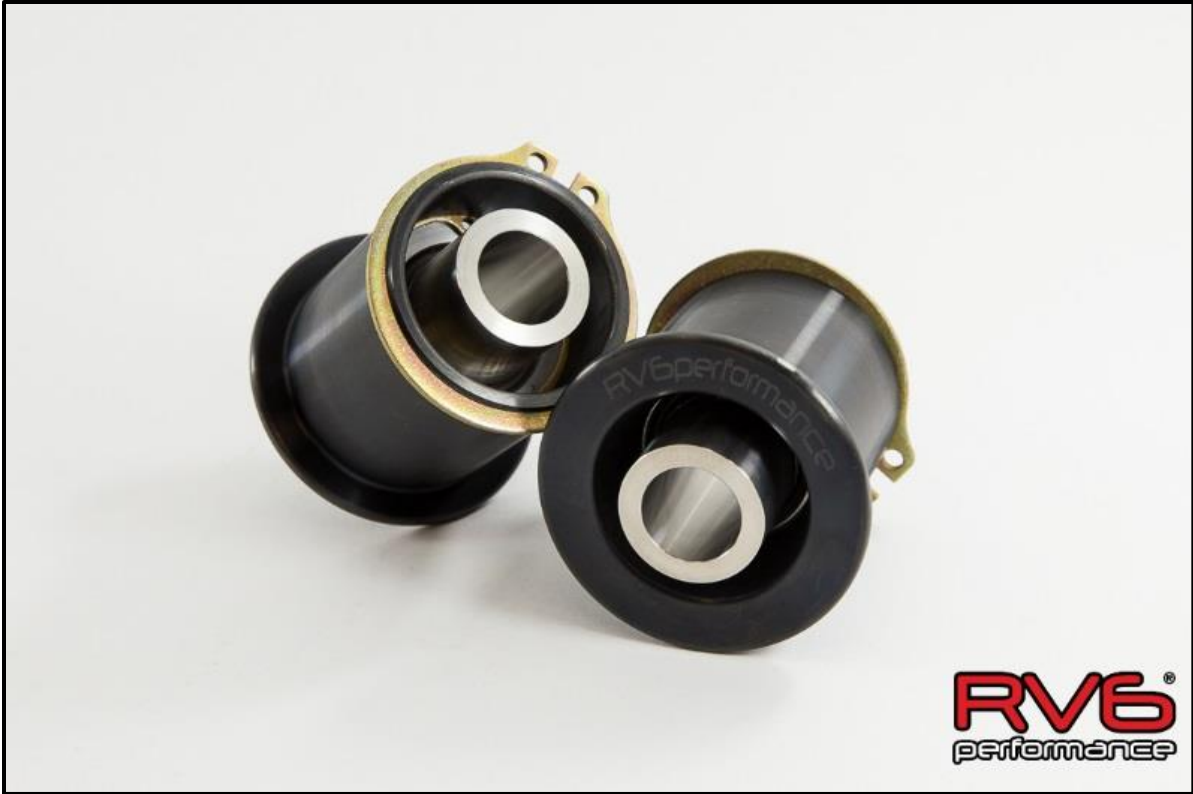
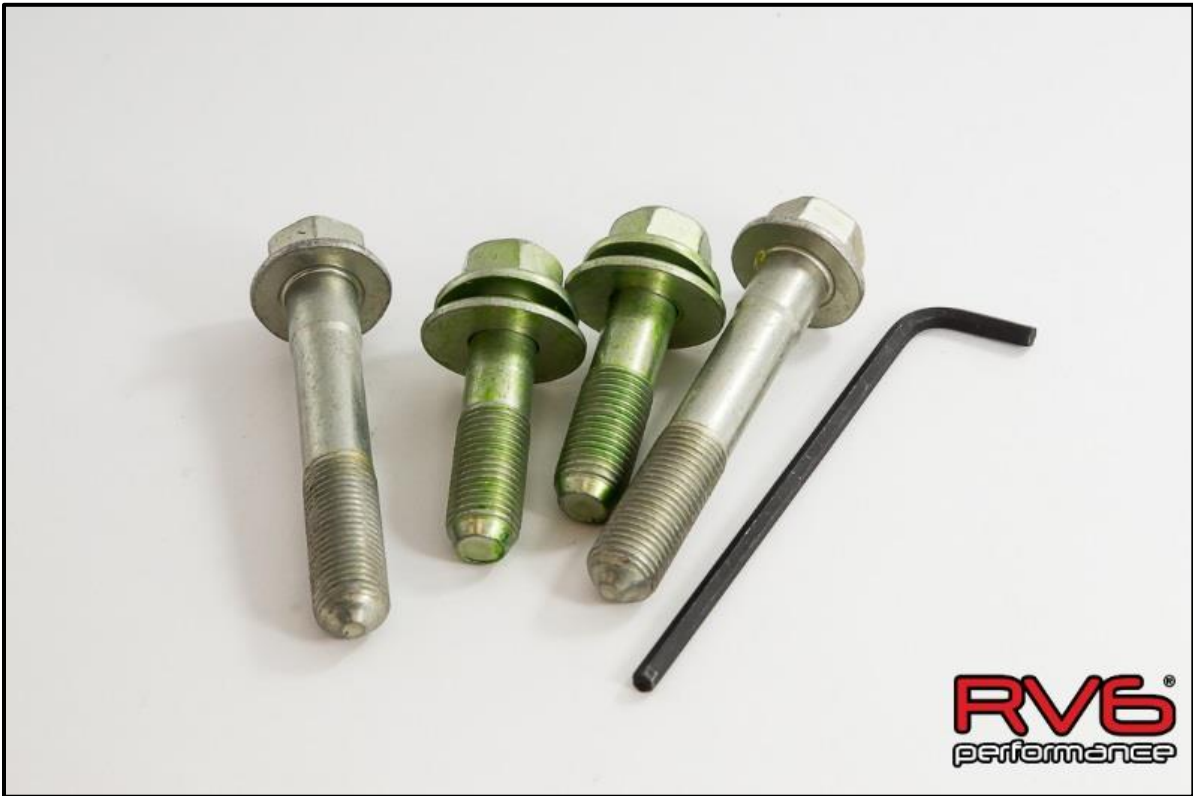
Included in this kit are 2x spherical bearings to replace the front bushing in the control arms (including 4x steel spacers to make the bearing an exact drop in), 2x solid compliance mount bearings and housings to replace the entire bushing and housing at the rear of the front control arm (including a shim pack to fine tune the bearing housing fit against the front sub frame), and 4x new bolts to secure the rear compliance mount housings to the chassis. A 4mm Allen wrench is also supplied to finish assembly of the compliance mount housings. Note the 2x stock M16 bolts securing the front control arm spherical bushings to the chassis must be re-used.

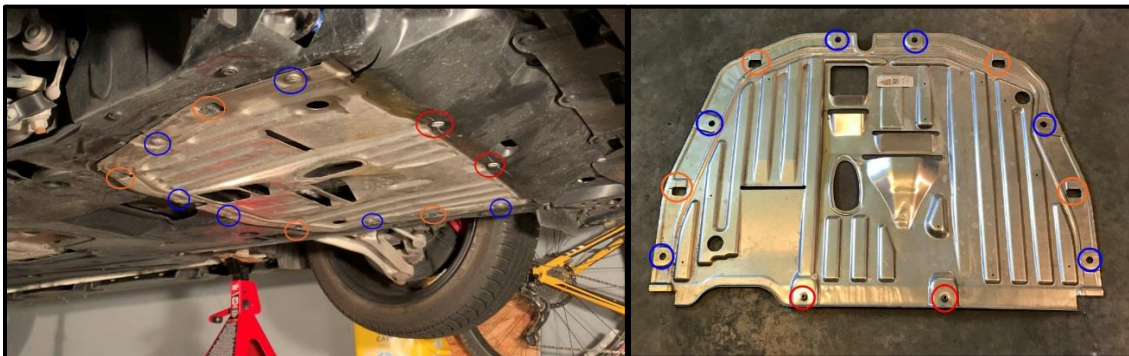
- 2.1: Remove 2x Phillips head machine screws at the front edge of the belly pan (Red Circles.) Remove 6x 90 degree plugs with a flat head screwdriver (Blue Circles.) Slide belly pan rearward to release it from the 4x tabs (Orange circles.)

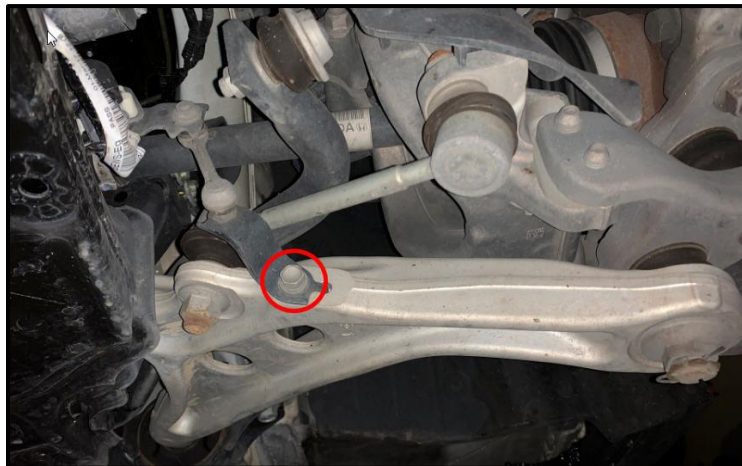
- 3.1: Remove 1x 12mm head bolt securing the ride height sensor linkage bracket from the control arm (Red Circle.) Gently reposition the linkage away from the control arm.

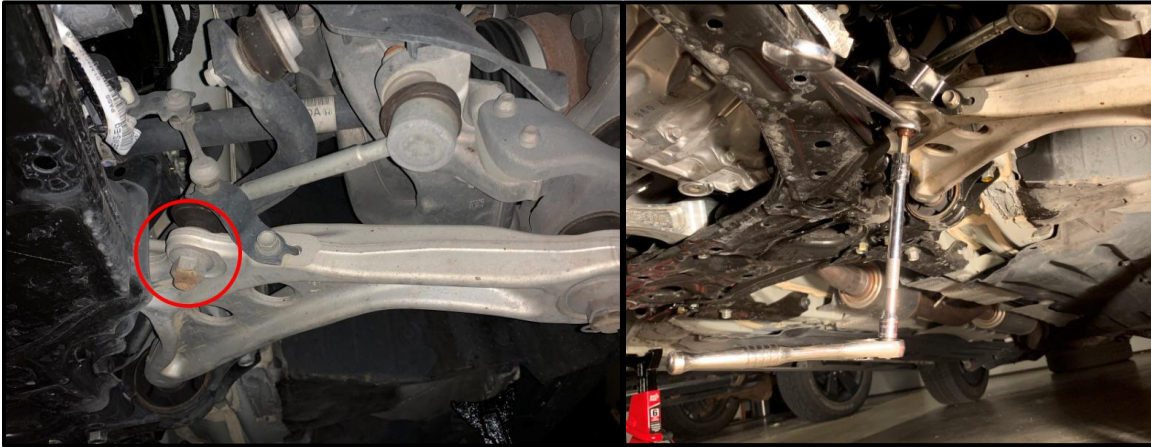
- 3.2: Remove 1x 19mm nut from the linkage stud (Red Circle.) This nut may be broken loose with a socket or impact but to fully remove the nut the stud will need to be retained with an 8mm hex bit while the nut is turned with a 19 mm wrench. See the photo below for a possible tool arrangement. Note there may not immediately be enough clearance to remove the linkage stud from the control arm - do not force the stud through the arm as this may damage the threads.

The steering knuckle can be rotated slightly to allow more freedom to slide this stud through the control arm or it can be removed once the ball joint is separated.

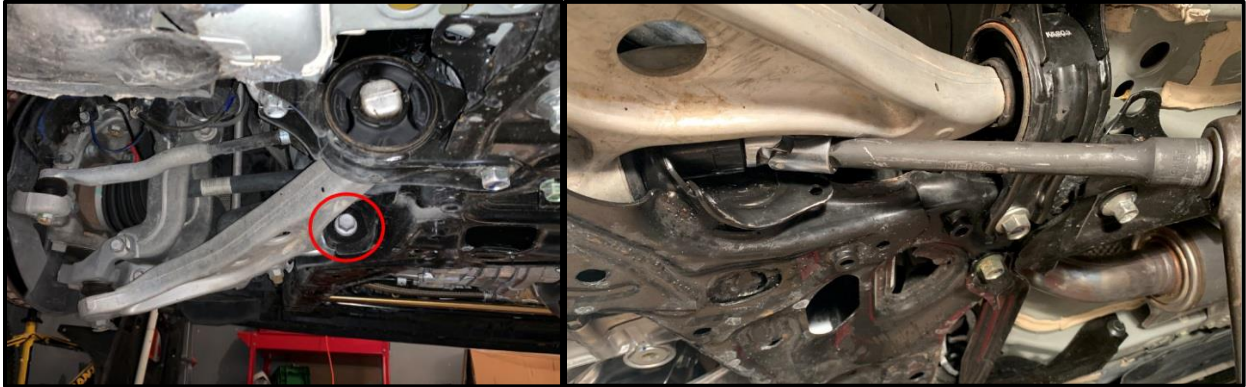
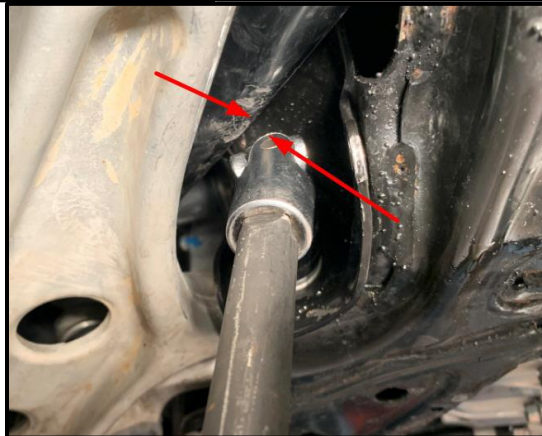
- 3.4: Remove 1x 19mm head bolt securing the front control arm bushing (Red Circle.) This bolt is the most difficult to access even after gaining more clearance by rotating the front sway bar. The method used here to remove the bolt was as follows:
 - Initially loosen the bolt with a 19mm socket and a breaker bar.
 - Continue working the bolt out using a 19mm socket, universal joint, extension and ratcheting socket wrench. Note this will only work for part of the removal as the universal joint will interfere with the sway bar at a certain point (Red Arrows in the final image.)

Ensure you leave enough clearance to remove all tools, otherwise the bolt will need to be partly re-installed to remove the sockets. A shallow 19mm socket may reduce the difficulty of removing this bolt.

- Finish removing the bolt with a 19mm wrench. There will be clearance to fully remove the bolt from the chassis.

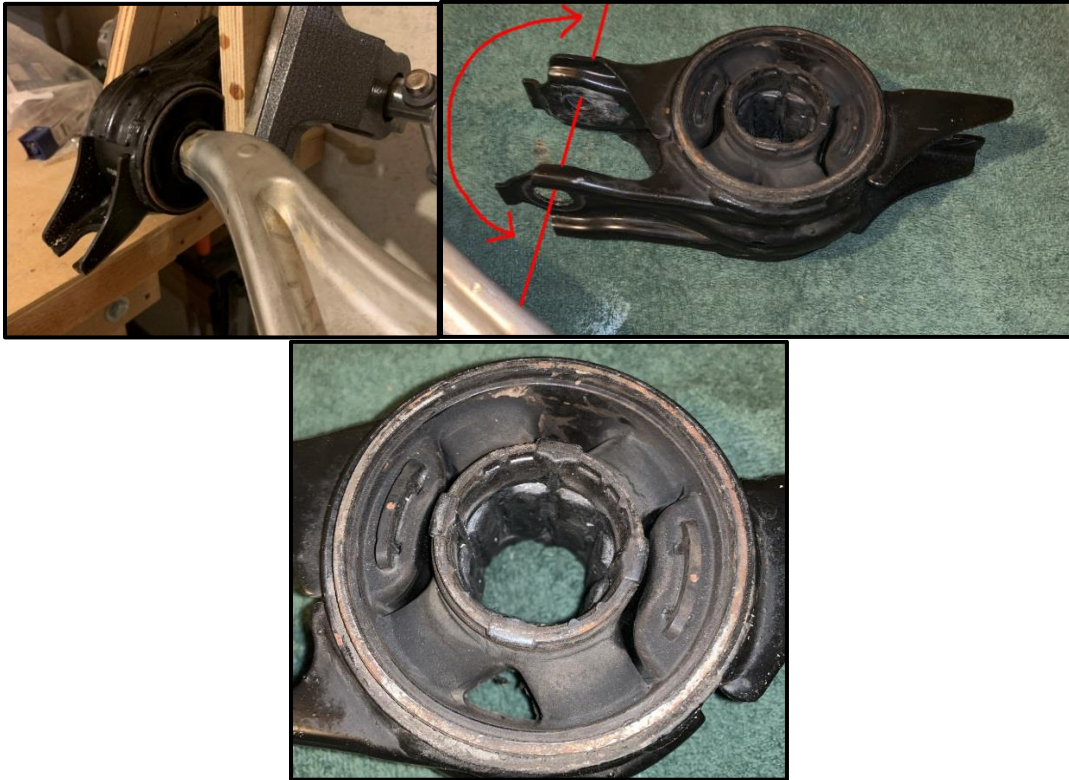
- 4.1: Remove the rear control arm bearing and housing from the rear spindle of the control arm. This can be accomplished by clamping part of the bearing housing in a bench vise and twisting / pulling the control arm. Alternatively, the control arm may be secured to a solid surface and the bearing can be physically rotated and pulled to remove it. A screwdriver or solid rod can be inserted into the two holes on the clevis side of the bearing housing and then used to rotate the bearing against the control arm (depicted below in Red.) A combination of any methods can be used as long as care is taken not to damage the control arm when securing it (for example use

clamps with rubber holding surfaces or insert a sacrificial piece of scrap wood between the control arm and a metal vice.) The inner profile of the rear bearing is also shown to illustrate the "ribbed" profile that reacts against the square profile on the control arm spindle. It may be difficult to rotate the bearing against the spindle initially, but as you successfully slip the bearing against the spindle it will gradually become easier to perform the motion and ultimately remove the bearing.

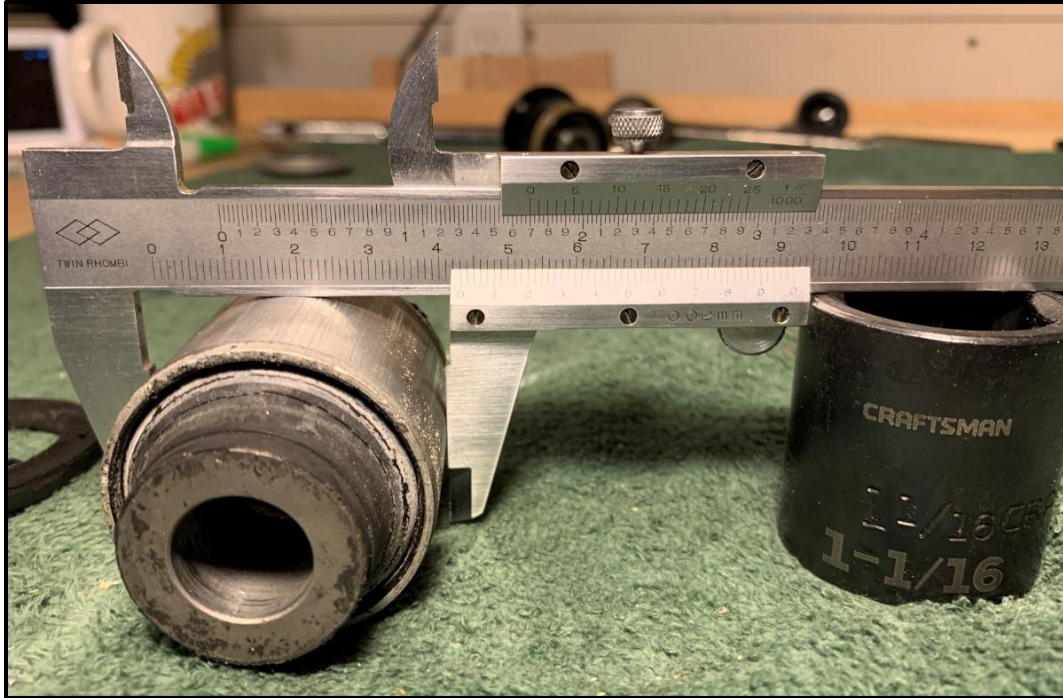
The first step is to find the "driving" portion of your press setup. The removed stock bearing is shown below, which was measured to have an outer diameter of roughly 43mm. This means that you want to find something to drive out the bearing with a slightly smaller diameter to react against the bearing sleeve without interfering with the ID of the bore in the control arm. The setup detailed here used a thick washer measuring roughly 38mm as the driver. This is about the same diameter as a 1-1/16" socket. This was the largest socket readily available, but a slightly larger socket would have worked well too. It is not recommended to use a driver smaller than 38mm in diameter.

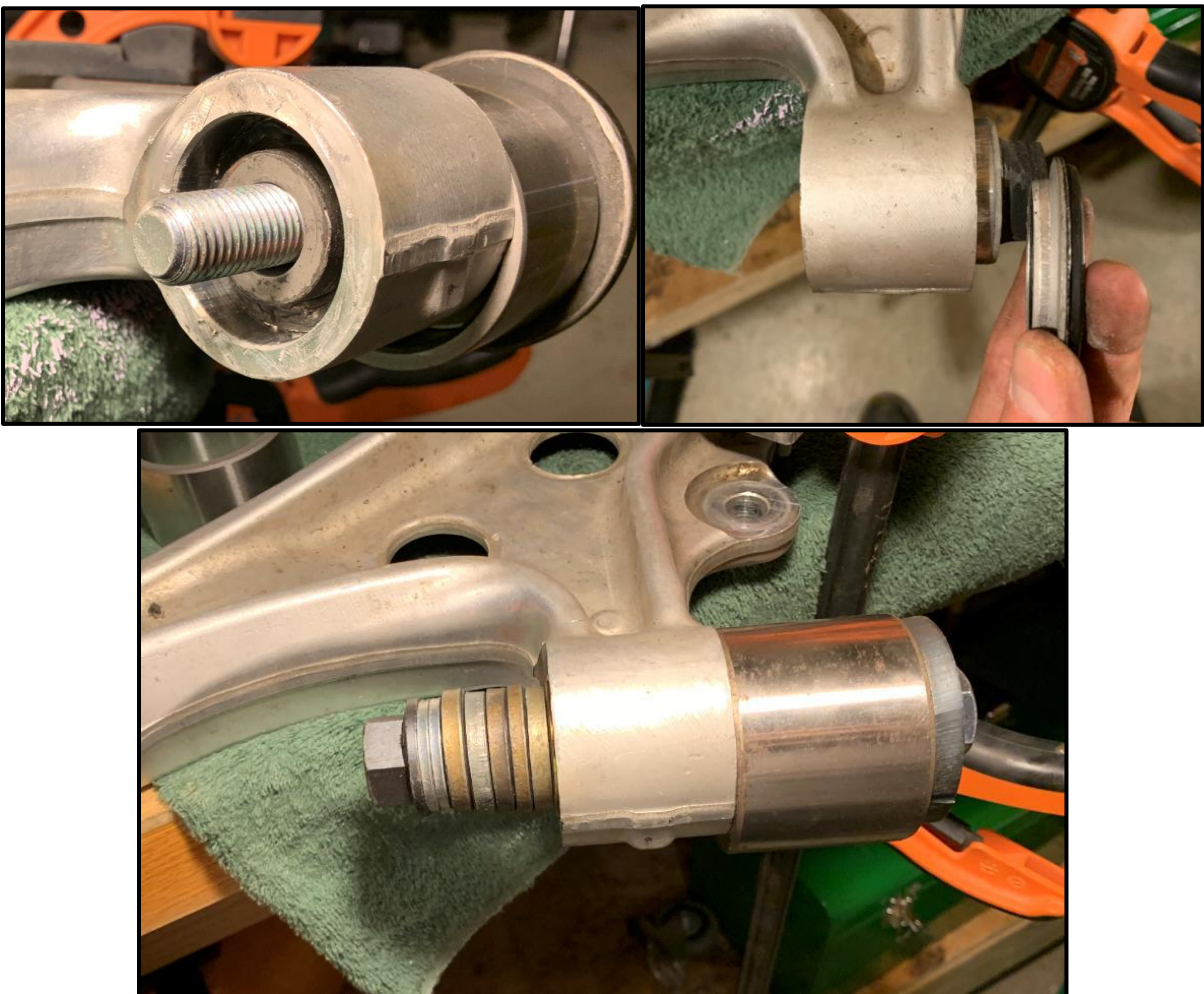
- 5.3: Remove the front control arm bearing using the pressing setup developed in the previous step. The bolt method will continue to be described here. As the bolt is tightened against the flange nut the bearing is gradually pushed into the "housing". The partially pressed bearing is shown below, which is also the moment the cap was identified as it fell out of the housing. Since M16 bolts in this length are generally not threaded on the whole length it is required to either loosen the joint and stack additional washers to properly space the bolt head and flange nut (as shown below) or to utilize a shorter length bolt. Continue this procedure until the bearing is fully removed from the housing. Hand tools were used in the bearing removal, but an impact gun could be utilized to make the process easier.

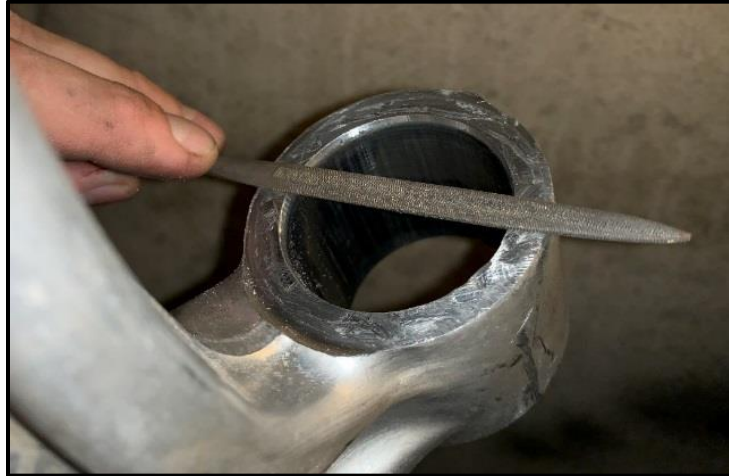
- 5.4: Prepare the control arm for the new bearings. As mentioned in the steps above a small amount of marring was incurred on the rear face of the control arm bore when prying off the integrated flange. A small file was used to remove any burrs or raised portions both on the rear face and the chamfer to the bore. The image below makes the marring look much more severe than reality due to the lighting. Small scratches on the face are acceptable as this surface only acts

as a stop to retain the bearing. The important part is to ensure any high areas are knocked down to allow the new bearing to be pressed in fully. Take care not to overly scratch or change the shape of the internal bore itself. At this point it is advised to clean the bearing surfaces while the components are on the bench prior to assembling any new components. Brake cleaner was used to clean the rubber residue left on the spindle from the rear control arm bearing removal and to ensure any metal shavings from the front control arm bore were removed.

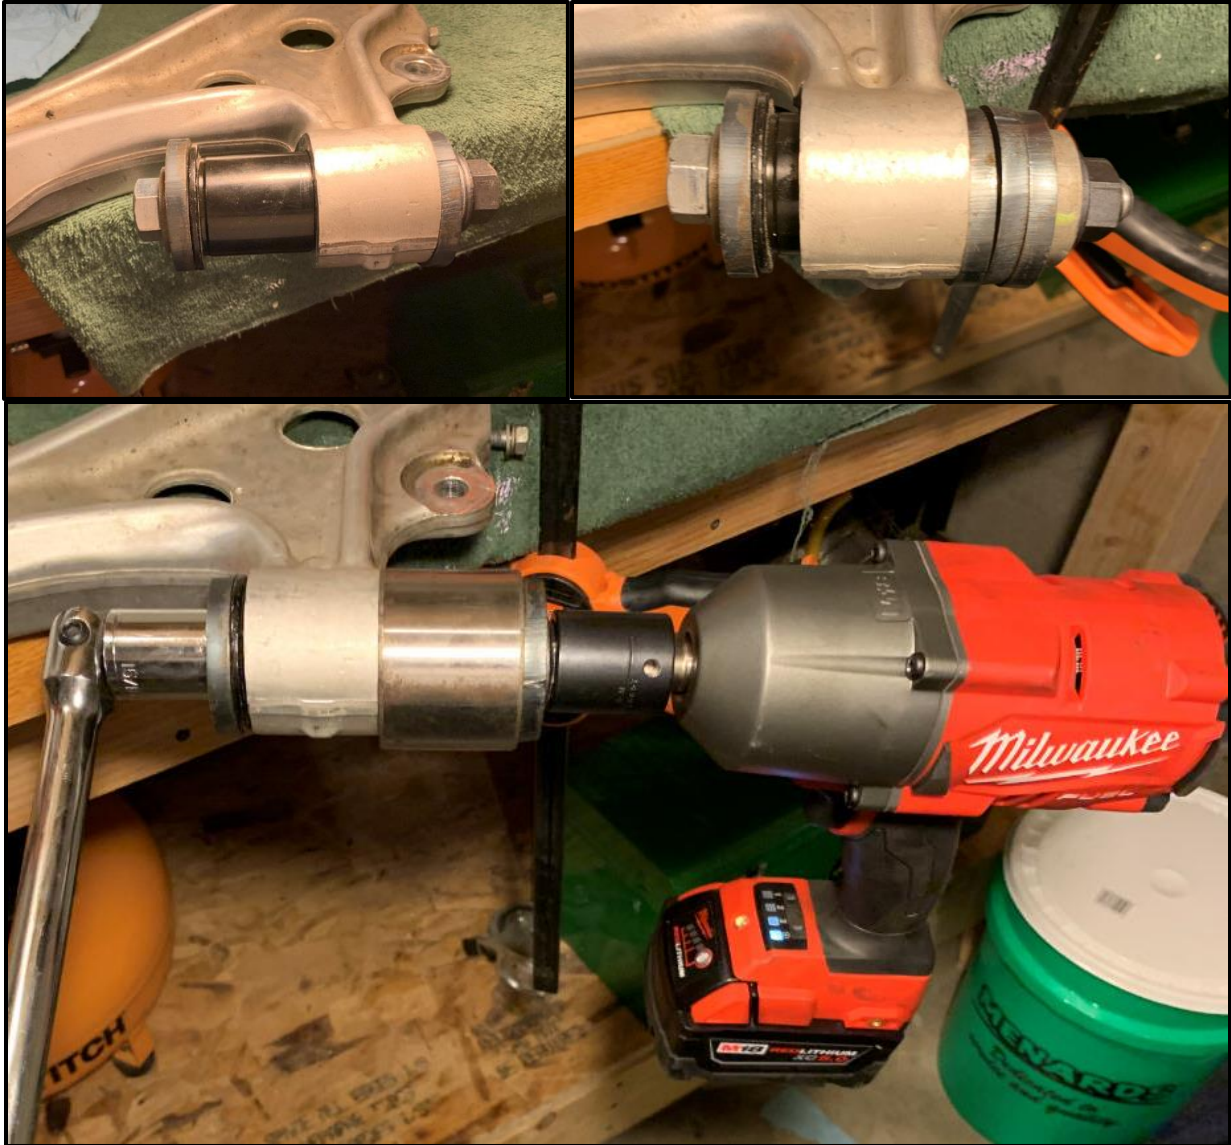
- 6.1: First ensure that the metal spacers on either side of the new spherical bearing are removed prior to pressing into the control arm. Using the same or a similar setup as detailed in step 6 the new spherical bearing can be pressed into the front bore of the control arm. The bearing is symmetrical and should be able to be assembled from either end of the control arm, but to maintain commonality with the stock vehicle it was chosen to press this bearing in from the rear face towards the front. The images below show the press used in various stages of assembly. The important notes for this step are:

- If using the bolt method initially torque the joint by hand to ensure proper seating and initial insertion of the new bearing into the bore. If using a conventional hydraulic press carefully monitor the initial pressing to ensure alignment during assembly.

- This bearing becomes increasingly difficult to press into the bore as it continues to work into the control arm. As such at roughly the halfway point hand tools were swapped for an impact gun to finish driving the bearing into the bore. Continue to drive the bearing until the rear flange on the spherical bearing is fully seated against the control arm face.

- Be mindful that the new bearing will protrude through the front face of the control arm bore once it is fully assembled. As such make sure you utilize a hollow "housing" portion that allows the bearing the clearance to fully seat. Note the pipe section used instead of the thick washers in the final image below.

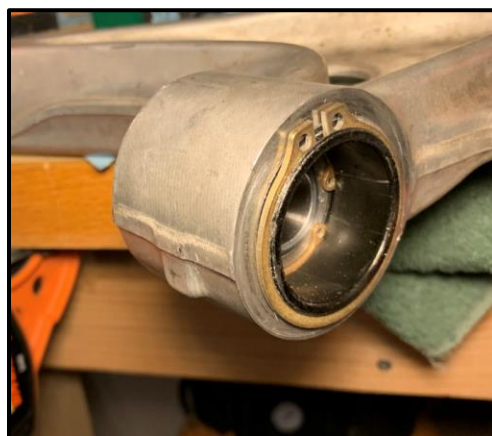
- 6.2: Using snap ring pliers assemble the retaining ring on the front of the spherical bearing once it is fully seated.

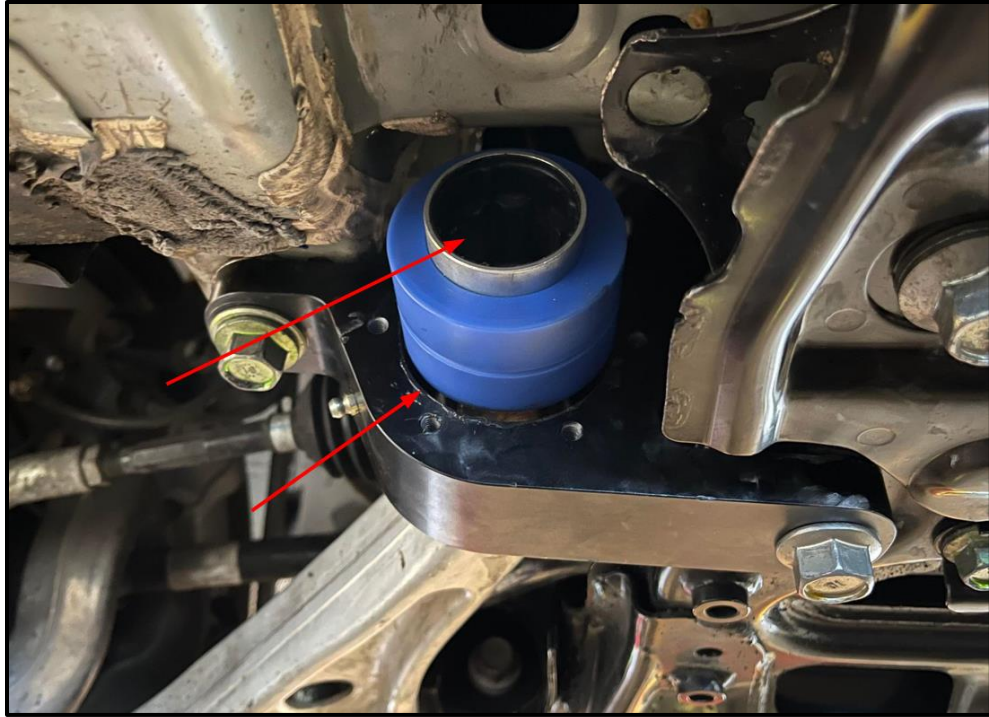
Next begin positioning the blue bearing onto the control arm spindle. Ensure that the grooves in the rubber lining of the bearing sleeve align with the profile in the control arm spindle (reference the Red Arrows below.) It should be possible to have the bearing slightly piloted onto the spindle by hand to keep it from falling off during the next steps. Grease can be applied to the inner surface of the housing and the spindle to make assembly easier.

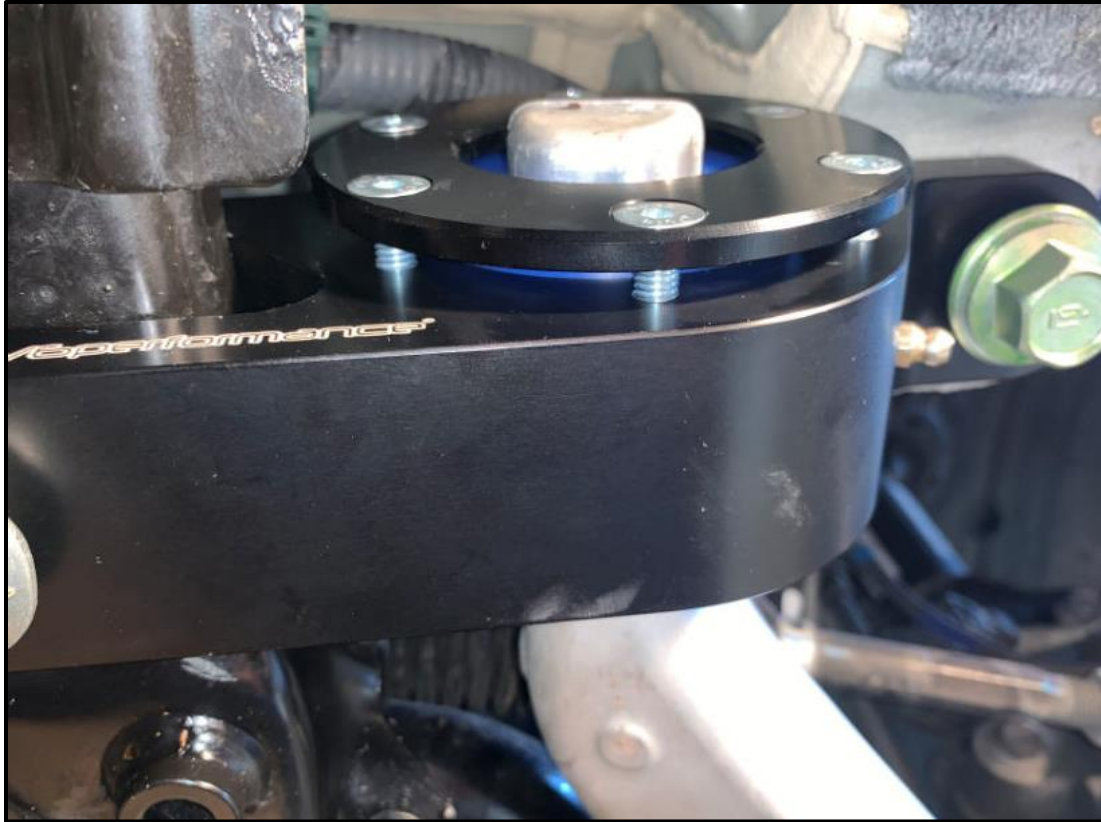
Due to the tight-fitting nature of this bearing against the spindle it will be required to be hammered on. It is advised to use a rubber or plastic dead blow to prevent damage to the bearing, but the solid material is quite hard and can resist damage from a standard claw hammer if used. A piece of scrap wood can also be placed between the bearing and hammer if a means to support all components safely can be found. Hammer the bearing onto the spindle until it is nearly at the surface of the compliance mount housing. A reasonable amount of hammering force will be required to move the bearing on the spindle. Next manipulate the control arm and compliance mount housing to align the blue bearing with the bore in the black housing. Continue to hammer the bearing onto the spindle and into the bearing housing.

Once the bearing is pressed in far enough onto the spindle it can become difficult to land accurate strikes with the mallet. At this point it was chosen to finish driving the bearing in with the rear housing cover. Take the rear cover for the compliance bearing and assemble it to the housing using 6x of the supplied internal hex bit screws. Run all 6x screws down using the 4mm Allen wrench supplied until the cover is snug against the rear face of the blue bearing. At this point gradually and evenly tighten the 6x screws to continue driving the bearing into the housing, ensuring a star pattern is used to tighten the screws. The recommendation is to make a half turn on one screw, move to a screw on an opposite side of the joint and repeat working around all 6x screws until the cover is fully assembled against the main compliance bearing housing. Note the image below shows a pre-production bearing without the integrated sleeve on the ID. The bearing seating process is the same.
