RV6 Performance Solid Rear Trailing Arm Spherical Bearing Kit Install Guide For 10th Generation CivicX

This is an install guide written for the RV6 Performance rear trailing arm solid spherical bearing kit for the 10th generation 2017+ FK8 Civic Type R. This kit replaces the rubber bushings in the rear trailing arms with solid bearings, which makes for a solid connection between the trailing arms and the vehicle chassis. This kit is aimed to remove the excess play and slop in the rear suspension resulting from using compliant rubber bearings to provide a clean, crisp and responsive suspension feel during sport driving.

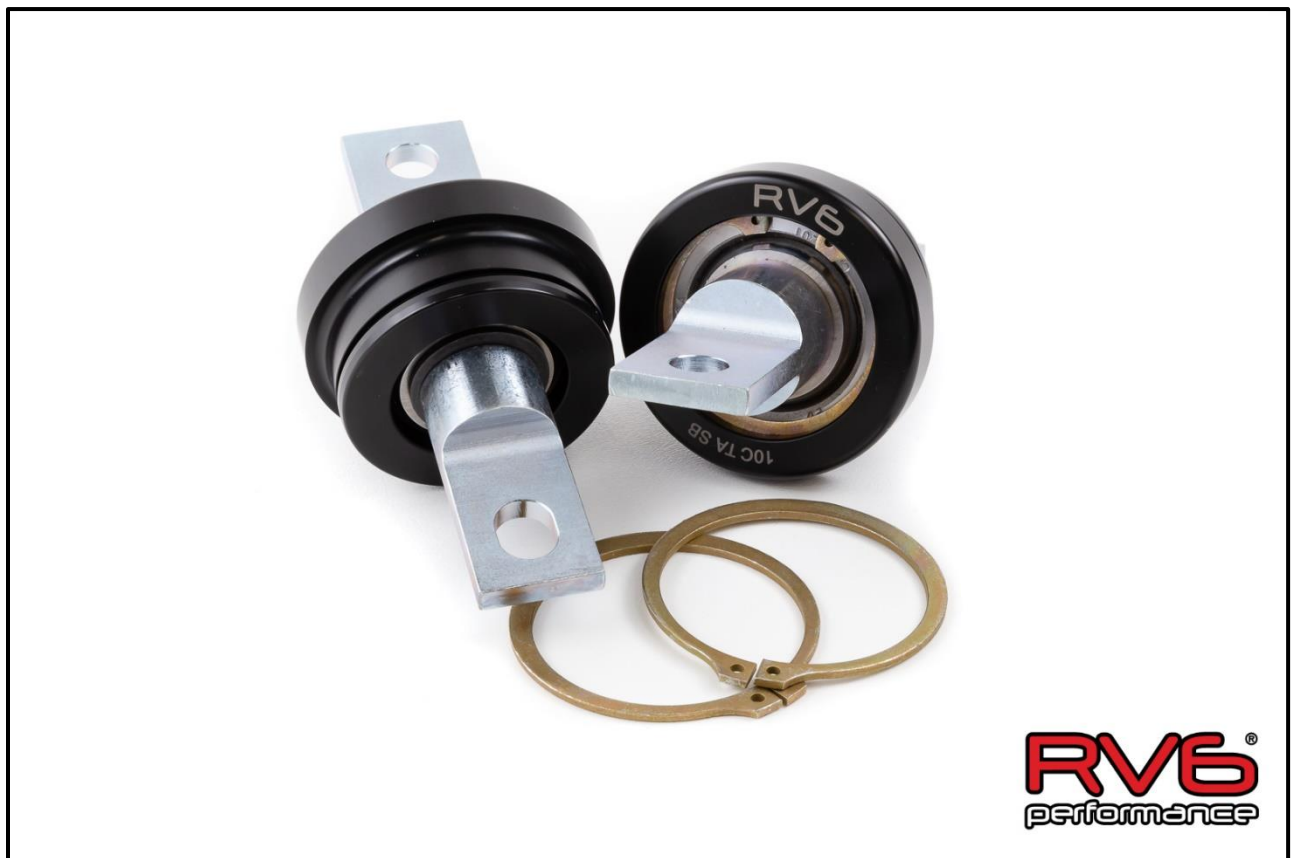
Included in this kit are 2x solid spherical bearings to assemble in the rear trailing arms and 2x snap rings. The spherical bearings to assemble into the rear trailing arms are complete with the center trunnion mount to connect the front of the rear trailing arms to the vehicle chassis.

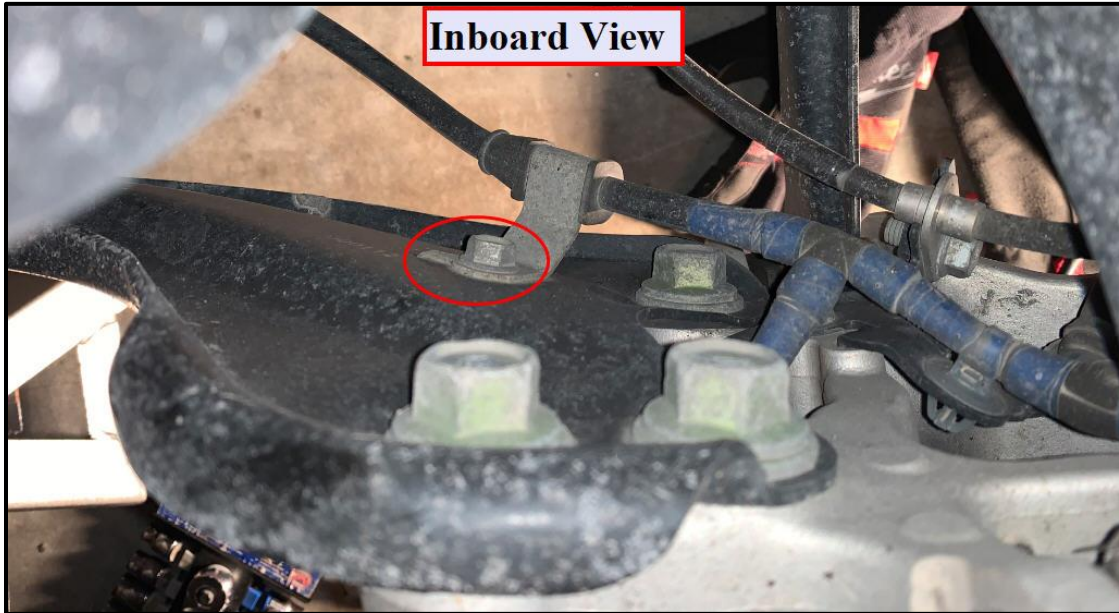
- 2.1: Remove 1x 12mm head bolt connecting the wire retention bracket to the inboard side of each trailing arm (Red Circles) on both left and right rear trailing arms, 2x bolts total. The below image shows the inboard side of the trailing arm, but the same bolt can be seen from the outboard side in the images used below for more clarification on location.

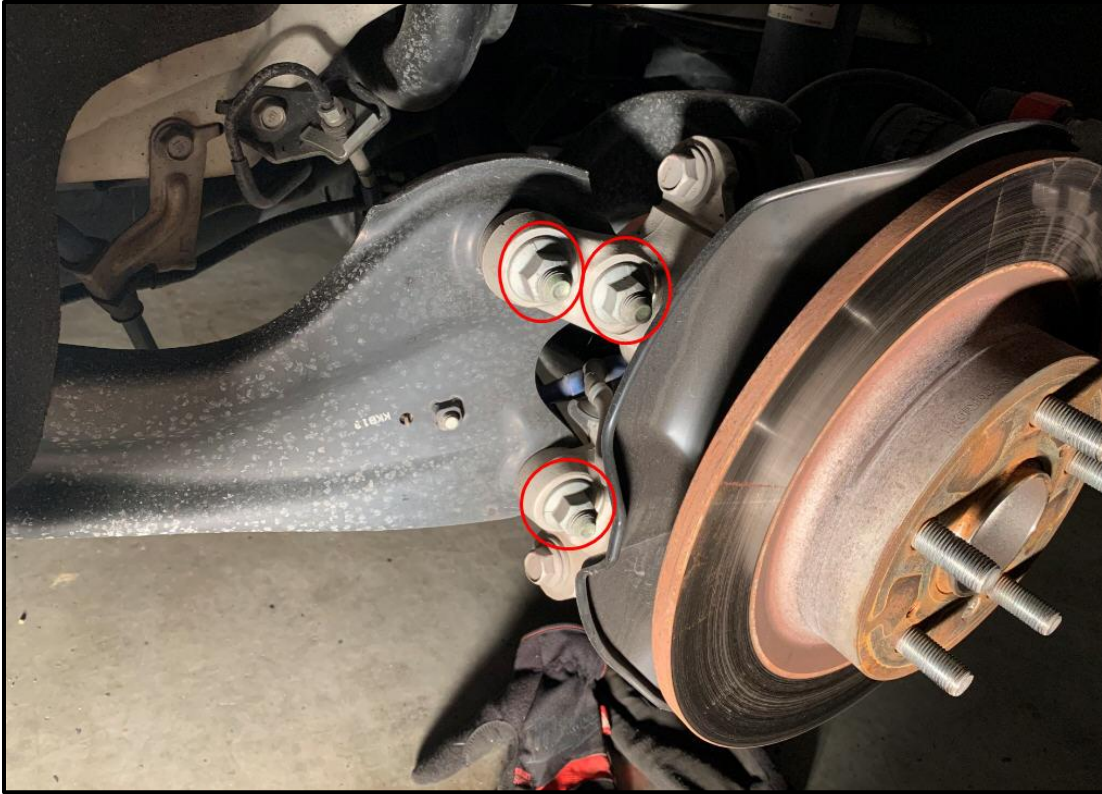
- 2.2: Remove 3x 19mm head bolts connecting the rear trailing arms to the rear knuckles (Red Circles) on both left and right sides of the vehicle, 6x bolts total. These bolts will require a 19mm socket to loosen each connection and a 19mm wrench or socket to act as a backup on the reverse side of a given bolt. Convenient tool access for some of these bolts can be difficult to obtain. The forward most bolt can be accessed easily from the outboard, nut side with an extension and a wrench or socket acting as a backup on the inboard, bolt head side. However, the two bolts closer to the rear edge of the trailing arm cannot be accessed this way due to the brake rotor and heat shield. These bolts were loosened using a socket and extension on the inboard, bolt head side and an open ended wrench acting as a backup on the outboard, nut side.

Note: After the nuts have been removed the bolts may still be difficult to remove from the joint until all 3x bolts on a given side have been loosened. Once all bolts have been loosened the trailing arm can be adjusted to remove any pressure on the bolts in order to remove them.

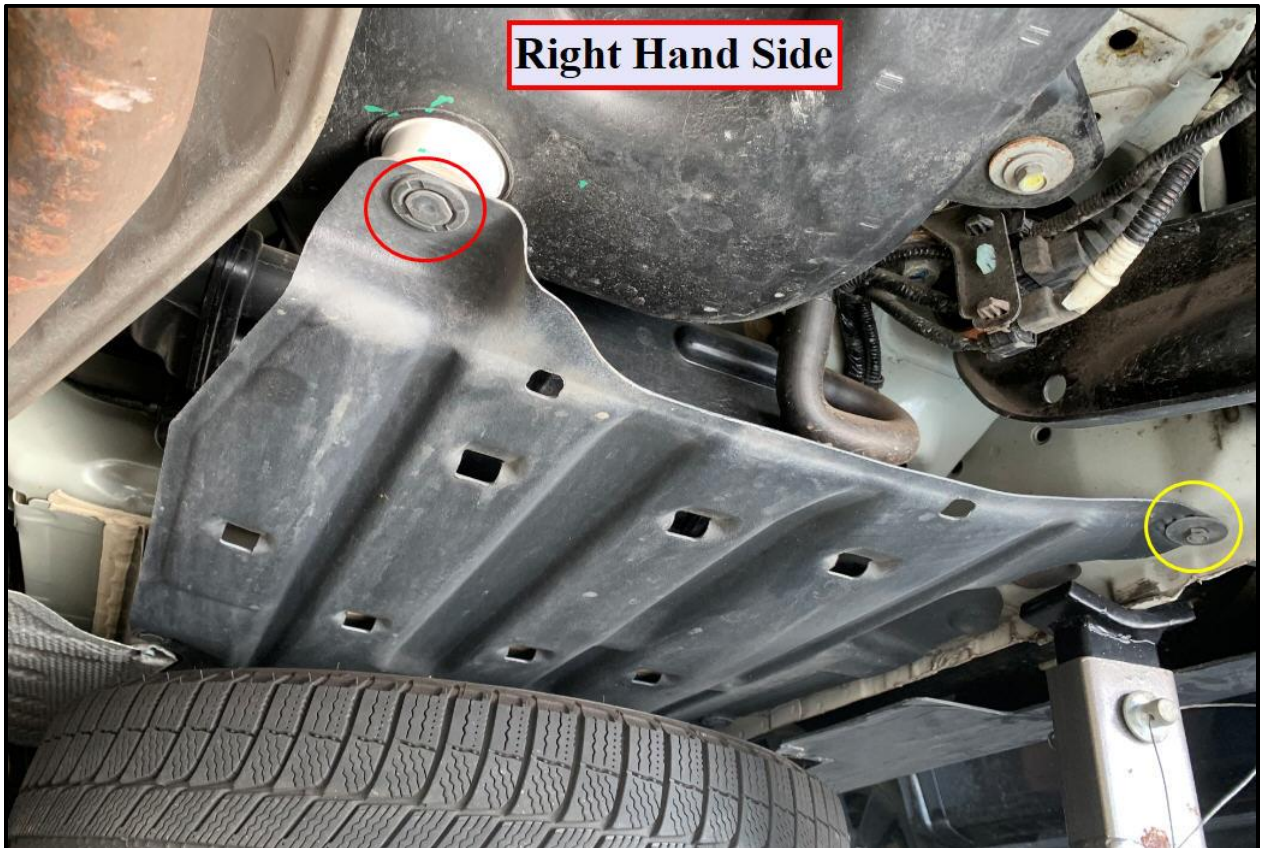
- 2.3: Drop the rear edge of the splash guards in order to gain straight tool access to the front of the trailing arms where they mount into the chassis. The left and right side splash guards do not mount into the vehicle in the exact same way. The left hand side requires the removal of 1x 10mm head bolt and 2x pop clips, and the right hand side has 1x 10mm head bolt but only 1x pop clip to remove. The below images show these locations (10mm head bolts in Yellow Circles and pop clips in Red Circles) for both the left and right vehicle sides. The image showing the left hand side is after the bolt and pop clips have been removed and the splash shield has been pulled down.

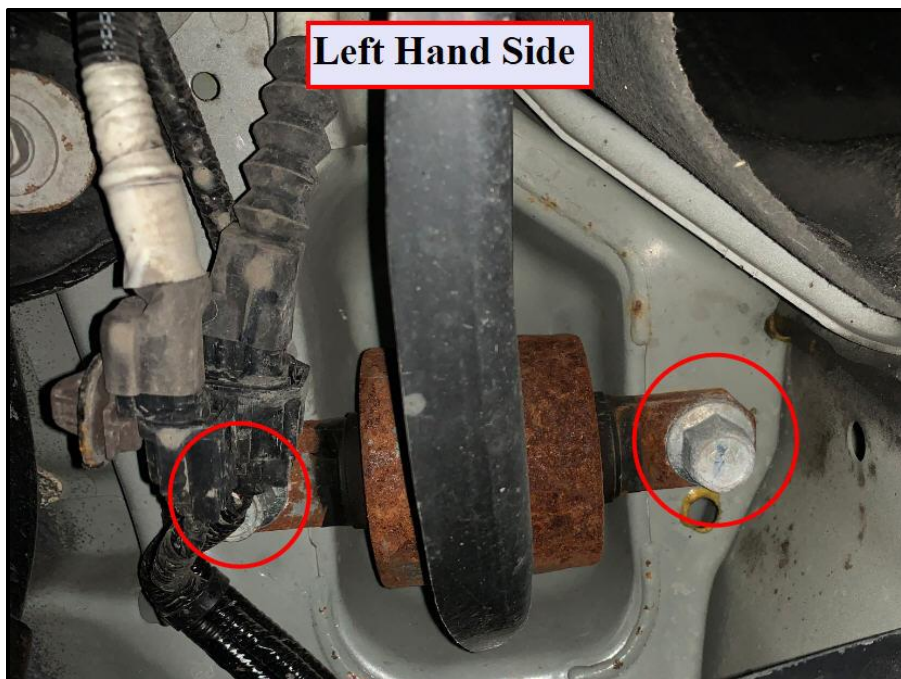
- 2.4: Remove 2x 19mm head bolts connecting the trunnion mounted bearing in the rear trailing arm to the vehicle chassis on both left and right sides of the vehicle, 4x bolts total. Tool clearance can be difficult to obtain due to the electrical harness retained to the chassis near this bearing. On the left hand side of the vehicle the harness could be gently moved to the side during hardware and component removal. On the right hand side the harness routing was slightly different and required the nearby retention bracket to be disconnected from the chassis. For the right hand side remove 1x 12mm head bolt (Yellow Circle) and gently move the harness to the side in order to remove the hardware and the trailing arm. Be very careful not to damage or pull the electrical wire when removing these bolts.

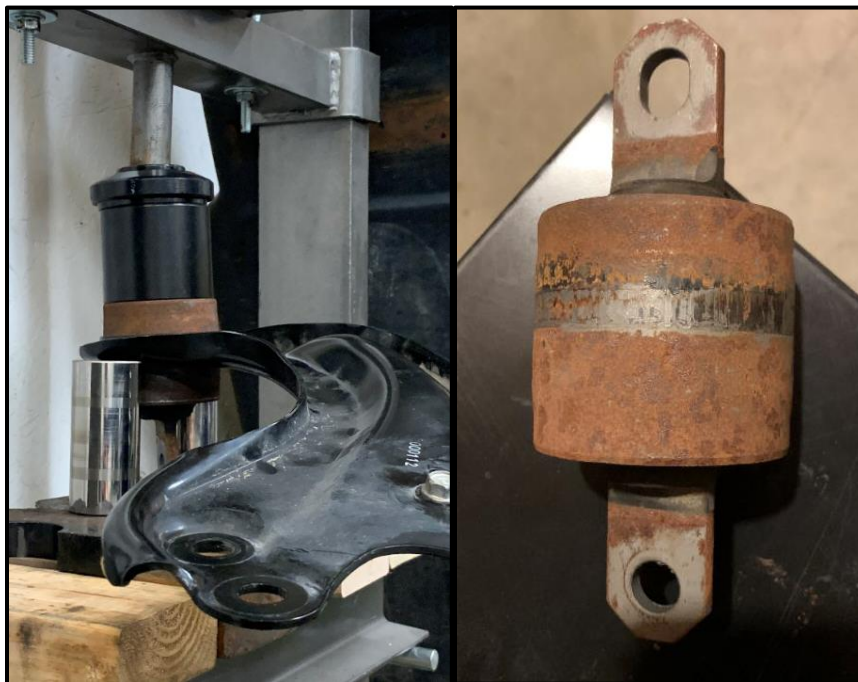
- 3.1: Brace the trailing arms in the shop press and prepare to press out the OEM bushings. The OEM bushings have a slightly barrel shaped housing (wider in the middle than at the ends) and as such should be pushed out towards the outboard side of the arms. In other words, push out the OEM bearings toward the side of the trailing arms that have the rounded surface at the bearing housings, not the sharp edges. Be sure to brace the outboard face of the trailing arms, not the housing of the bearings, and be sure to press against the inboard face of the bearing housings rather than the rubber portions or the central trunnions. A photo of the removed OEM bearing is also shown below.

It is highly recommended to source properly sized adapters or pipe sections to brace components when in the press. During the removal of the OEM bushing using the setup shown above a suitably sized adapter was not able to be located and as such two smaller adapters were used to brace the control arm on two sides while the bearing was pressed out. This method did work to remove the bearings, but some small cosmetic damage was inflicted on the trailing arms from

focusing all of the press force against the two smaller adapters. Step 3.3 shows a much more suitable press setup that was utilized after correctly sized components were sourced.
