2022 Exhaust Fan Sealant Repair

Rev07052022

This document provides instructions for repairing the seal between the exhaust fan and the van roof. After seeing an increasing trend in warranty calls regarding leaks, we launched an investigation into the source of the leaks and found the exhaust fan seal to be the culprit. The repair procedure outlined below has been successfully tested and incorporated into our current production process. Please contact Storyteller should you have any questions or need any assistance with these instructions.

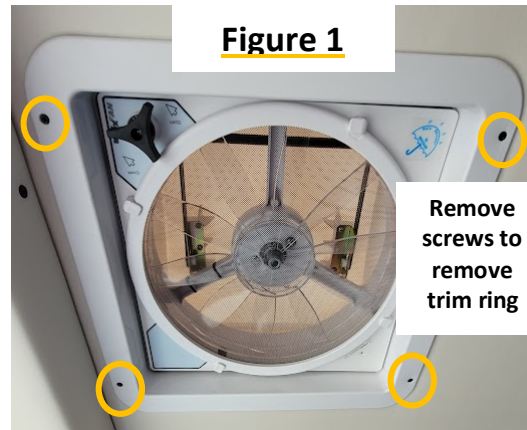
1. Use an impact driver with a #2 Phillips bit to remove the (4) screws securing the trim ring to the ceiling. Set trim ring and screws aside. See figure 1. **NOTE: Beast MODE vans will also have a metal plate positioned above the trim ring flange.**
2. Disconnect fan wiring
 - a. Disconnect the (2) spade terminal connectors located at the rear passenger side corner of the fan. See figure 2.

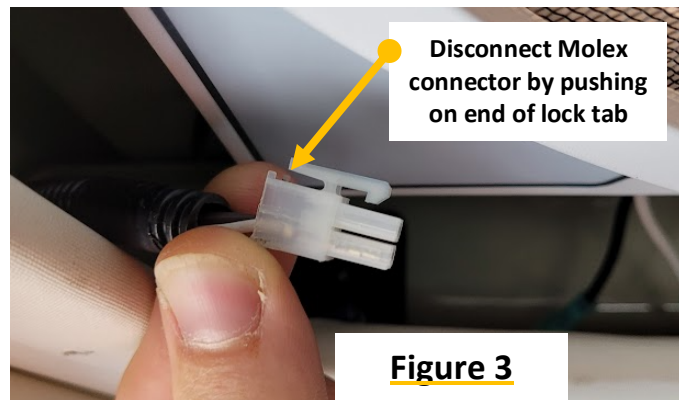
- b. Disconnect the Molex connector from the fan circuit board located along the passenger side toward the rear corner of the fan. The release tab is located on top of the connector and must be pushed to release the lock. See figure 3. Note: If you are unable to release the connector with the fan installed, you can disconnect the connector once the fan is lifted up slightly in the next step. Just be careful to not tug on the wires.
3. Remove fan from roof of van
 - a. Start by carefully removing the (16) original screws that secured the fan to the roof. See figure 4.
 - b. Carefully pull up on 1 corner of the fan's flange to start breaking the sealant as shown in figure 5. Set fan aside.

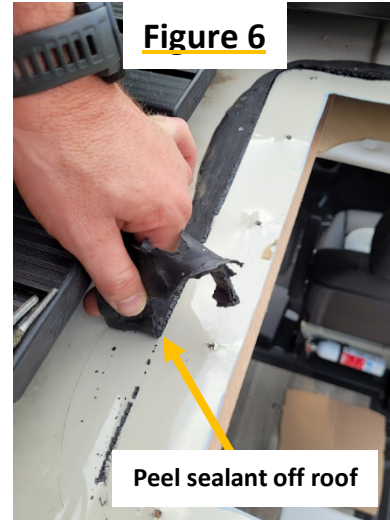
- a. Using a plastic putty knife or scraper, peel away the large sections of sealant from the roof of the van. **See figure 6.**
- b. Once the big clumps of sealant have been removed, use a rag and denatured alcohol to clean around the roof cutout. **See figure 7.** NOTE: Be very careful while working around the cutout in the roof. the cut edges are very sharp.

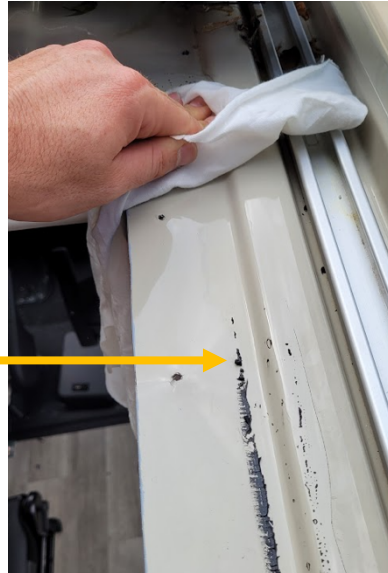
Figure 7

Clean off remaining sealant

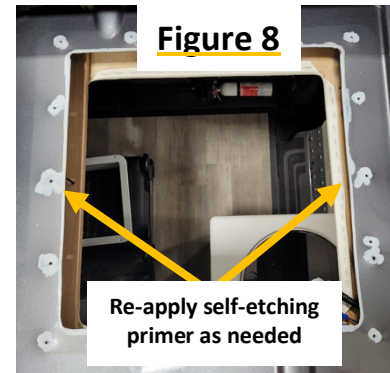
- c. As needed, wipe and let dry any rust spots on or around the cutout and screw holes and reapply self-etching primer if necessary. **See figure 8.**
- d. Peel off the old gasket from the bottom of the fan's mounting flange as shown in **figure 9.**
- e. Repeat steps 4a-4b for the fan. **See figure 10.**

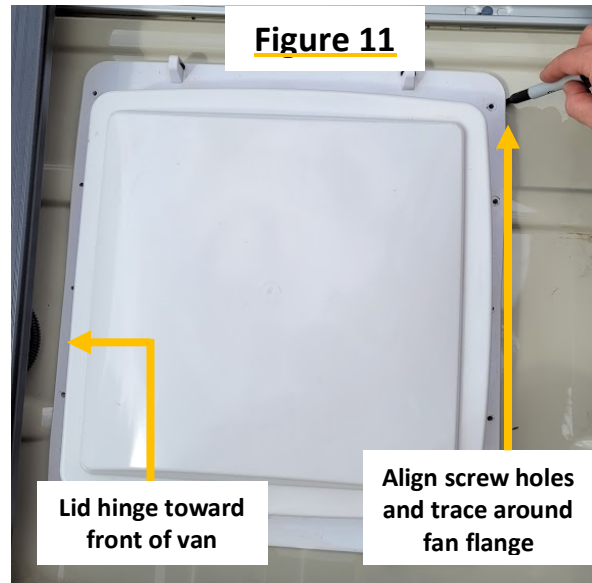
- a. Place the fan back into the roof cutout, ensuring the lid's hinge is on the front side. Use a marker to closely trace around the fan's mounting flange onto the van roof. **See figure 11.**

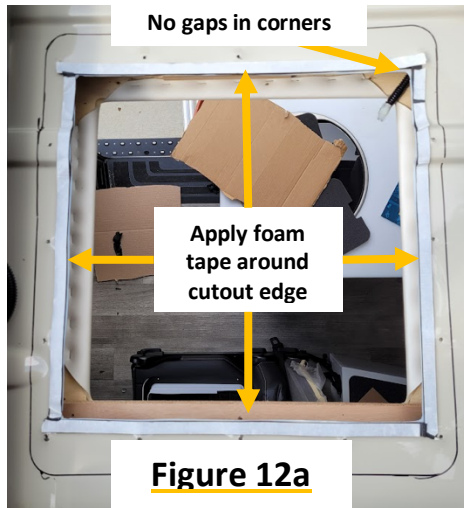
- b. Set the fan aside and apply the 1/2" wide double-sided foam tape along the cut edge in the roof. Cut the tape as needed to align the corners. The tape must form a closed border around the cutout with no gaps. It is also critical that the tape sits flat on the roof and follows the contour of the roof ribs so that no gaps are left. This tape will act as a barrier to prevent sealant from seeping into the van. **See figures 12a and 12b.**

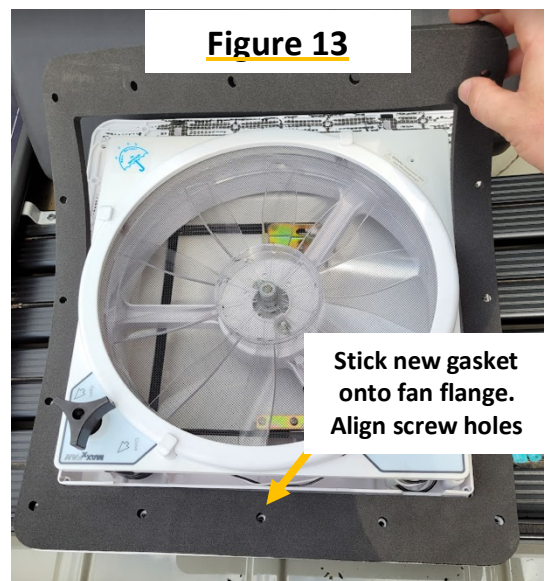
- c. Peel the plastic backing off the replacement fan gasket then stick the gasket onto the bottom side of the fan's mounting flange by aligning the thick sides of the gasket with the thick sides of the fan and aligning the pre-punched holes over the fan's screw holes. **See figure 13.**

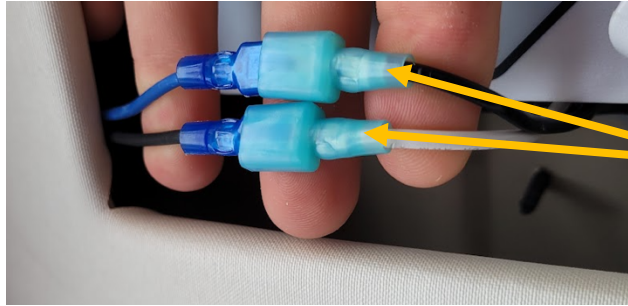
Figure 17

- b. Reconnect the spade terminal connectors as follows: White fan wire to black harness wire; Black fan wire to blue harness wire. **See figure 17.**

Reconnect spade terminals between harness and fan

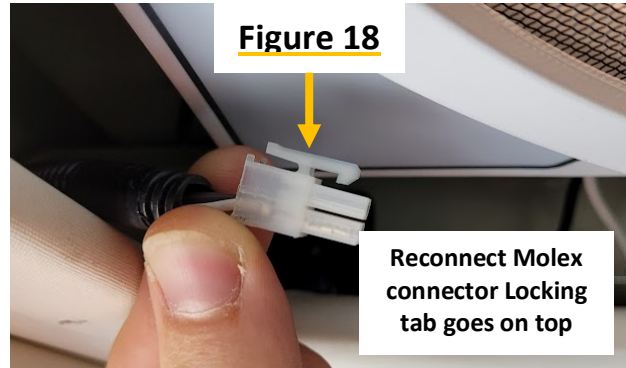
Figure 18

- c. Reconnect the Molex connector to the circuit board. Ensure the locking tab is positioned to the top. **See figure 18.**

Reconnect Molex connector Locking tab goes on top

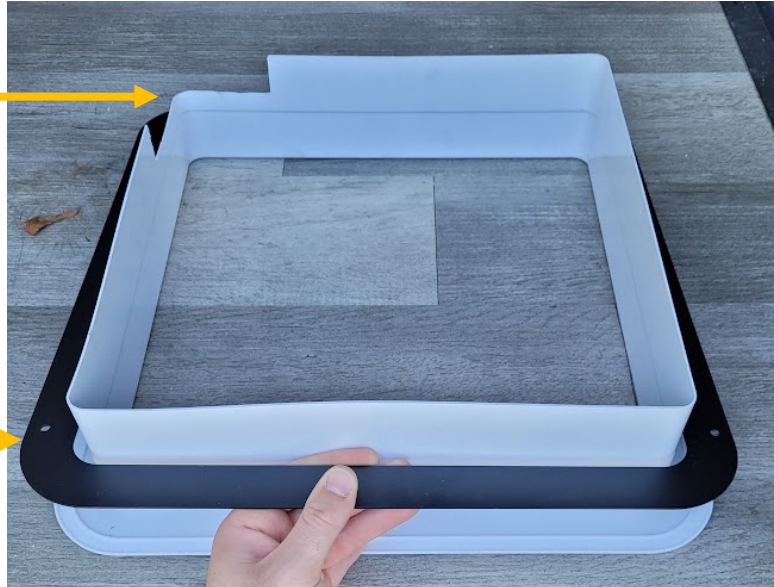
Figure 19

- d. Reinstall the trim ring to the ceiling using the original (4) screws. The cutout corner goes to the rear passenger side corner of the fan. **See figure 19. NOTE: Beast MODE vans will also have a metal plate positioned above the trim ring flange that will need to be installed with the trim ring.**

Cutout corner positioned at passenger rear corner of fan

Metal ring only present on Beast MODE vans

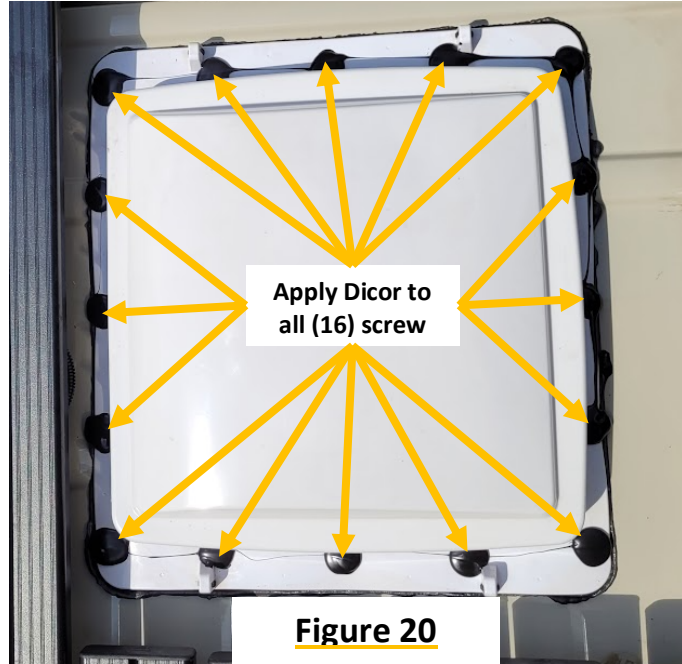
8. Once at least 1 hour has elapsed since completing step 6, apply Dicor sealant around the top of the fan
- a. Using a caulk gun loaded with the supplied Dicor sealant, apply a Hershey's Kiss size blob of sealant to each of the (16) screwheads. Ensure the sealant makes a good seal around the screwheads. **See figure 20.**

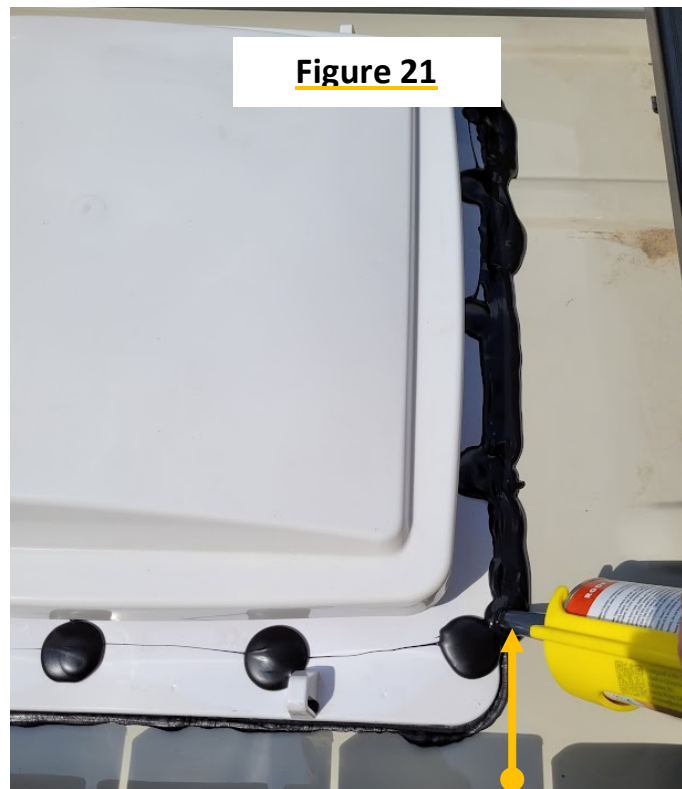
- b. Apply a continuous bead of sealant along the seam between the outside edge of the fan's flange and the van roof. Ensure the sealant fully bridges from the top of the flange to the van roof. Once the first pass is made around the fan, apply the rest of the tube to spots as needed to ensure a full seal. **See figure 21.**
- c. Allow the sealant to cure for at least 48 hours before driving the van.

Apply continuous bead of sealant around fan edge seam
