TSB-STO2023-003: Coolant Line Securing Around Transfer Case

Rev07212023

Overview:

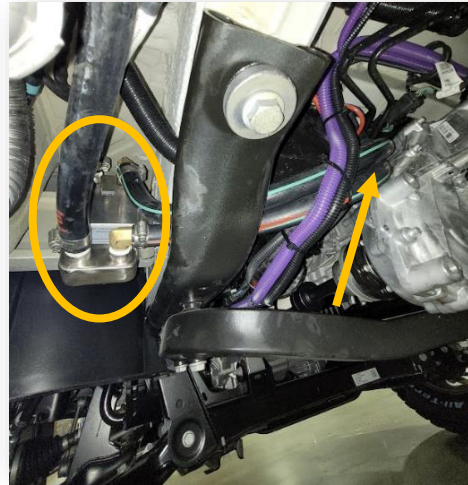
Figure 1

- a. Locate the Rixen heat exchanger that is mounted to the chassis frame just behind the driver side front tire as shown in figure 1.
- b. Follow the (2) coolant lines from the right side of the heat exchanger toward the center of the chassis and between the transmission and battery box. See figure 1

Locate Rixen heat exchanger under the van circled in the figure. Follow the (2) coolant lines between the transmission and battery box as pointed out with an arrow.

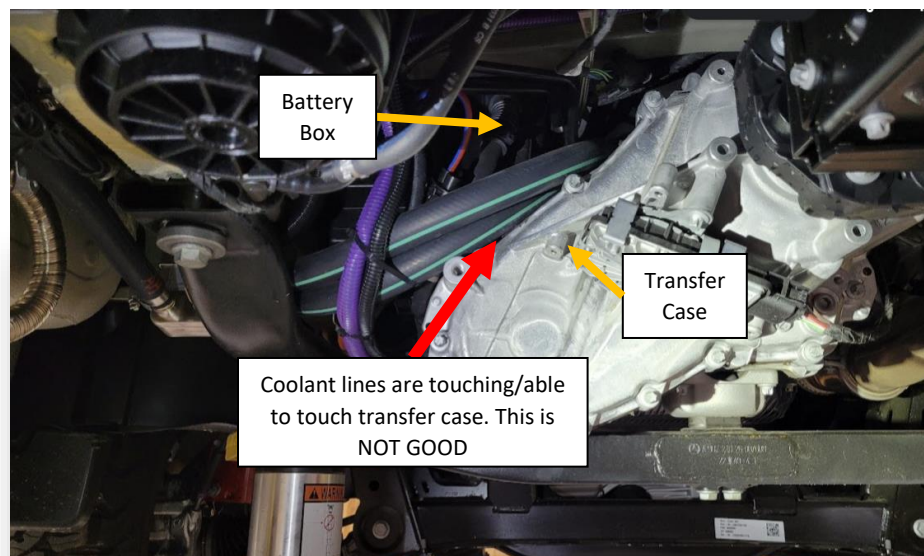
- c. Closely inspect the coolant lines at the rear inboard corner of the battery box next to the transfer case as shown in figure 2. Check whether the coolant lines are touching or able to touch the transfer case. Figure 2 shows an example of what is NOT GOOD. We do not want the coolant lines to be able to touch the transfer case at all. **Check for any signs of chafing, wear or damage to the coolant lines in this area and note what is found on the Coolant Line Securing Checklist at the end of this document.**

12. Add the 2nd heavy duty zip tie around the coolant lines and the negative (black) battery cable that comes out the rear inboard corner of the battery box. Position the zip tie toward the top of the battery cable so it pulls the coolant lines away from the transfer case considerably as shown in figure 7.

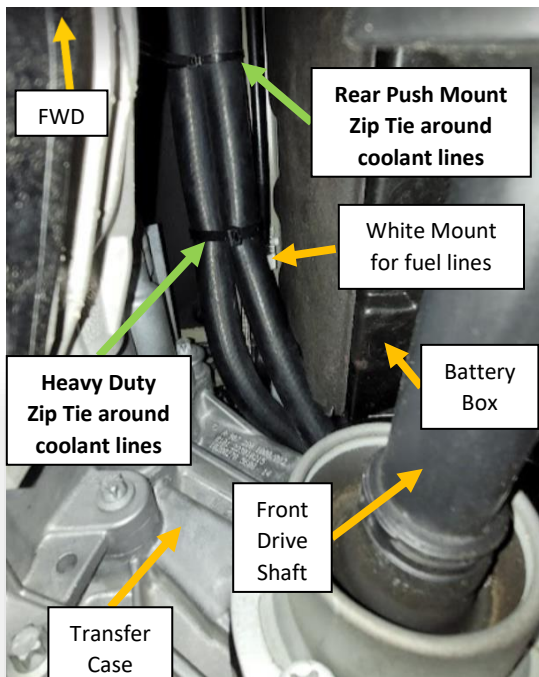
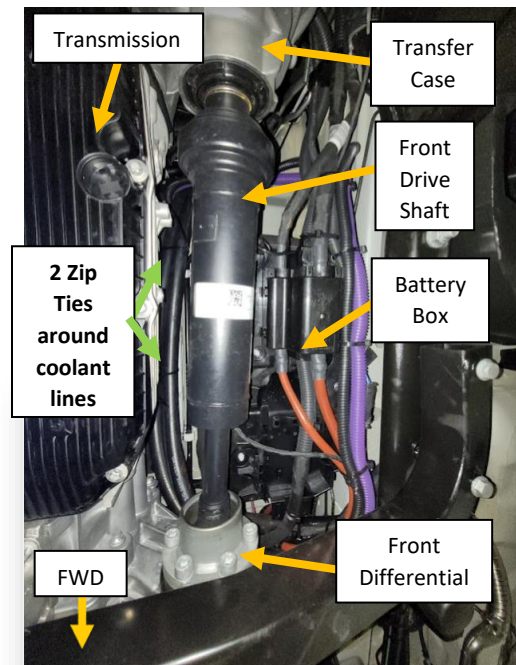
- d. Continue to follow the coolant lines toward the front of the van. Closely inspect the (2) coolant lines in the area between the battery box and the transmission from the transfer case to the front differential above the front drive shaft. **Verify there is a heavy duty zip tie around the coolant lines above the transfer case in front of the white routing mount for the fuel lines and there are at least (2) additional zip ties around the coolant lines securing them to the chassis frame above the front drive shaft so that the coolant lines are not allowed to contact the front drive shaft, transmission or transfer case.** See figures 3a and 3b.
- e. **Check for any signs of chafing, wear or damage to the coolant lines in this area and note what is found on the Coolant Line Securing Checklist at the end of this document.**

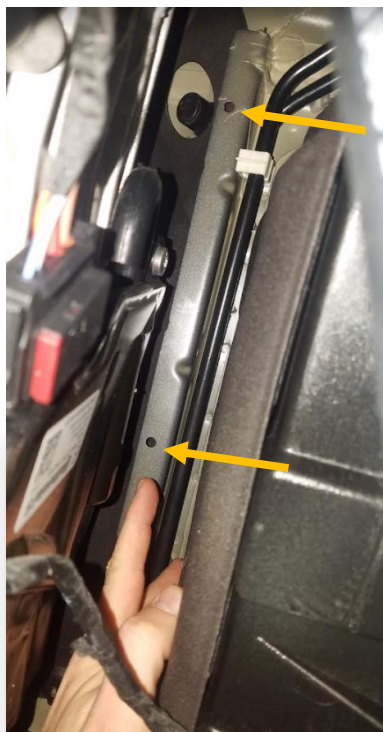
Figure 5a

7. Install a push mount (once threaded onto the zip tie) into each of the (2) holes in the chassis frame on the underside of the floor located between the transmission and battery box as pointed out in figure 5a. Make sure the push mounts are pressed fully into each hole to provide a secure hold.
8. Position the coolant lines up against the frame so they are prevented from making contact with the front drive shaft. Wrap each zip tie around both coolant hoses and secure the zip ties so they are snug against the coolant lines but will not restrict coolant flow. See figure 5b
9. Cut off the excess end of the zip tie using a pair of cutters and ensure the coolant lines do not and are not able to make contact with the front drive shaft or any moving component.

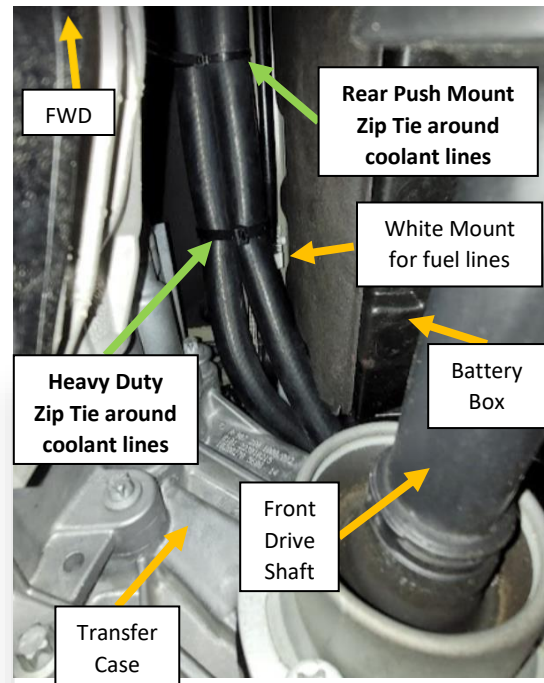
Figure 6

10. Secure 1 heavy duty zip tie around the coolant lines and the hole in the chassis frame member just in front of the white chassis hose mount that is located between the battery box and the transfer case and above the front driveshaft on the underside of the van body floor. NOTE: Be sure to not bundle the fuel lines that are routed through the white mount with this zip tie. It is easiest to feed the zip tie between the fuel lines and the frame member first, then through the hole in the frame member and then around the coolant lines to secure. See figure 6

11. Cut off the excess end of the zip tie using a pair of cutters and ensure the coolant lines do not and are not able to make contact with the front drive shaft or transfer case in this area.
