TSB-STO2023-004: Coolant Line Replacement-2

Rev07212023

Overview:

All STO Mercedes Sprinter AWD MODEs

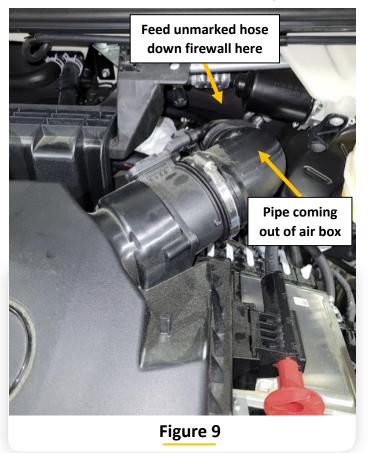
- i. Use a pair of cutters to snip any remaining zip ties that are secured around the 2 coolant hoses being removed.
- j. From underneath the van, pull the 2 coolant lines out from the van and dispose of them.
- 4. Install replacement hoses
 - Mark one of the hoses with a marker at each end in order to help differentiate between the 2 hoses during the next steps.
 - b. In the engine bay, start feeding the <u>unmarked</u> hose down the firewall and over the pipe coming out of the air box. Only feed the hose about 2 feet down. See figure 9.
 - c. Feed the <u>marked</u> hose under the black hose coming out of the brake booster, above the ECM, then down the firewall about 2 feet down. See figure 10

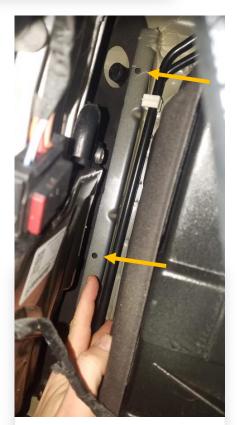
Figure 16

- b. Install a push mount (once threaded onto the zip tie) into each of the (2) holes in the chassis frame on the underside of the floor located between the transmission and battery box as pointed out in figure 16. Make sure the push mounts are pressed fully into each hole to provide a secure hold.
- c. Position the coolant lines up against the frame so they are prevented from making contact with the front drive shaft. Wrap each zip tie around both coolant hoses and secure the zip ties so they are snug against the coolant lines but will not restrict coolant flow. See figure 17
- d. Cut off the excess ends of the zip ties using a pair of cutters and ensure the coolant lines do not and are not able to make contact with the front drive shaft or any moving component.
