TEST REPORT

No. : XMIN2203001960CM

Sample Name	:	REJUVENATIONS HET SHEET PRODUCT
Product Specification	:	2mm thick
Manufacturer	:	SOURCED BY ARMSTRONG FLOORING PTY LTD.
Material and Mark	:	Filled PVC

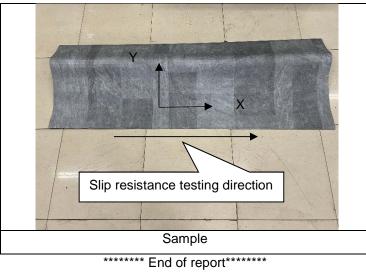
Original Sample Photo:

No.	Test Item	Test Method	Test Condition	Test Result	
1	Slip resistance	AS 4586-2013 Amdt 1-2017 Annex D	Specimen: 1000mm×500mm, 1pcs Testing direction & testing surface: see the photo	Critical angle of inclination: 10.4° Classification: R10 (See Note)
