Plunger Repair Kit Replacement

Part# RK600 [Ref. #15-2 – #15-5]
Content: 3pcs

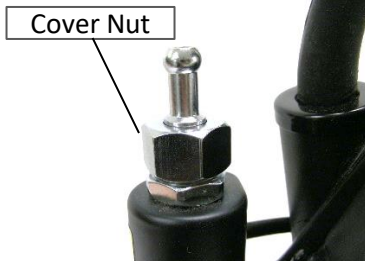
- 1** Unscrew *cover nut*
(Use wrench if overtightened)

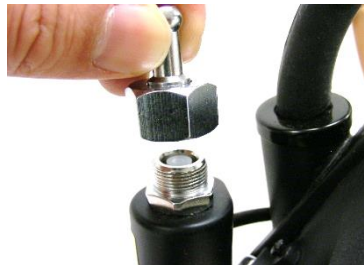
- 2** Remove *cover nut* and *fitting* off
the *solenoid valve*

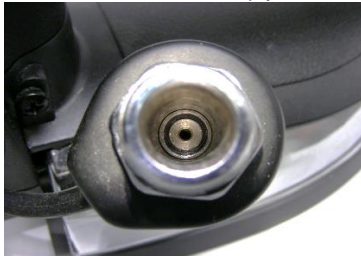
- 4** After removal of *plunger* and *spring*
make sure the valve is empty inside

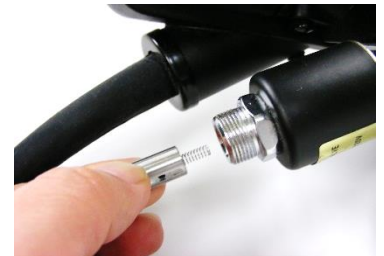
- 6** Tilt iron to the side and slide-in *plunger*
and *spring* into the valve. Turn iron right up

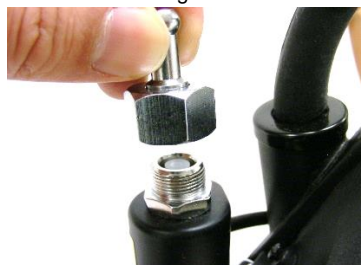
- 7** Hand tighten *cover nut* and *fitting*
Note: Do not overtighten
