## Outer Cover Replacement

Part# S6060 [Ref. #21-7]  
Content: 1pc

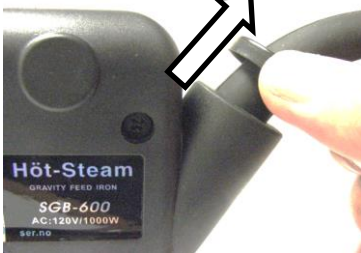
- 1 Hold and slide up *metal ring*, then detach from the *outer cover*

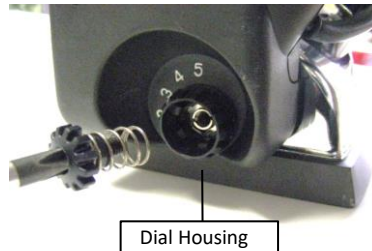
- 2 Remove *dial screw* and *dial spring* set, then the *dial housing*

- 9 Repeat steps 6, 7 and 8 until the stem is successfully centered. Tighten the outer cover screws(step 3) and then the dial set (step 2)

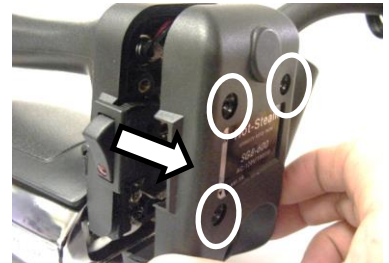
- 3 Remove screws(3) and gently open the *outer cover*

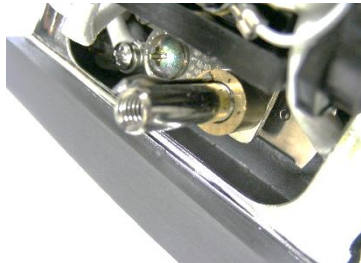
- 4 Inspect and make sure to remove all broken pieces from inside of iron

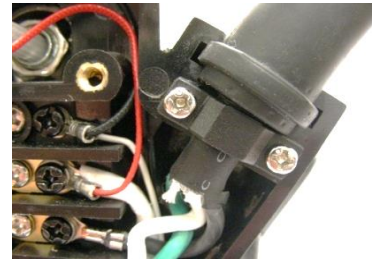
- 5 Make sure to properly tuck in all wires in between the covers before closing

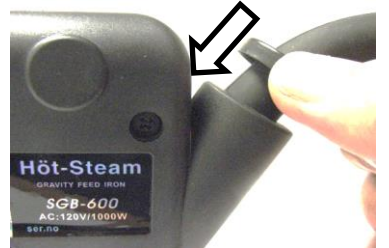
- 6 Gently install new *outer cover* and lock both covers in place with the metal ring

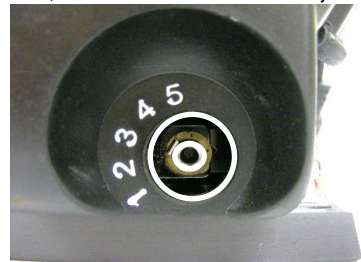
- 7 Verify the thermostat stem is centered. If not, remove cover and make adjustments

- 8 By loosening screw(2) the cover can be moved slightly up, down and left, right
