MECHANICAL TESTING REPORT

Report No: QRM15-0728
Date of Issue: 20-10-2015
Page: 1 of 2
Client: Bronze & Brass Fasteners Pty Ltd
Attention: Anthony Cowan
Address: PO Box 205
Crows Nest, QLD 4355
Order Number: COD
Job Description: The Load testing of (2) Bolt and Plate Assemblies.

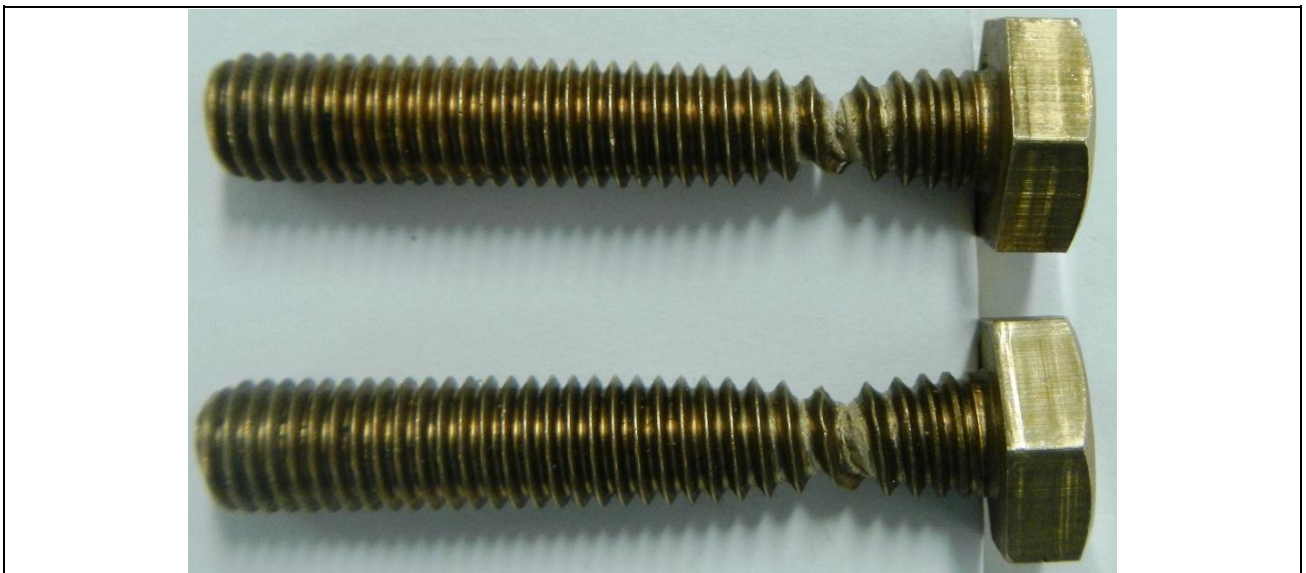
Assembly ID	Bolt Size	Bolt Area	Maximum Load	Maximum Stress	Location of Fracture	Fracture Face Appearance
A	M10	58mm ²	29.44kN	508MPa	Bolt – Approx. 8mm from Head	Ductile

Assembly ID	Bolt Size	Bolt Area	Maximum Load	Maximum Stress	Location of Fracture	Fracture Face Appearance
B	M10	58mm ²	29.34kN	507MPa	Bolt – Approx. 8mm from Head	Ductile

Note: No Deformation was observed on the engaged thread of both the bolt and the plate.
