**SECTION 4
MASH TEST 3-71 SUMMARY**

Test Article: BR0037 & BR0108
 Test Program: MASH 3-71

Project No. BR0037 & BR0108
 Test Date: 02/10/2021, 3/16/2022

MASH TEST 3-72 SUMMARY

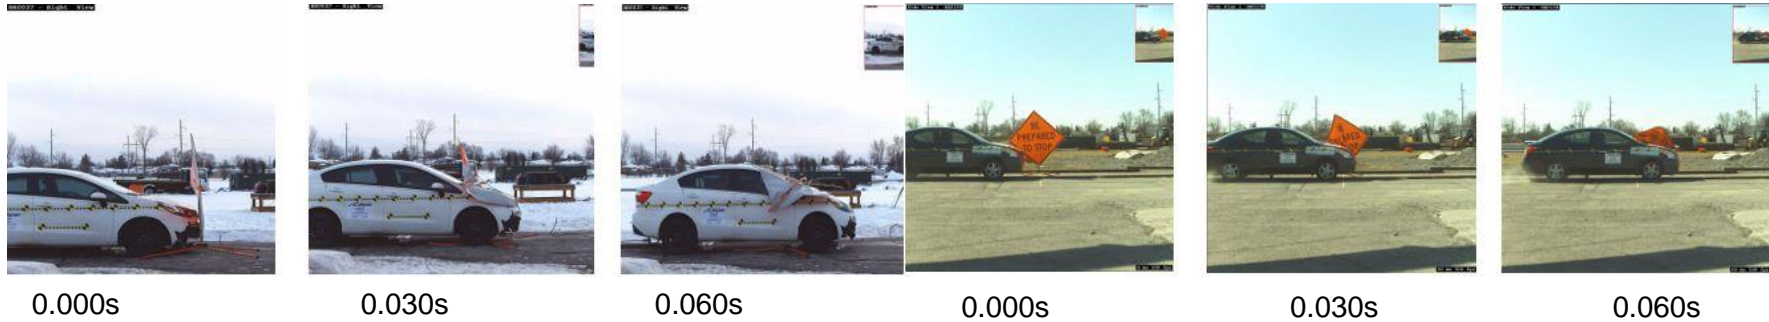
SEQUENTIAL PHOTOGRAPHS

0° Orientation Side View 1 BR0037

90° Orientation Side view 2 BR0108

Vehicle BR0037 is at 63 MPH when it contacts the sign and it is 5 feet from the point it is released from the tow system (which occurs at 0 feet in scale). Vehicle BR0108 is at 62 MPH when it contacts the sign and it is 25 feet from the point it is released from the tow system.

Vehicle is stopped at 180 feet from the point of initial release from the tow system (which occurs at 0 feet on scale).
