Silver Honey™ Equine Field Trial

AUGUST 8 2019

WF Young Inc. Authored by: Lucas Pantaleon DVM

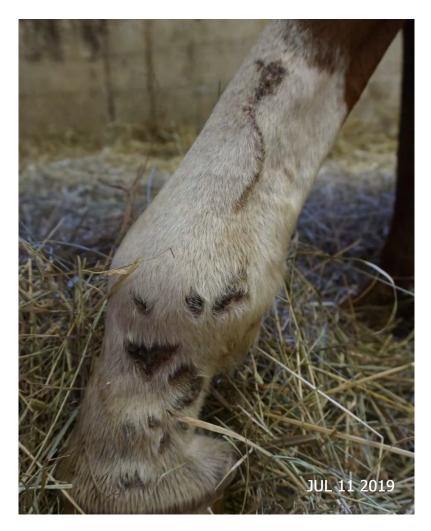
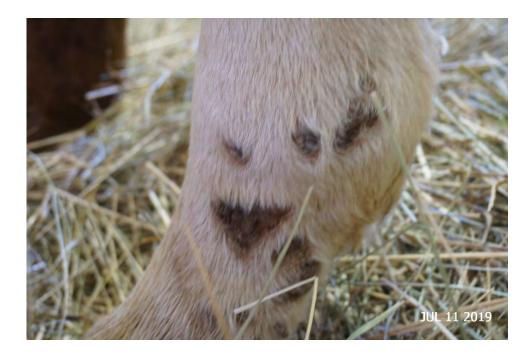
Pictures July 11th – Day 0 – Before Silver Honey[™] application:

Right hind limb (white hair areas) superficial scratches on lower lateral cannon bone and pastern areas. Wounds looked dry and crusty. Lesions present since spring time. Not being treated currently.

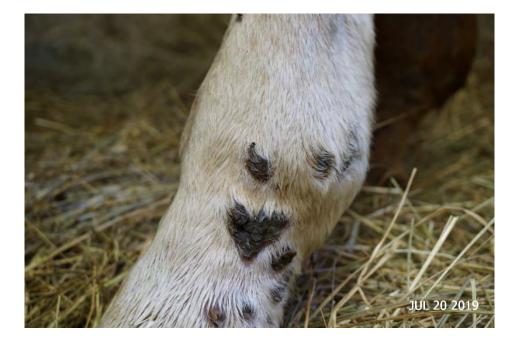
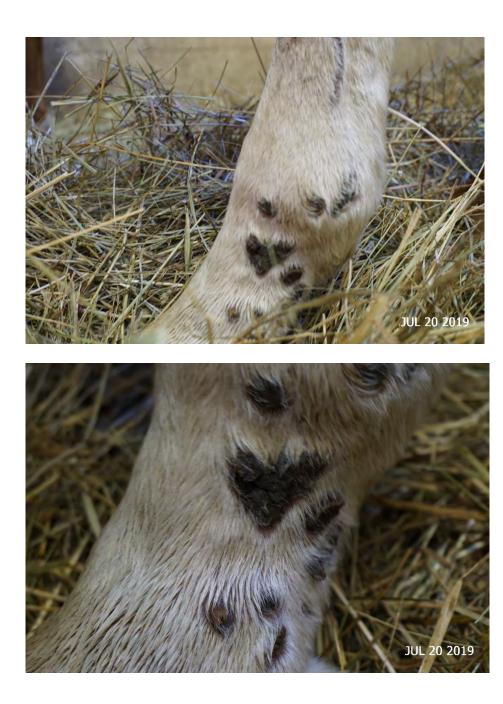
Pictures July 20th – Day 8 – after Silver Honey[™] application:

There was no significant changes on the lesions. Scabs remained. Recommend to bandage with Silver Honey™ cream to see if scabs would soften.

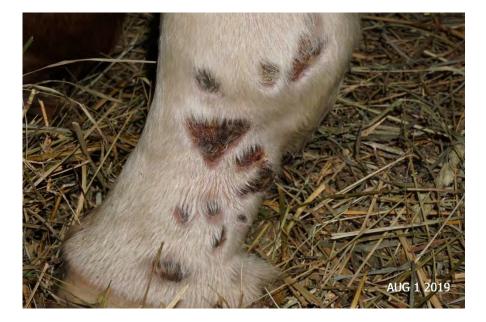
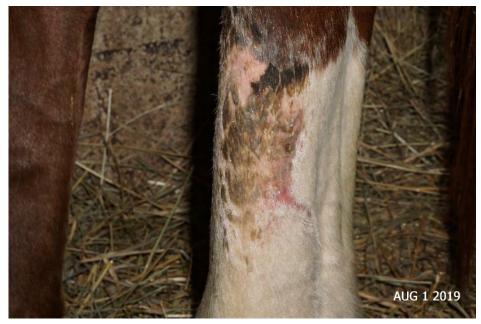
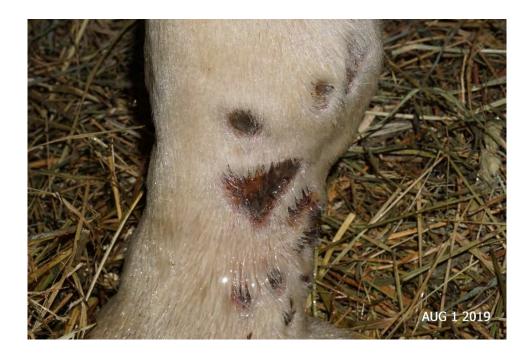
Pictures August 1st – Day 21 – after Silver Honey[™] application:

There was no significant changes regarding the size of the lesions on the pastern. However, the margins of the lesions looked healthier, pink and the scabs seemed to be shrinking. The linear lesion on the canon bone is healing well, no scab was seen and pink healthy skin. This mare will go back to her original farm on August 15th and they are hoping to carry on with the treatment.

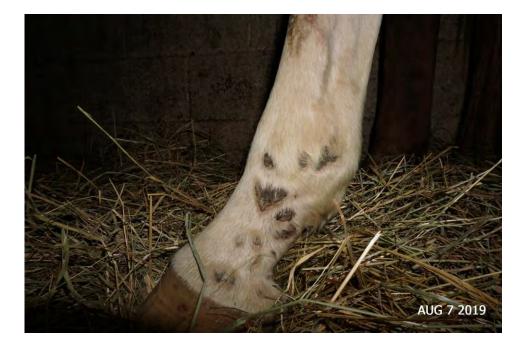
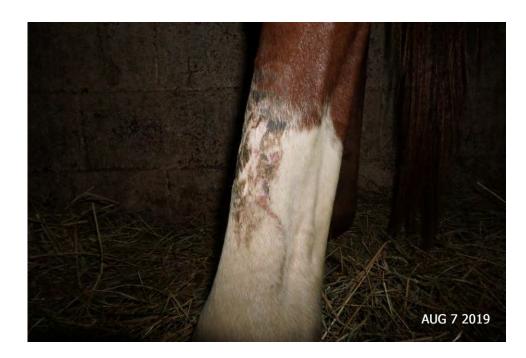
Pictures August 7th – Day 27 – after Silver Honey[™] application:

The lesions have not changed significantly from the last examination. The scabs remains tightly attached, margins are healthy and there was no pain to the touch. The linear lesion on the canon bone continues to heal, the skin is pink and healthy with hair growth.

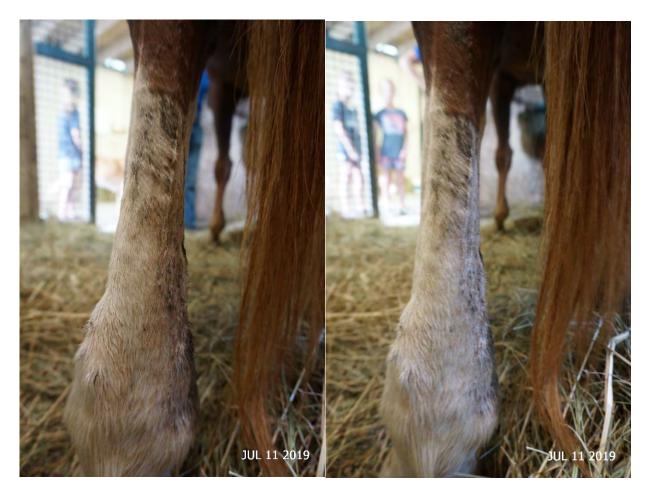
Pictures July 11^{th} – Day 0 – Before Silver Honey^m application:

Left hind limb dry superficial crusty wounds on back of cannon bone area, white hair area.

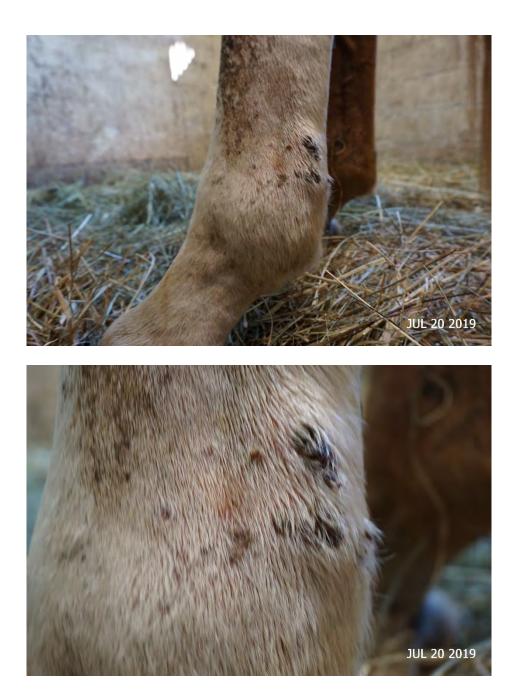
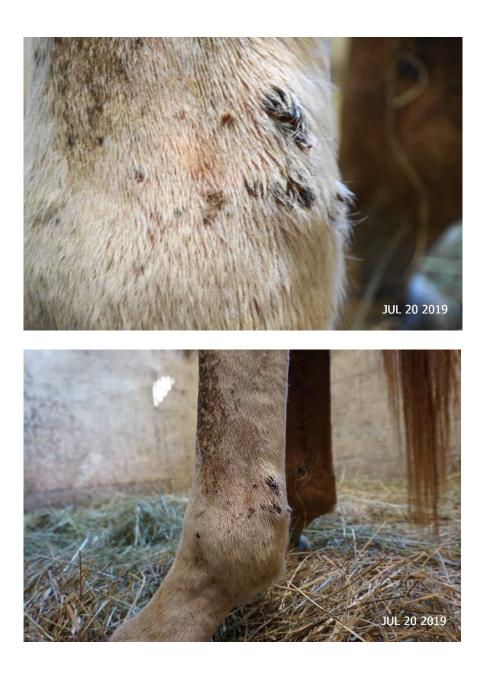
Pictures July 20th – Day 8 – After Silver Honey[™] application:

Left hind limb dry superficial crusty wounds showed no significant improvement. Scabs remain present and tightly attached. The areas appeared to be less inflamed. The manager will work on removing scabs and continue with the application of the gel.

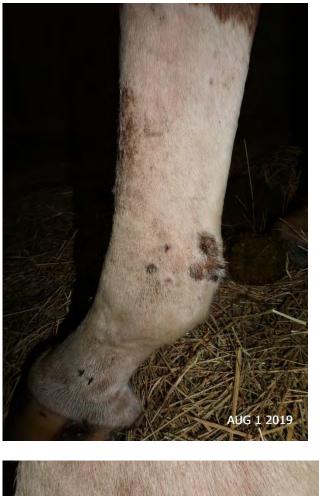
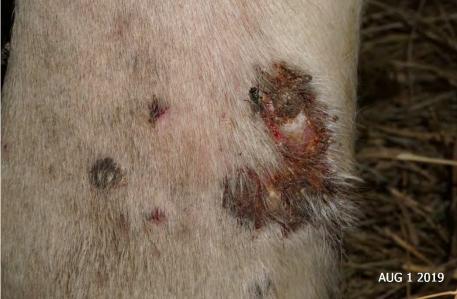
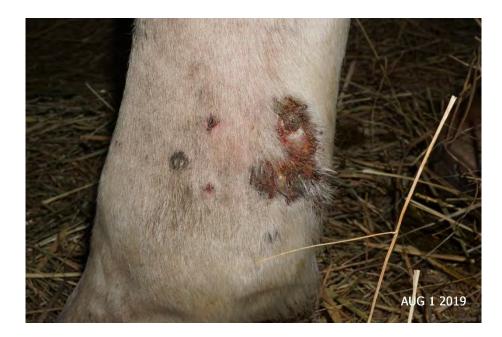
Pictures August 1st – Day 21 – After Silver Honey[™] application:

Manager stated that the small spots that were there initially healed. She said that there is a new spot (lesion) on the outside part of the left hind limb. However, looking at the pictures it appears that the 2 spots that were there last week have coalesced into one larger. Scabs on this area were tightly attached. I removed some of the scabs and the skin appeared inflamed and bleeding. The mare was mildly painful when scabs were pulled. The manager was applying the ointment on this lesion.

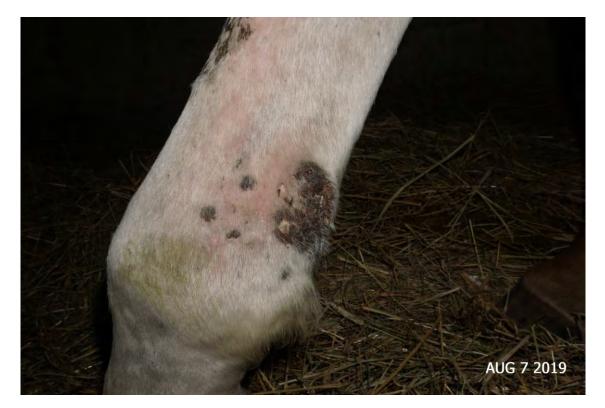
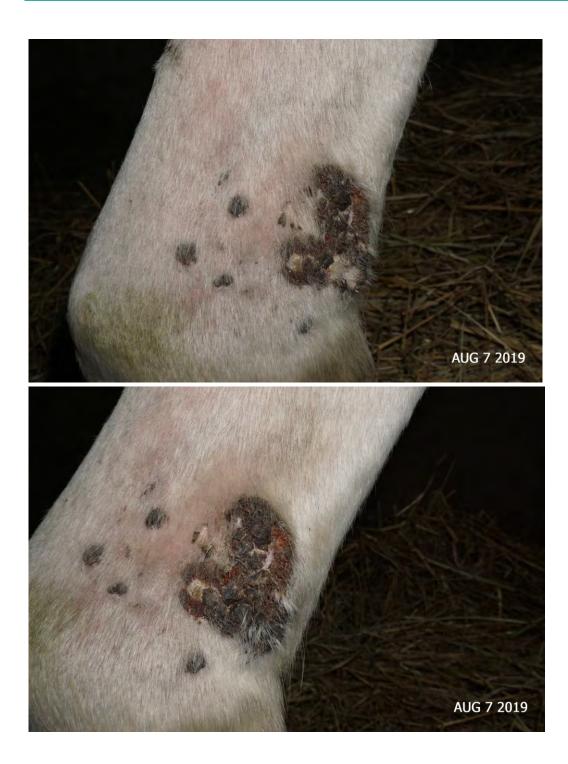
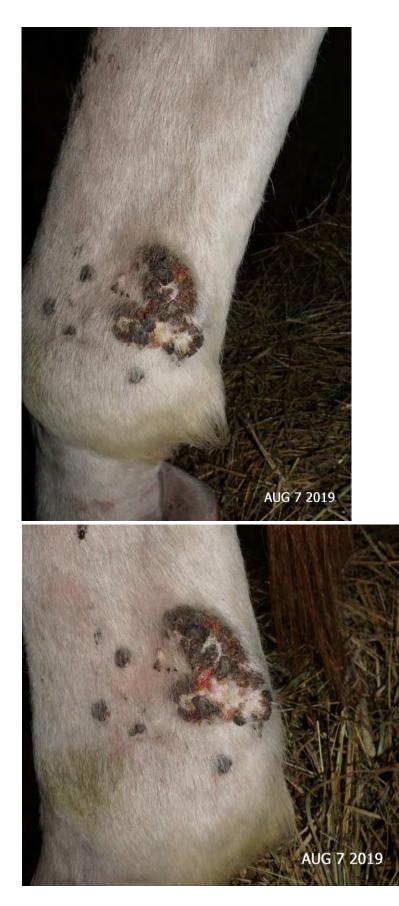
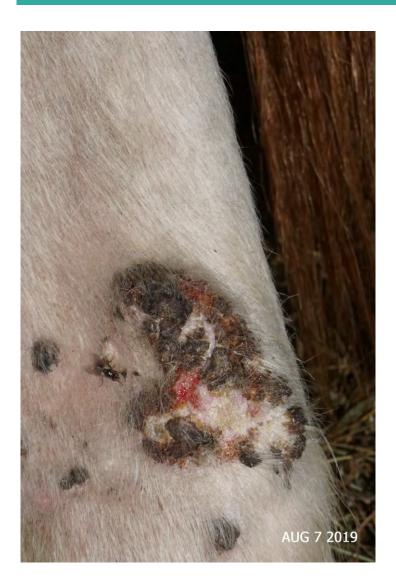
Pictures August 7th – Day 27 – after Silver Honey[™] application:

The lesion on the left hind limb appeared to have not changed from the last examination. There are scabs covering the area and the skin under the scab remains inflamed and there was bleeding when scabs were removed. The mare was mildly painful when I attempted to remove the scabs.

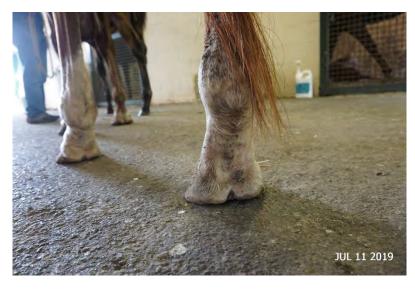
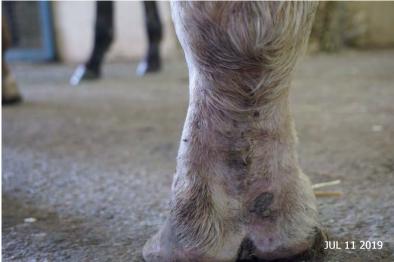
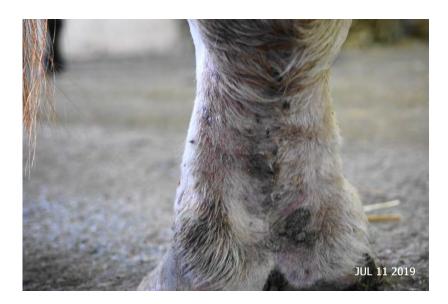
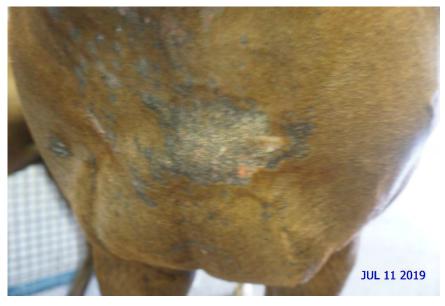
Pictures July 11th – Day 0 – Before Silver Honey[™] application:

Right hind pastern area crusty superficial wounds on white hair region. Large superficial wound on the pectoral area secondary to itching.

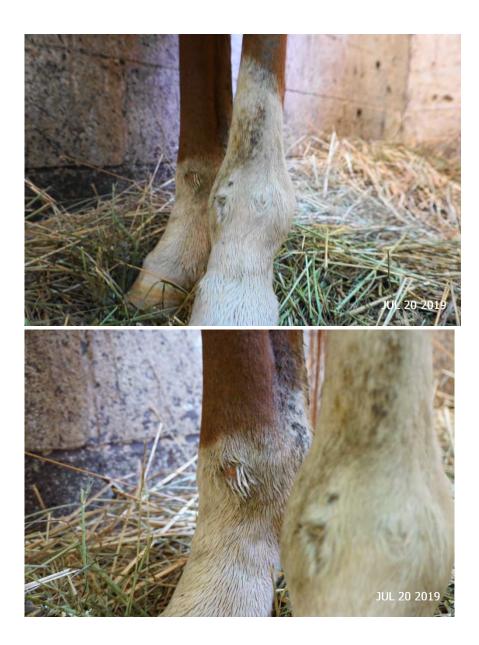
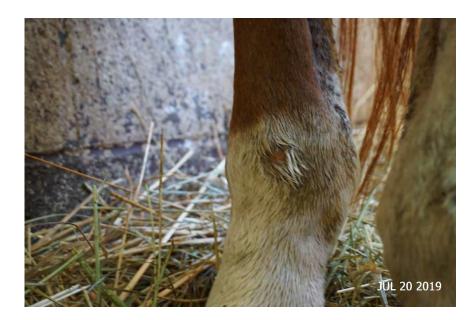
Pictures July 20th – Day 8 – After Silver Honey[™] application:

Right hind - wound on the front of the fetlock that is healing well, no scab. The area on the back of the pastern appeared to be improving, no picture taken. There were some scabs on the front of the fetlock on the left hind leg, no significant changes seen thus far. For the area on the chest the Silver Honey[™] was discontinued since their vet prescribed Ivermectin for the itching and the mare improved.

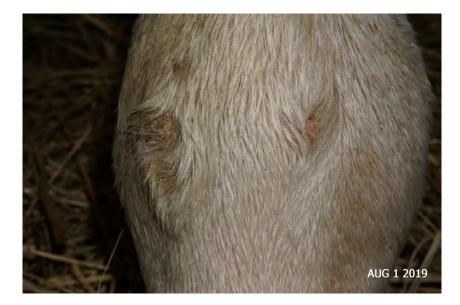
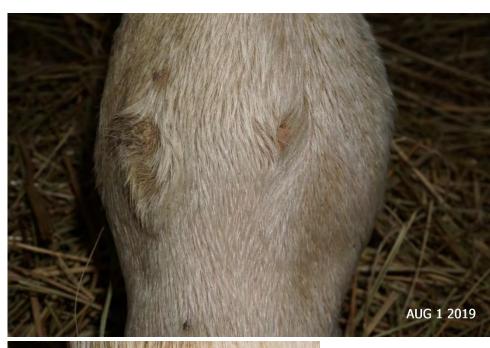
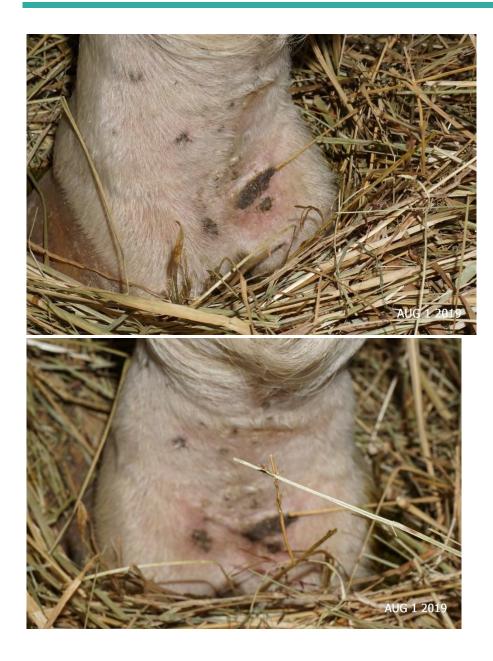
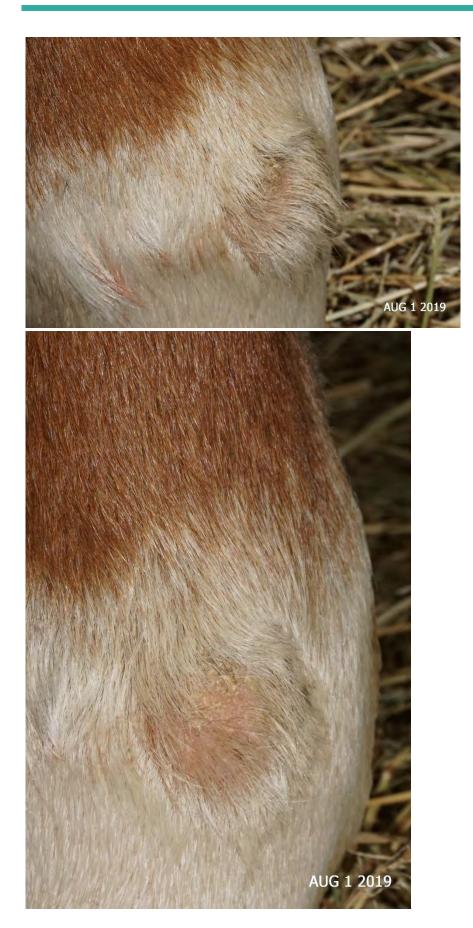
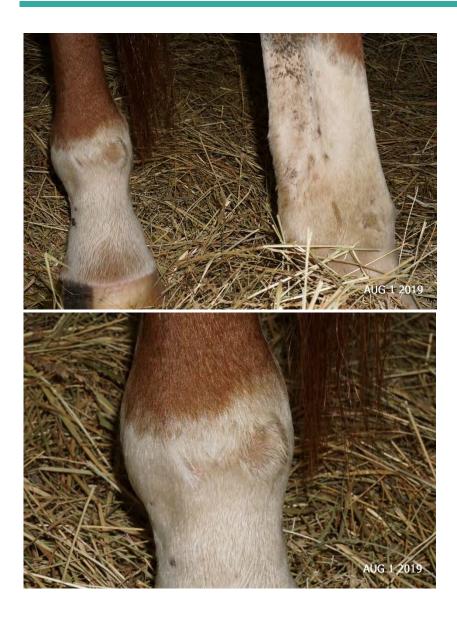
Pictures August 1st – Day 21 – After Silver Honey[™] application:

There was a marked improvement on the lesions on the pasterns and there were no scabs seen. The skin on the affected areas is healthy, pink and there are hairs growing. The area on the back of the pastern is improving as well and there was one small scab present.

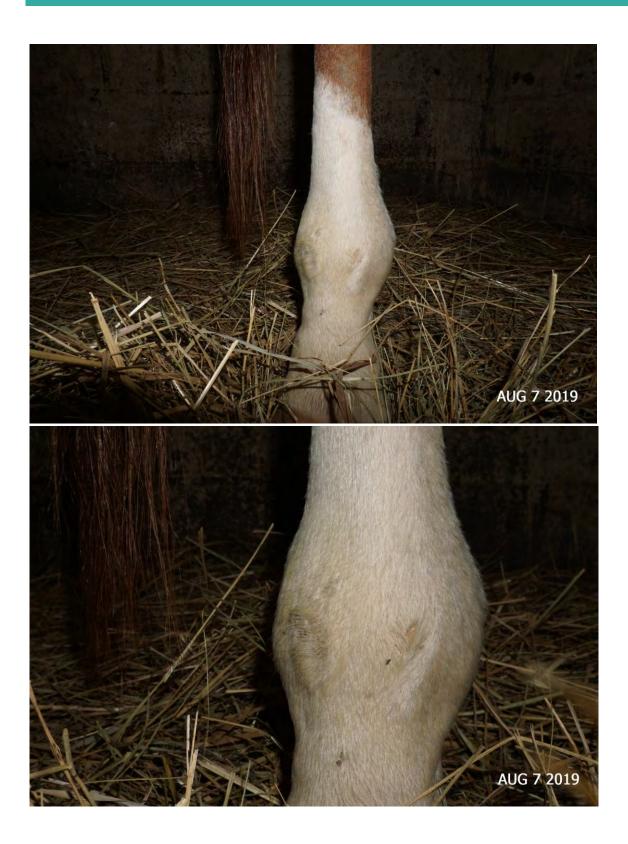
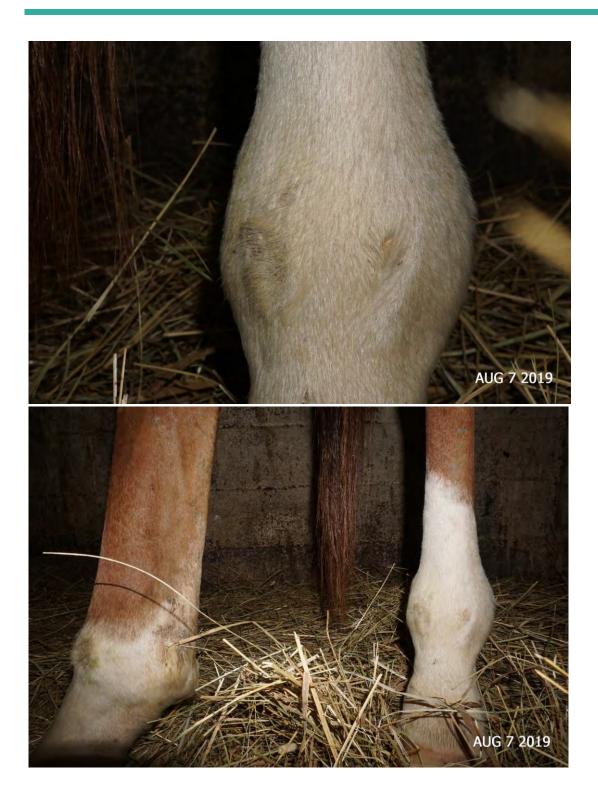
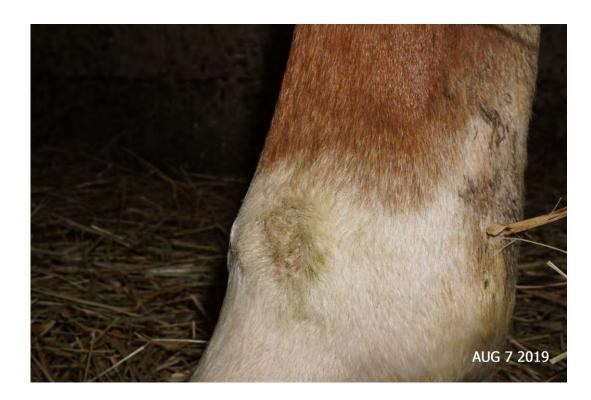
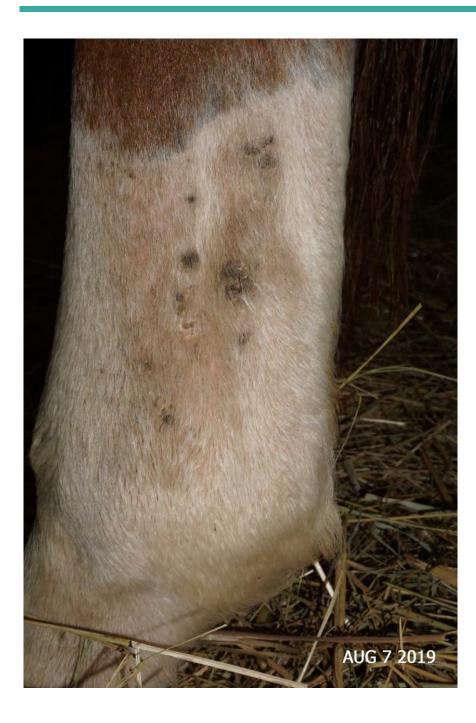
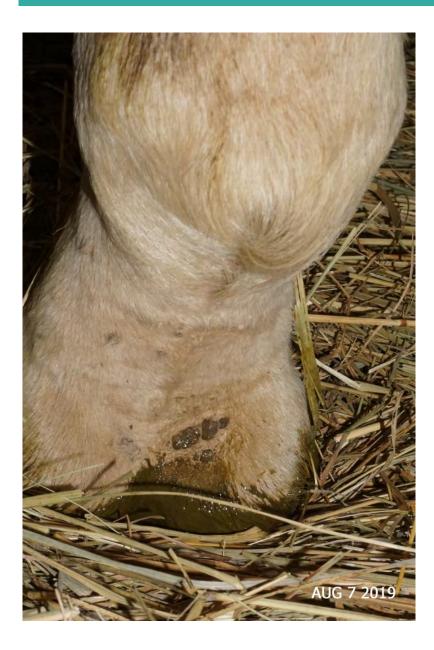
Pictures August 7th – Day 27 – after Silver Honey[™] application:

There was a continuous improvement of the lesions. The affected areas were almost completely covered with hairs and the skin underneath looked healthy and normal. The small scab on the back of the pastern remains with a small scab and healthy skin around it. The response to the therapy was very good on this mare.

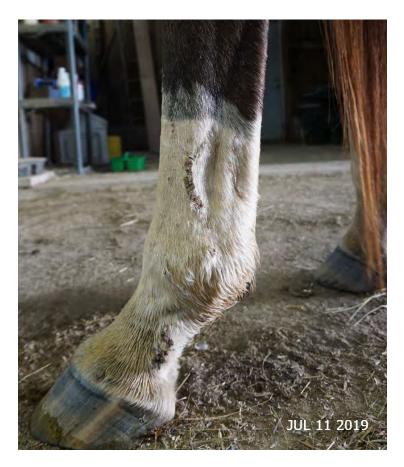
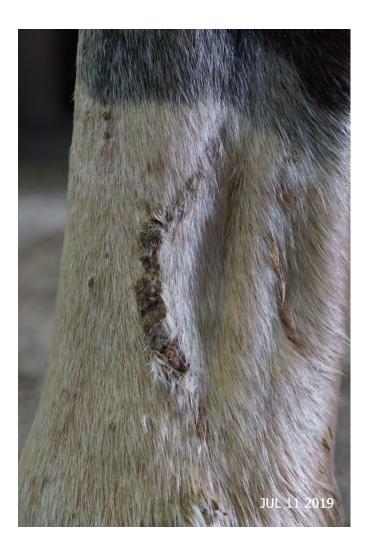
Pictures July 11th – Day 0 – Before Silver Honey[™] application:

Left hind white hair area lateral cannon bone. Lesion dry and crusty.

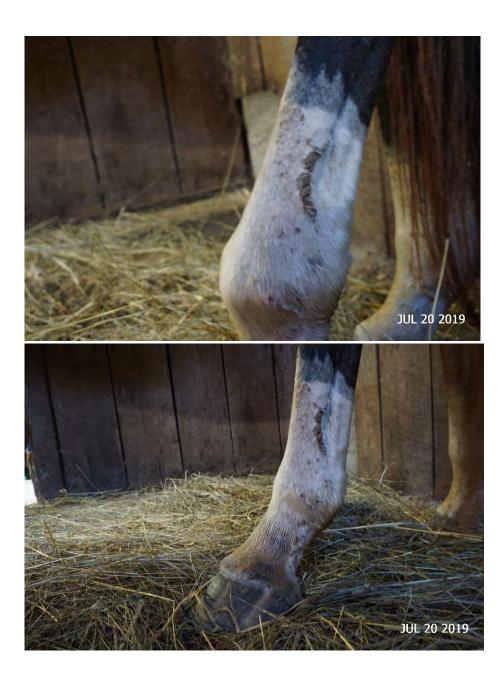
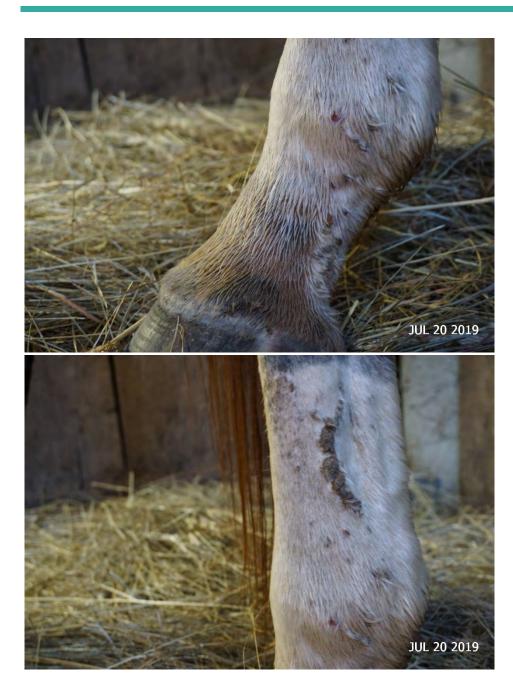
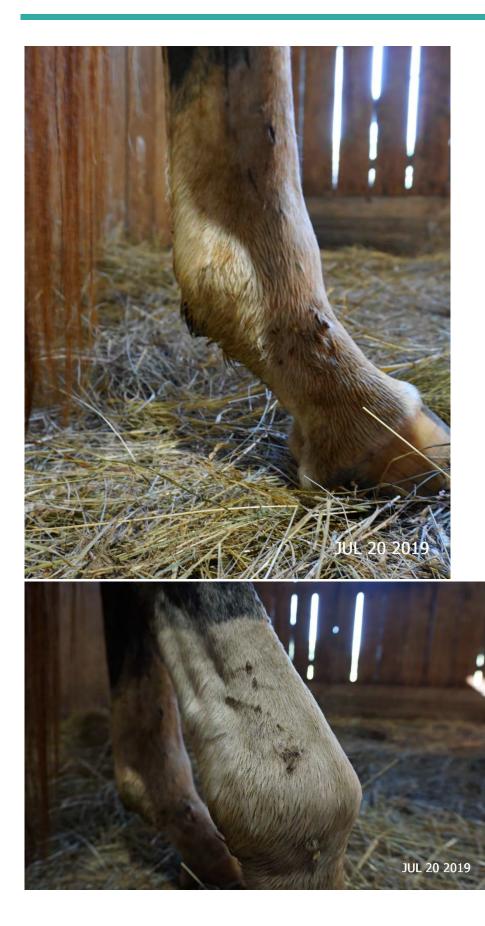
Pictures July 20th – Day 8 – After Silver Honey[™] application:

No significant changes. Scabs remain. Recommended to bandage with the Silver Honey[™] cream to see if aid with scab softening and removal.

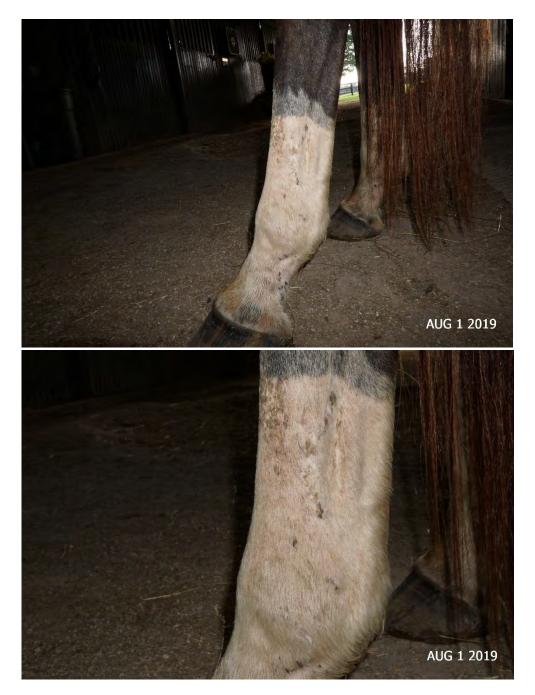
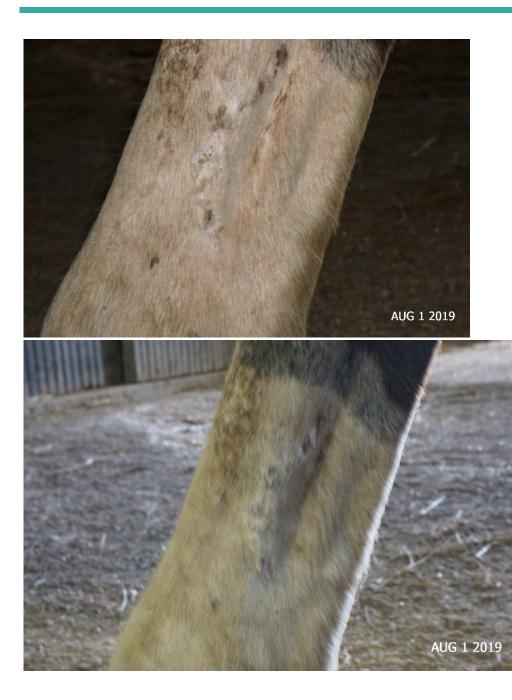
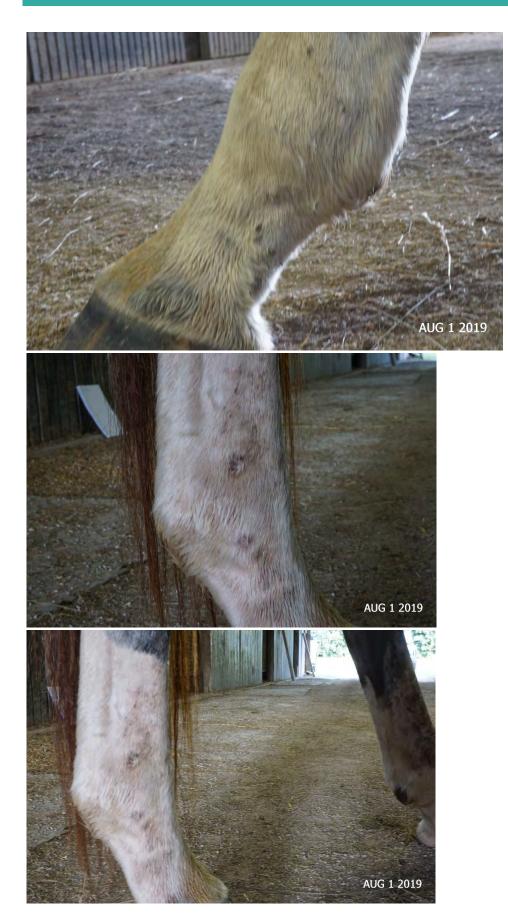
Pictures August 1st – Day 21 – After Silver Honey[™] application:

Very good improvement on the lesions. Small scabs, there is no pain and the skin appeared healthy.

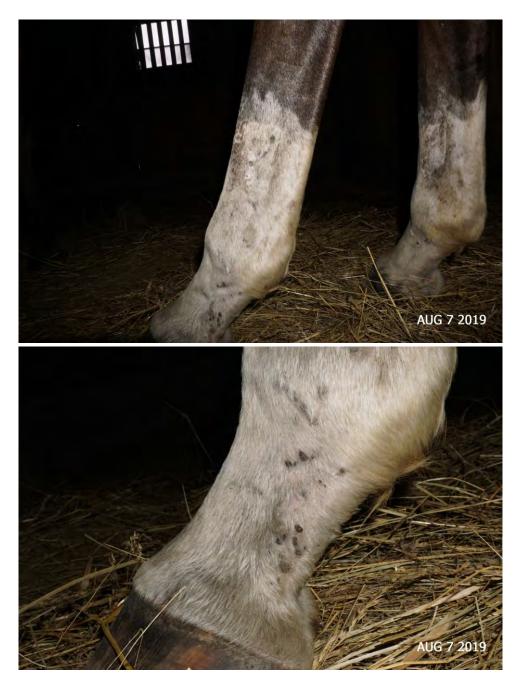
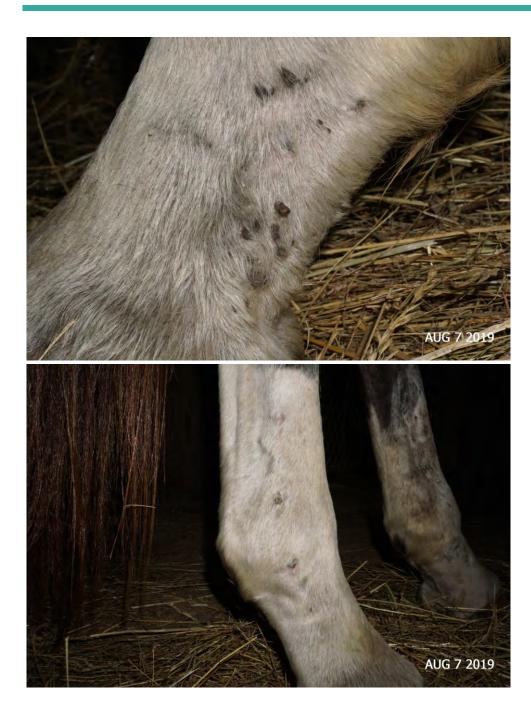
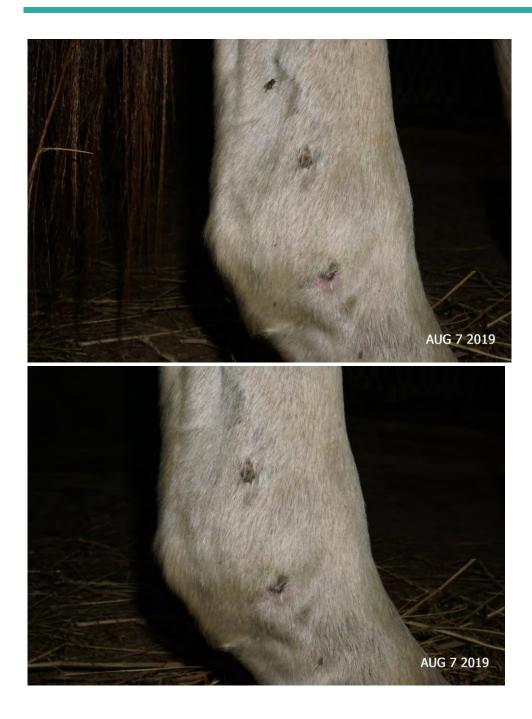
Pictures August 7th – Day 27 – after Silver Honey[™] application:

Small scabs present. No evidence of inflammation on the area around the scabs. The linear scabby lesion on the left cannon bone seen on the first day has resolved.

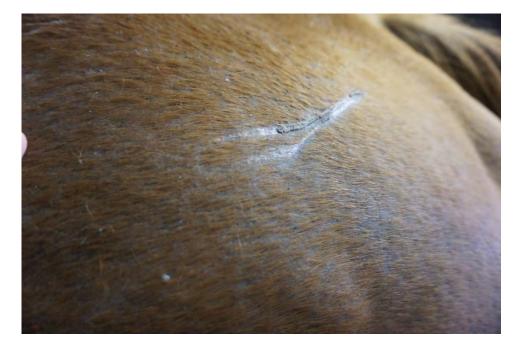
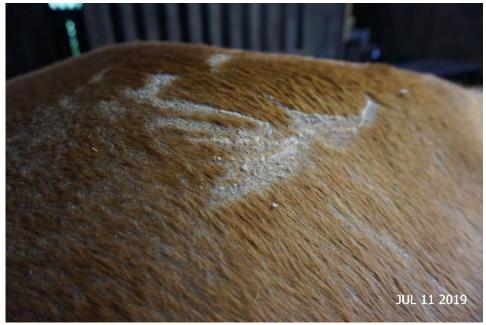
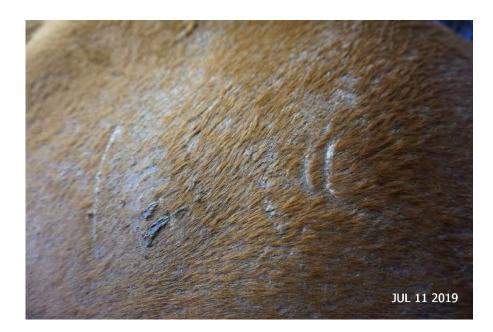
Pictures July 11th – Day 0 – Before Silver Honey[™] application:

Superficial scratches on both sides of the rump area.

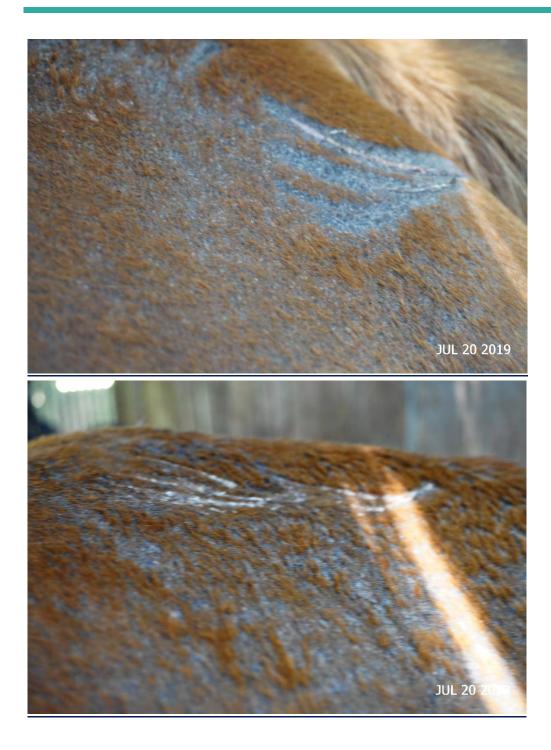
Pictures July 20th – Day 8 – After Silver Honey[™] application:

There was no significant changes to the scratches. However, overall the area appeared healthy and less scabby.

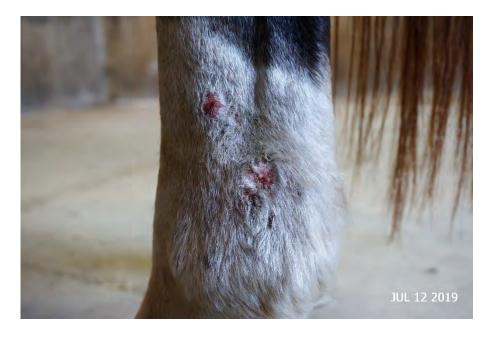
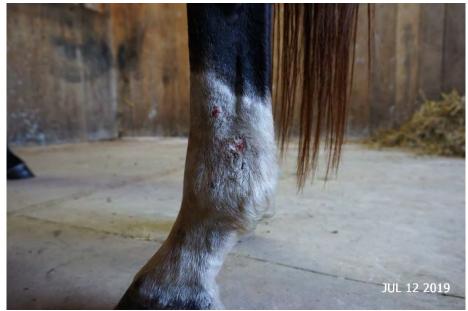
Pictures July 12th – Day 0 – Before Silver Honey[™] application:

Left hind pastern area crusty superficial wounds on white hair region. Scabs were pulled off and exposed red inflamed skin lesions with small amount of bleeding. This mare develops these lesions every year in the summer and it is very difficult to treat, only improves during the winter. She was not on any current treatment.

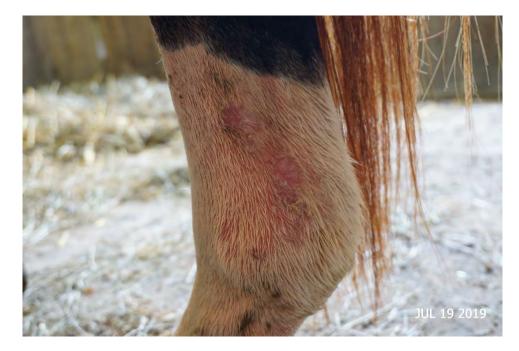
Pictures July 20th – Day 7 – After Silver Honey[™] application:

Scabs were removed before application. Significant improvement on the wounds. This mare was treated with the spray gel. Owner very happy on the way wounds are healing.

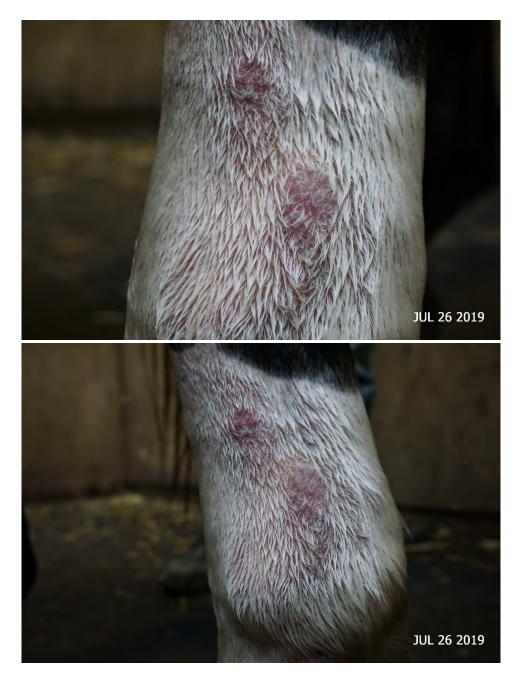
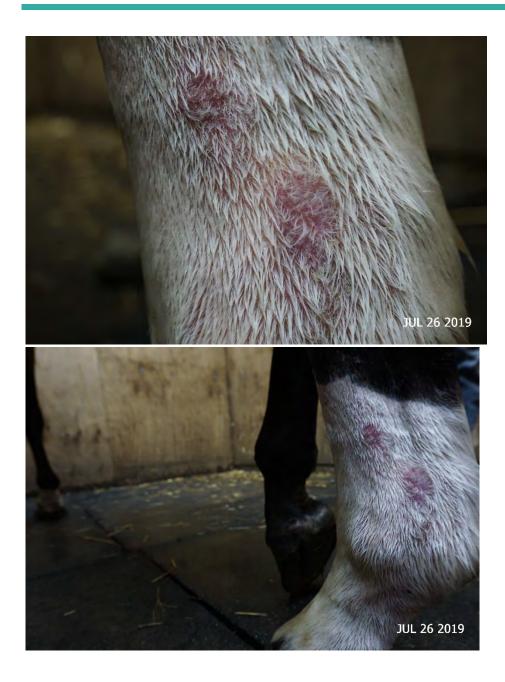
Pictures July 26th – Day 14 – After Silver Honey[™] application:

The wounds continue to heal very well. The skin looks pink and healthy, no evidence of inflammation or swelling. Hairs are growing within the lesions. There is no pain to the touch. Owners is very happy with the progress of the mare.

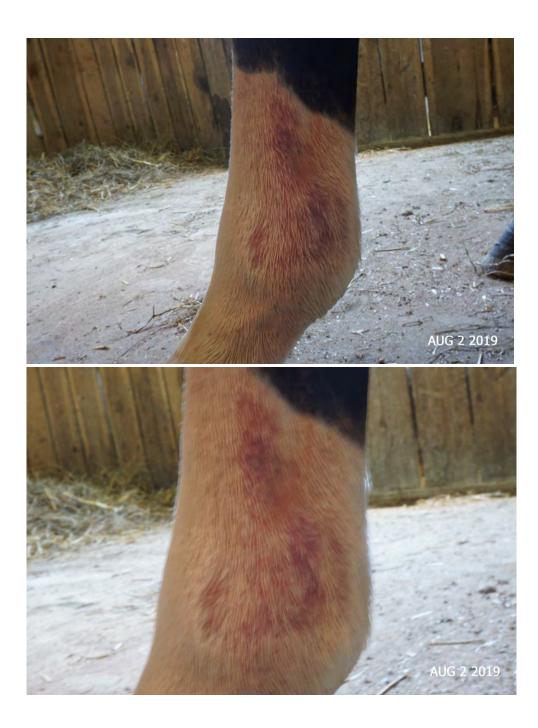
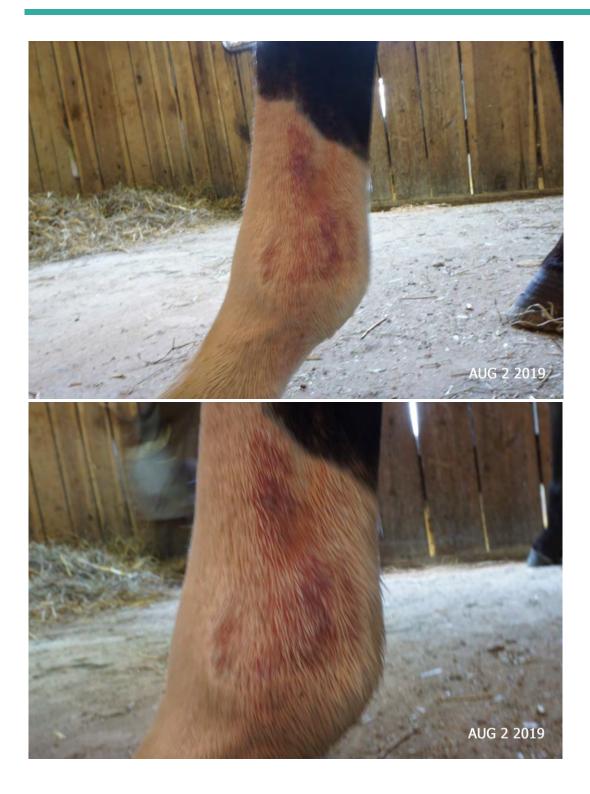
Pictures August 2^{nd} – Day 21 – After Silver Honey^m application:

The owners has been very happy with the way the Silver Honey[™] spray worked. The lesions were considered healed. As it can be appreciated on the pictures - the skin appears pink and hairs continue to grow. She will continue to apply the spray once a day.

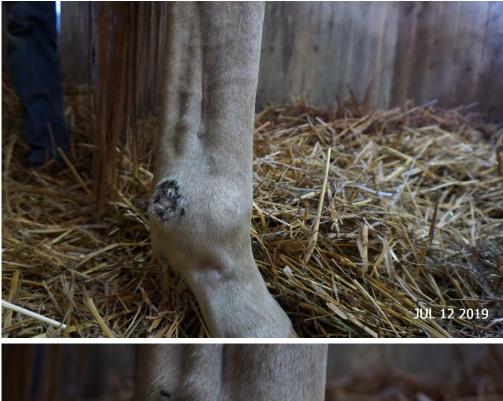
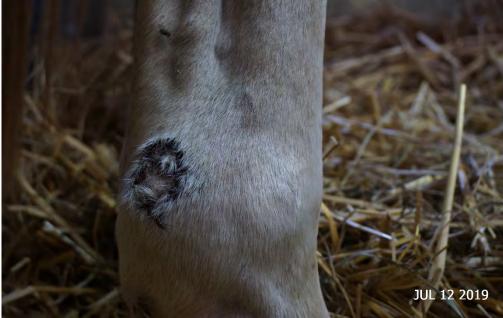
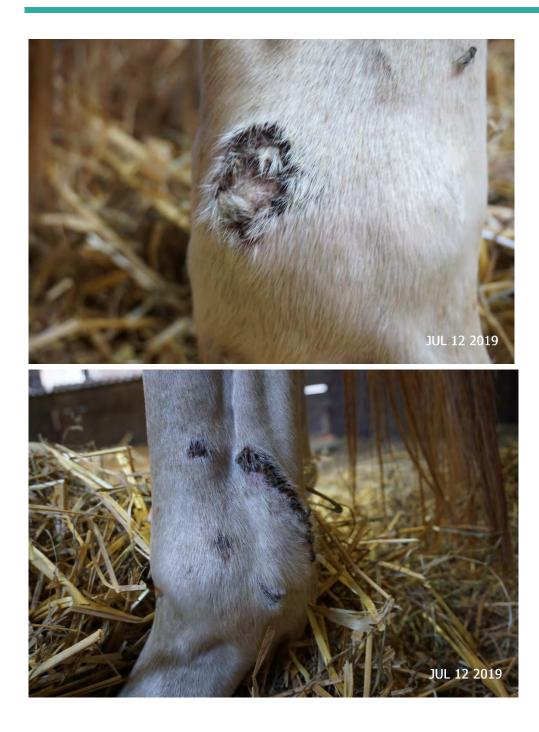
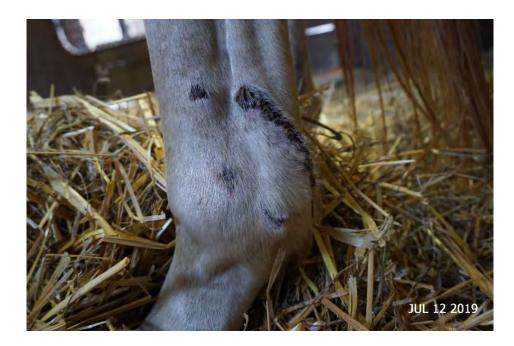
Pictures July 12th – Day 0 – Before Silver Honey[™] application:

Right hind lateral fetlock area crusty circular lesion. Left hind pastern area of a linear crusty superficial extending from lower cannon bone to fetlock area. The wounds were on white hair region. Since the scabs were tightly attached it was recommended to soften them with warm water and soap and then apply Silver Honey[™].

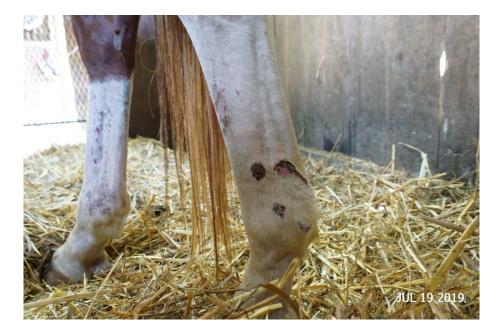
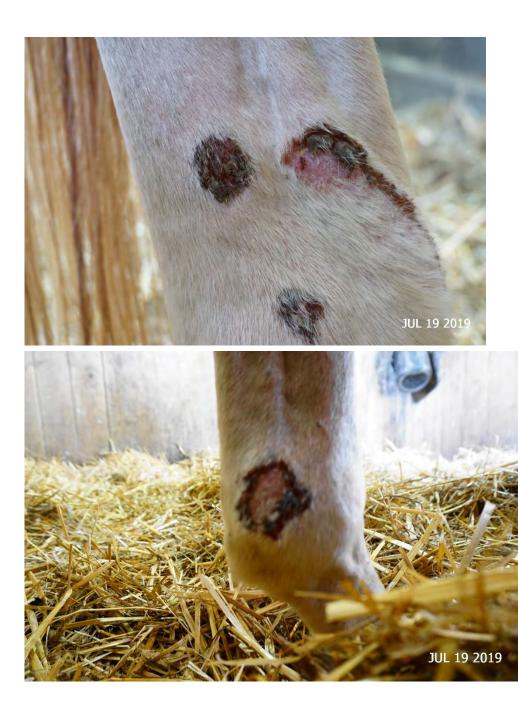
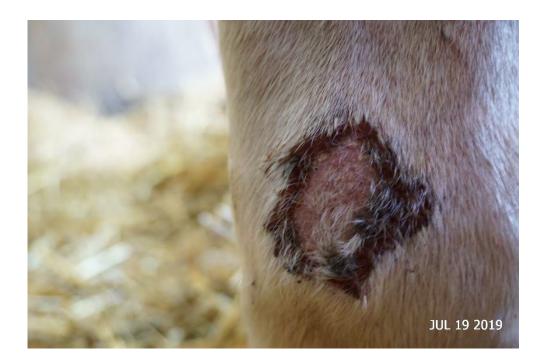
Pictures July 20th – Day 7 – After Silver Honey[™] application:

Right hind fetlock area circular area seems to have healthier skin in the center. Still has scabs mainly on the margins. Left hind linear lesion, there was an area where no scab were present. Here the skin looked pink and healing. There was no much change on areas where scabs remain present. This gelding has been treated with the Silver Honey[™] cream. We were more aggressive with removing the scabs and the owner will apply Silver Honey[™] gel on areas where scabs are difficult to remove and the cream on areas where scabs were removed.

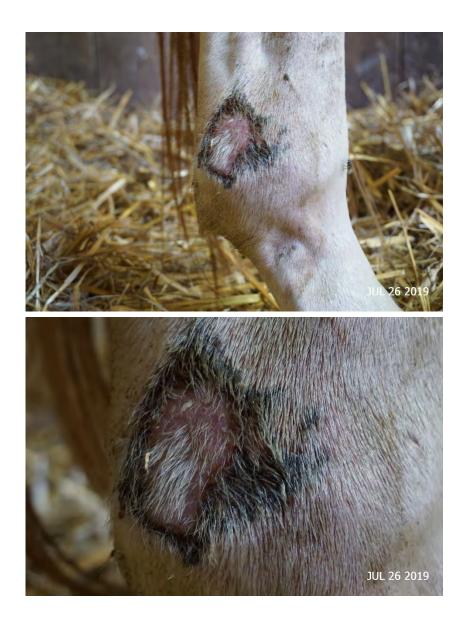
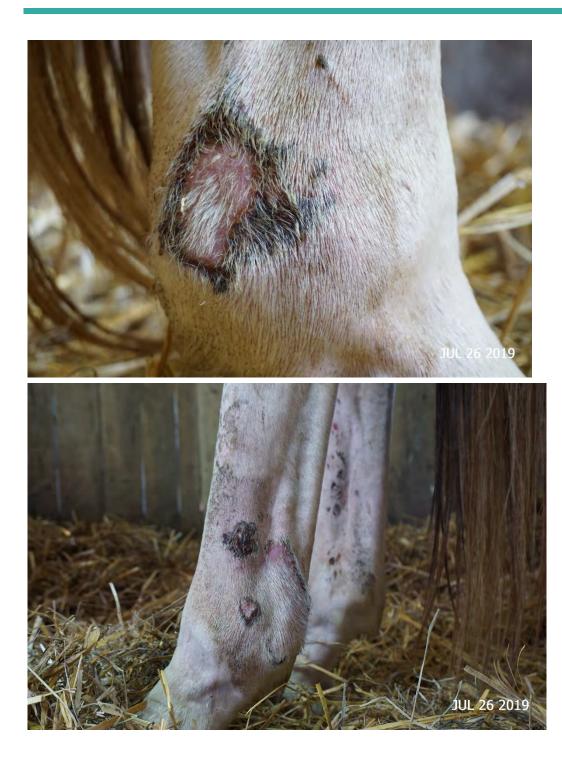
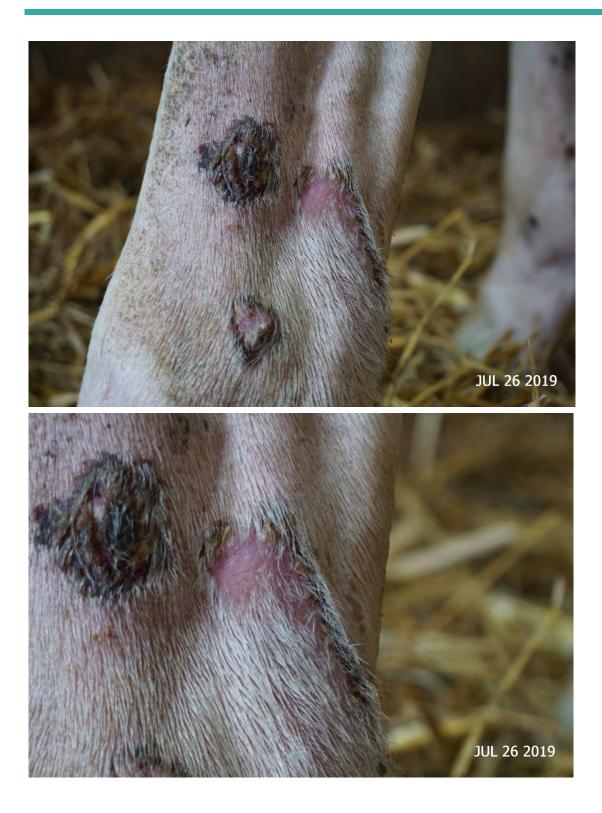
Pictures July 26th – Day 14 – After Silver Honey[™] application:

Right hind limb large circular lesion continues to improve. The skin looks healthy there is no pain to the touch and there are hairs that continue to grow within the area.

Left hind limb the area without scabs had healthy pink skin with hairs growing in some areas. The scab on the circular lesion was removed and the skin under it was pink without evidence of inflammation and hairs starting to grow. The treatments aimed at softening the scab was effective. Also, the honey likely was able to penetrate the scab as evidenced by the healthy skin.

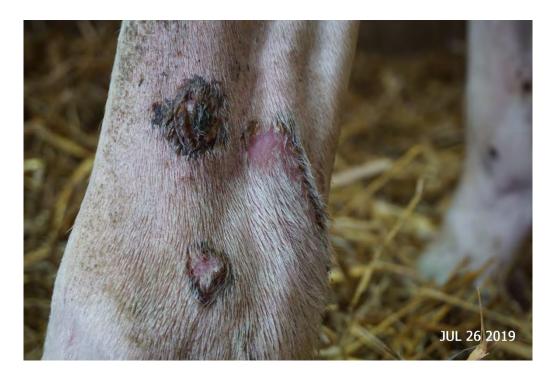
The picture shows the circular lesion with the scab. When touched the scab was soft and loosely attached to the skin. The scab was easily removed, see picture below.

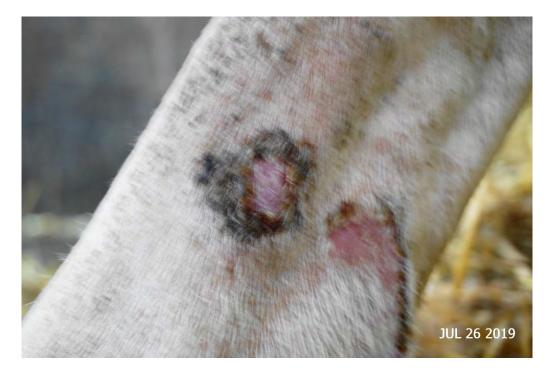
After the scab was removed on the circular lesion. The skin underneath is healthy with some hairs growing within it.

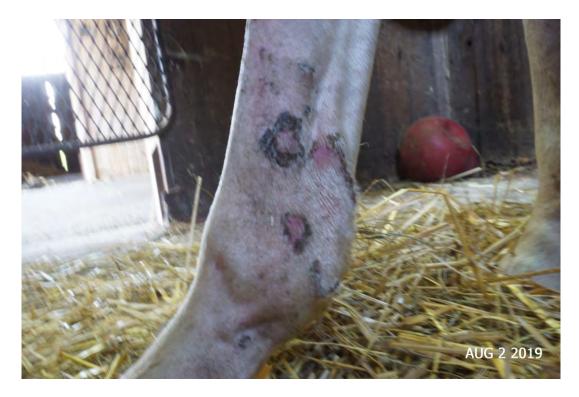
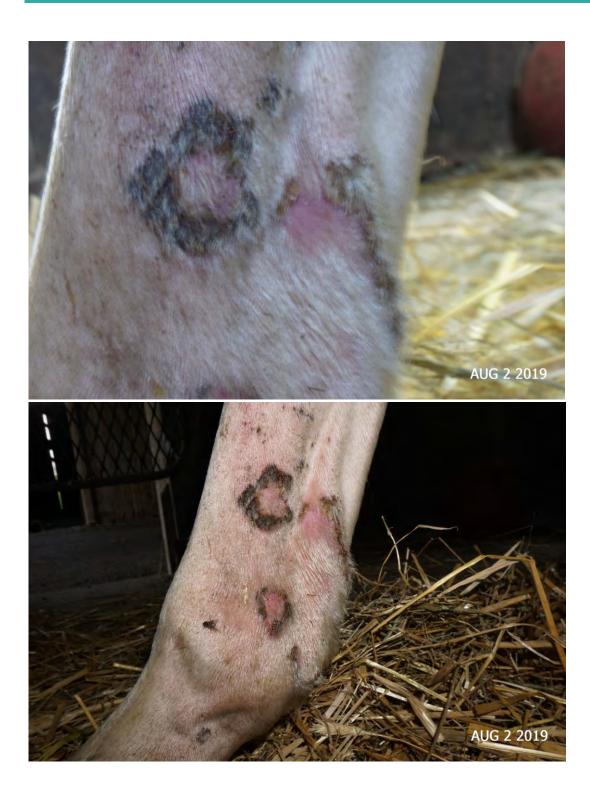
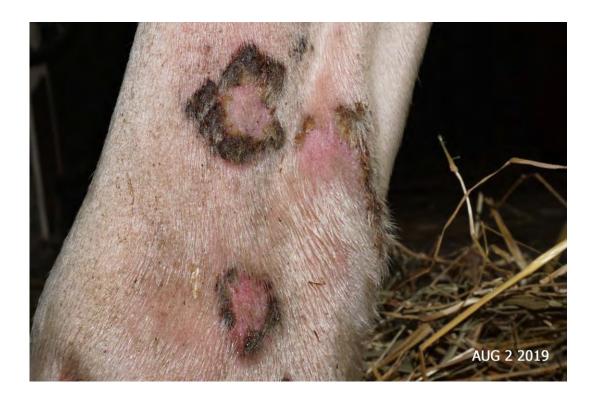
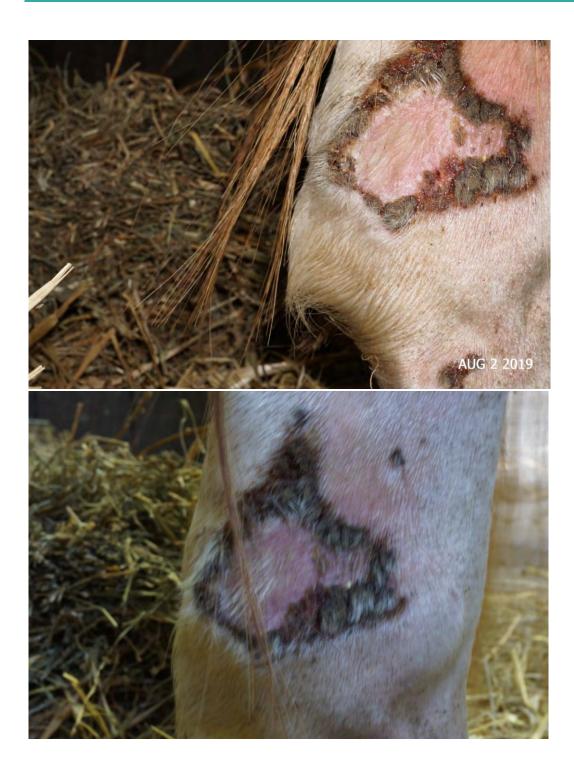
Pictures August 2^{nd} – Day 21 – After Silver Honey^m application:

Right hind limb large circular lesion continues to improve. The skin on the center of the lesion looks healthy there is no pain to the touch and there are hairs that continue to grow within the area. See the last picture for a comments and close up for the lesion's margins. The lesions on the Left hind limb continue to improve. There are scabs present on the margins of some of the lesions. However, the center of the lesions continues to improved, evidenced by healthy skin and hair growth.
