Silver Honey™ Equine Field Trial

AUGUST 8 2019

WF Young Inc. Authored by: Lucas Pantaleon DVM

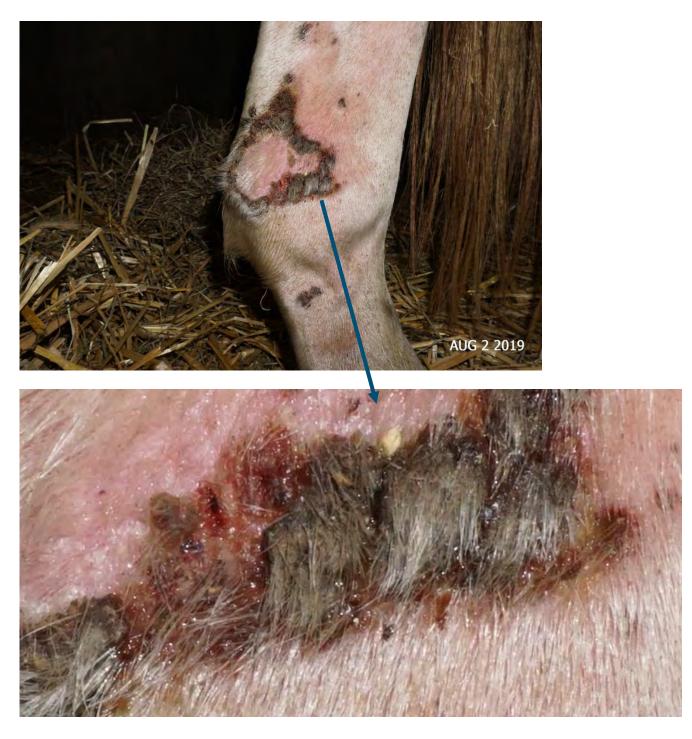
Picture above is a close up view of the lower margin of the right hind limb. There is still evidence of inflamed skin under the scabs with small amount of bleeding as the scabs were removed. The center of the lesions has healthy pink skin with no evidence of inflammation and hairs growing.
