Installation

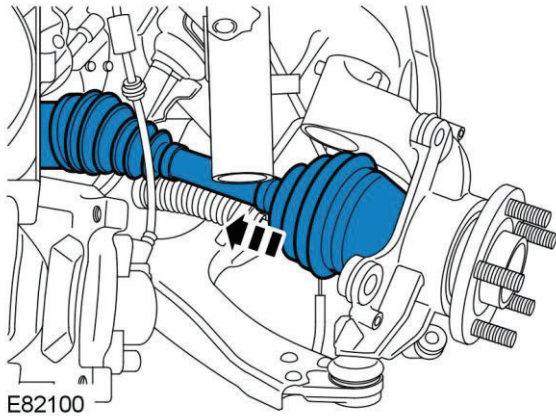
CAUTION: Do not allow halfshafts to hang unsupported at one end or joint damage will occur.

CAUTION: Do not use a hammer to detach the halfshaft from the hub assembly, failure to follow this instruction may result in damage to the halfshaft.

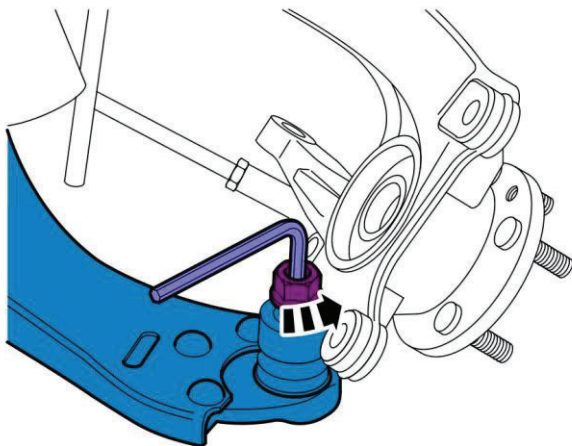
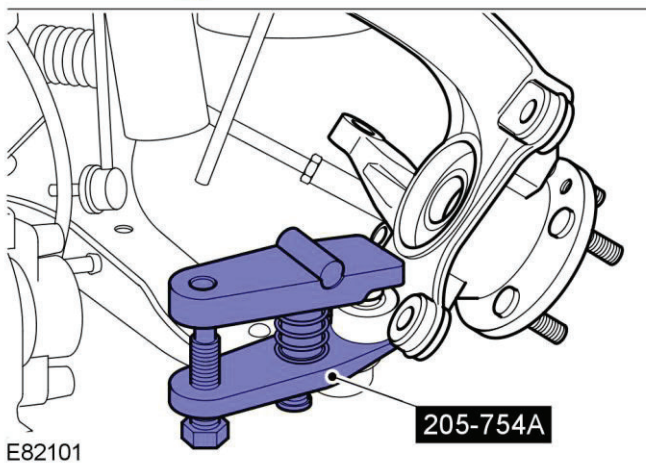
E82101

WARNING: Make sure that a new lower arm ball joint nut is installed.

CAUTION: Make sure that the ball joint ball does not rotate.

Torque to: 100 Nm

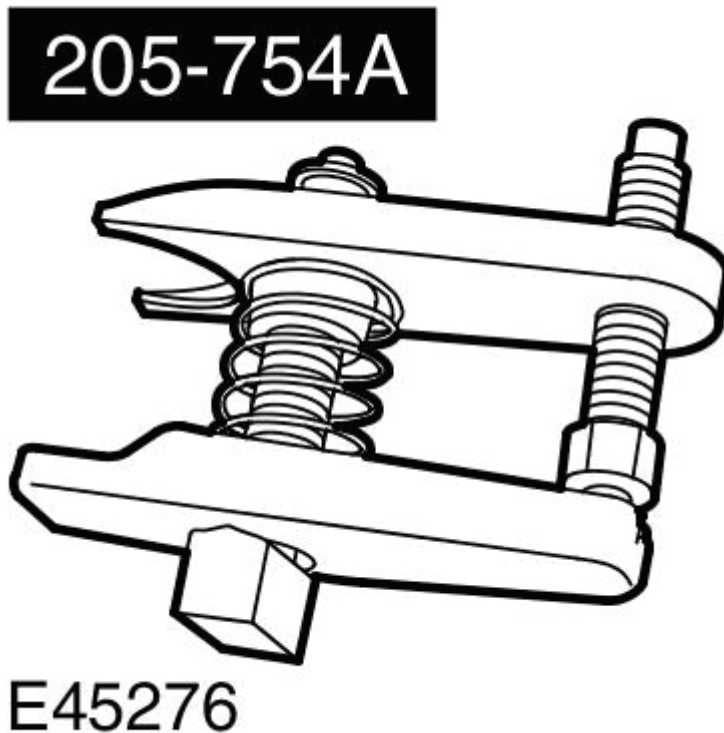
Special Service Tool

Splitter, Ball Joint, 205-754A
