IMPORTANT
INSTRUCTIONS AND WARRANTY INFORMATION
PLEASE READ.

This Power Steering Pump has plastic spacer installed between the reservoir and pump. See pictures below.

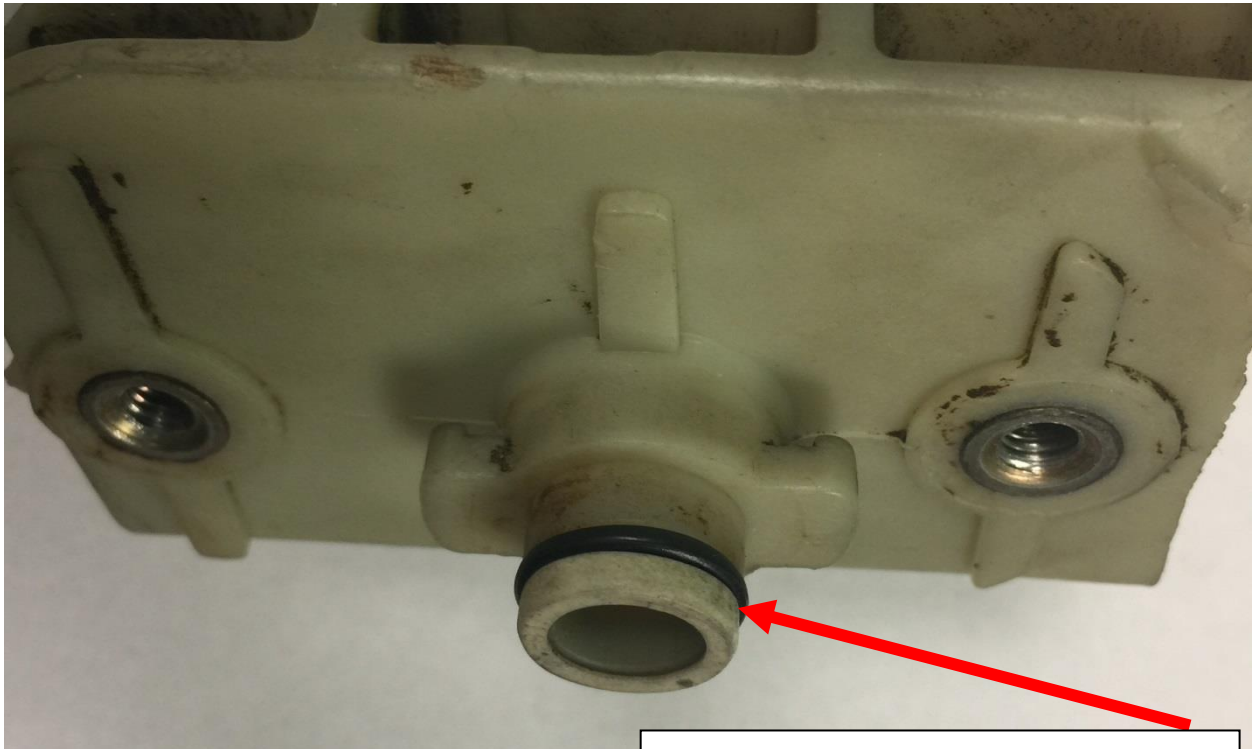
Old plastic spacer and new o’ring

It is critical to replace o’ring on the reservoir and transfer old plastic spacer, for pump to work properly. Failure to transfer old plastic spacer and change this o’ring will lead to leak between housing and reservoir.

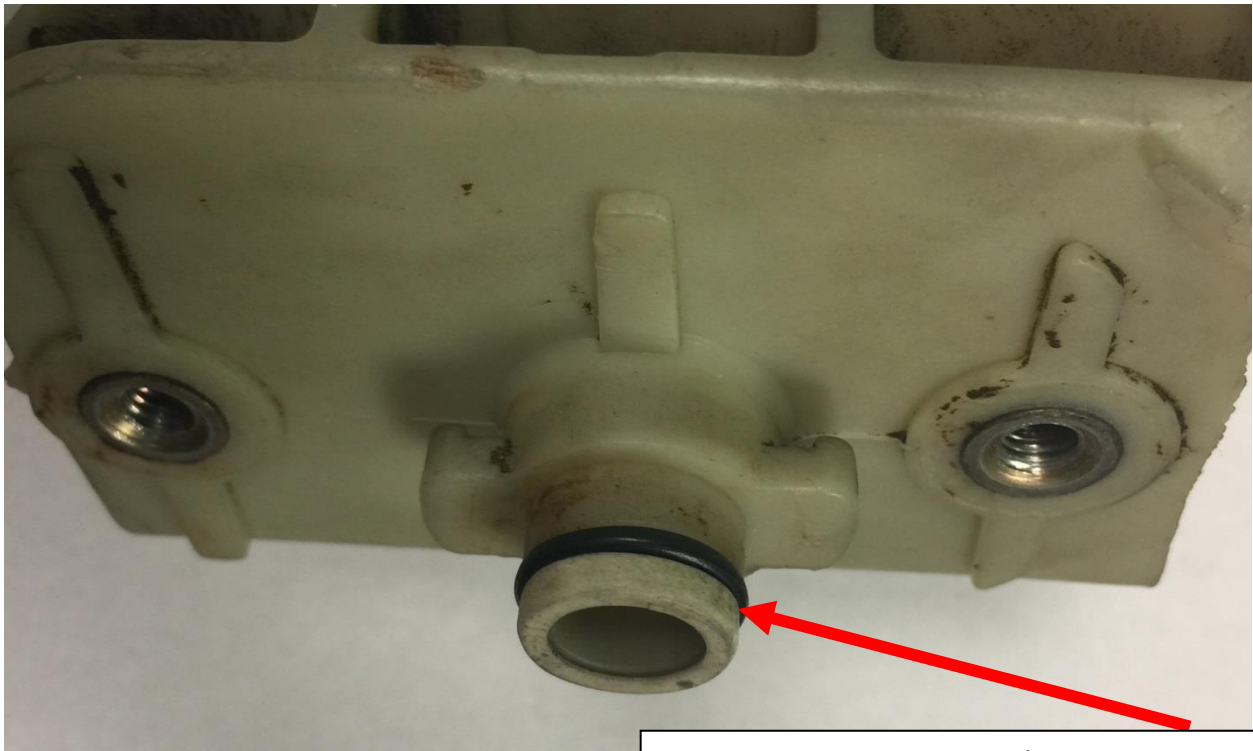
Esta bomba de dirección asistida tiene espaciador de plástico instalado entre el depósito y la bomba. Vea las imágenes a continuación.

Viejo espaciador de plástico y nuevo o'ring

Es fundamental reemplazar el o'ring en el depósito y transferir el espaciador de plástico viejo, para que la bomba funcione correctamente. Si no se transfiere el espaciador de plástico viejo y se cambia este o'ring, se producirá una fuga entre la carcasa y el depósito.
