ROYAL NAVY
SHIPS' BOTTOMS AND BOOT-TOPPING 1936-1950

Richard Dennis

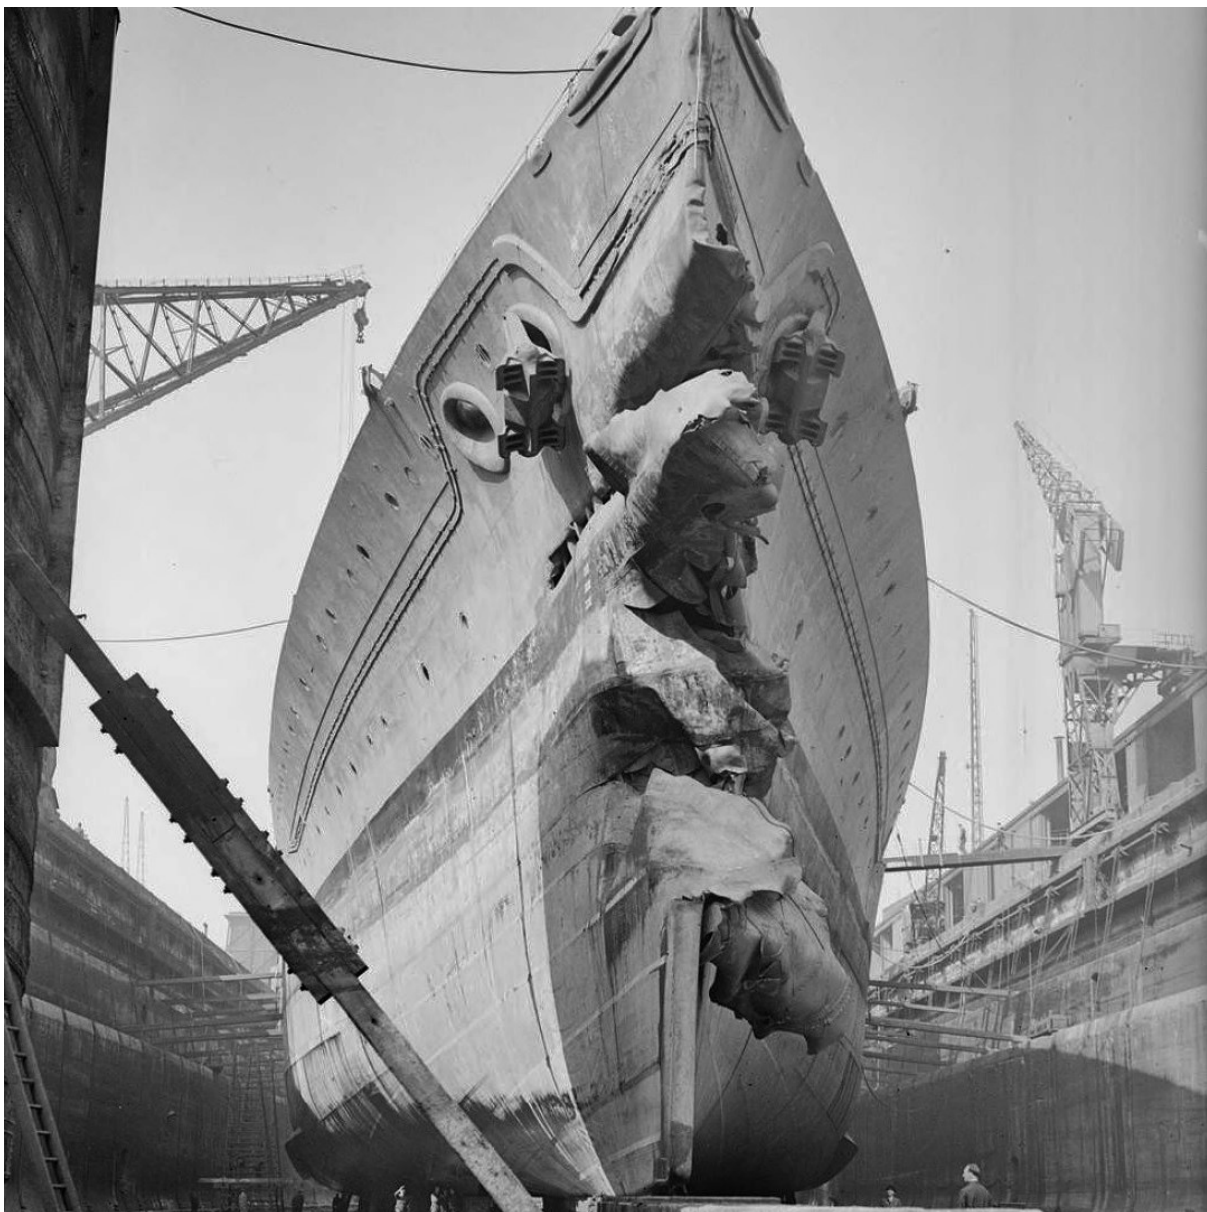
HMS King George V in Gladstone Dock, Liverpool May 1942 (IWM A9949)

Other manufacturers supplied their anti-fouling in two colours, one normally black and the other red or grey. If a contemporary (black & white) photo is available showing the boot-topping and the lower hull of the ship in question and if there is significant contrast between the tone of the black boot-topping and the tone of the lower hull then the anti-fouling can be assumed to have been the colour other than black. So for example HMS King George V's D.495s record that her lower hull was coated with Moravia compositions during World War 2 until her docking in Australia in late 1945. Moravia Admiralty quality anti-fouling came in black or grey. Photos of HMS King George V in dry dock from the early years of World War 2 show her lower hull was distinctly lighter than her boot-topping indicating that her bottom was grey.

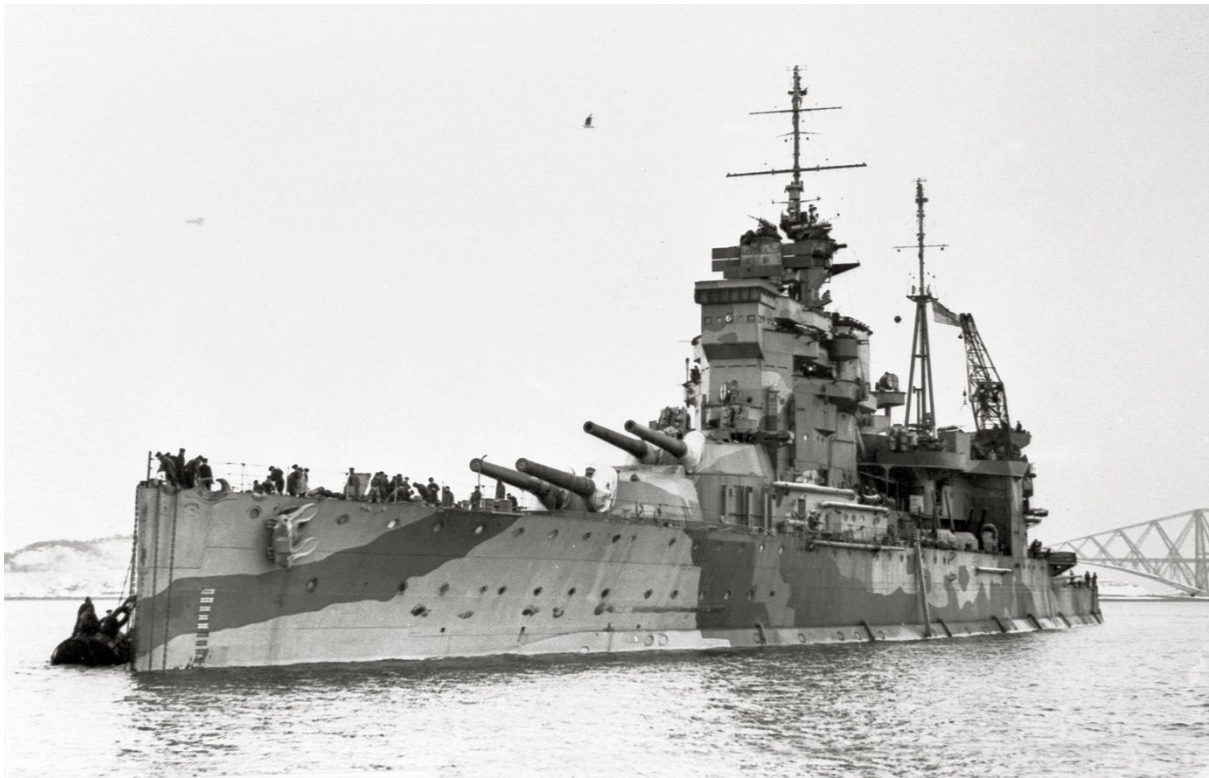
HMS Queen Elizabeth at Rosyth February 1941 wearing disruptive camouflage and with no visible boot-topping (Author's collection)

However it was recognized that in wartime the continuous line of boot-topping visible above the waterline was an aide to estimating inclination and defeated the purpose of patterned camouflage designs. The over-painting of the boot-topping area with upper hull paints down to the waterline was therefore a widespread policy with the official camouflage designs of the early war years.

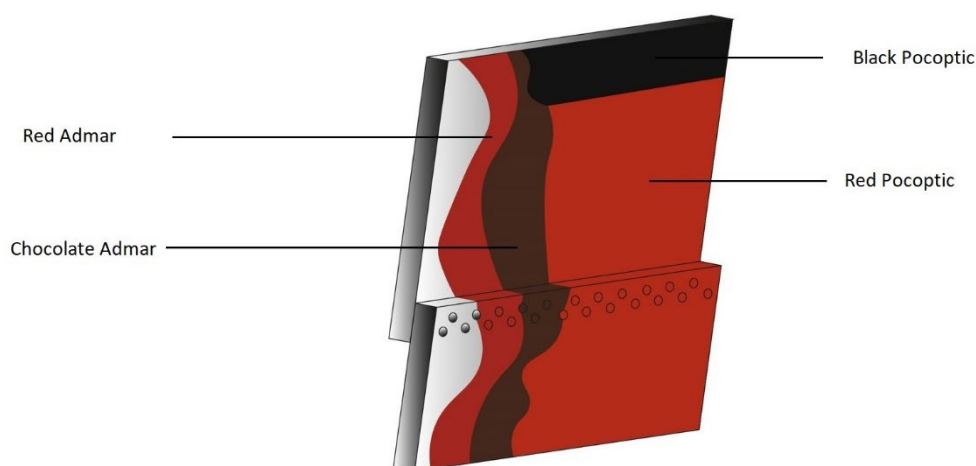
Lower hull painting of surface ships postwar

Wartime research resulted in a synthetic resin protective paint which had superior qualities. Initially named Pomar, in 1948 it was renamed Admar. This became the approved protective coating for Royal Navy ships' bottoms in March 1948 and was supplied in red and chocolate. The policy for surface ships was a first coat of red and then a second coat of chocolate. The different colours were to facilitate coating and inspection.

Pocoptic was produced in red and black. Red was intended for surface ships and black was intended for submarines. Black Pocoptic was also used as the boot-topping on surface ships. From 1948 onwards therefore the apparent colour of the bottoms of Royal Navy surface ships in commission would have become increasingly restricted to the red of the new Pocoptic anti-fouling composition. However large wartime stocks of propriety compositions had accumulated and these continued to be used on ships of the Reserve Fleet and by overseas stations for a couple of years more until used up.
