STAINLESS STEEL 2 PIECE BALL VALVE DIRECT ISO MOUNTING PAD - FIRE SAFE MODEL - SS2020D 15-100MM

STAINLESS STEEL 2 PIECE BALL VALVE DIRECT ISO MOUNTING PAD - FIRE SAFE MODEL - SS2020D 125-250MM

STAINLESS STEEL 2 PIECE BALL VALVE DIRECT ISO MOUNTING PAD - FIRE SAFE MODEL - SS2020D 15-250MM

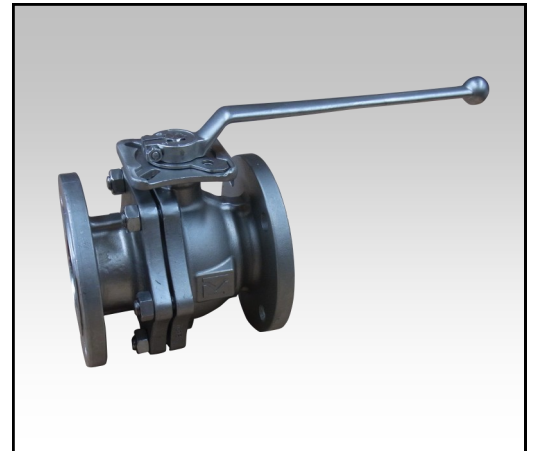
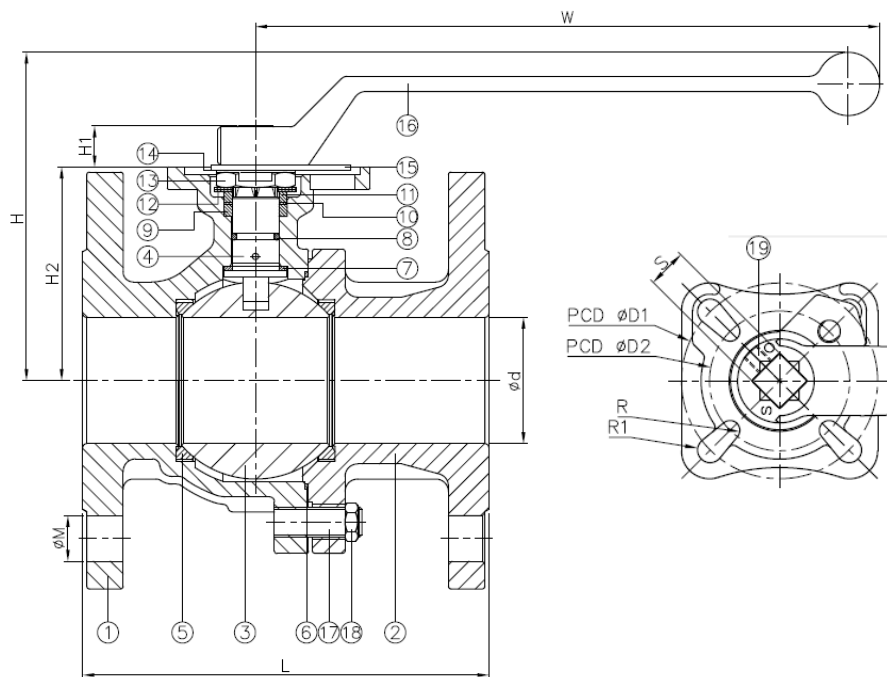
NO.	PART NAME	MATERIAL
1	Body	ASTM A351-CF8M
2	Cap	ASTM A351-CF8M
3	Ball	ASTM A351-CF8M
4	Stem	ASTM A276-316
5	Seat	RTFE
6	Body Seal	Graphite
7	Thrust Washer	CTFE
8	O-Ring	Viton
9	Packing A	Graphite
10	Packing B	CTFE
11	Gland Ring	AISI 304
12	Belleville Washer	AISI 301
13	Nut	AISI 304
14	Lock Washer	AISI 304
15	Stopper	AISI 304
16	Handle	AISI 304
17	Stud	AISI 304
18	Nut	AISI 304
19	Socket Set Screw	AISI 304

DIMENSIONS																
DN	D1	D2	M	d	L	H	H1	H2	W	R	R1	S	Breakaway (Nm)	Action (Nm)	(Kg)	(Cv)
15	42	36	16	15	108	85	8.5	50.5	190	2.75	2.75	9	5.2	3	1.7	37
20	42	36	16	20	117	89.5	8.5	55	190	2.75	2.75	9	8	4.7	2.1	68
25	50	42	16	24	127.5	94.2	10.5	59	190	2.75	3.5	11	12.5	9	3.2	101
32	50	42	16	30	140.5	97.9	10.5	62	190	2.75	3.5	11	12	8.5	3.7	162
40	70	50	16	38	165	120.9	14	76	235	3.5	4.5	14	24.5	18	6	268
50	70	50	19	50	178	129.9	14	84.5	235	3.5	4.5	14	32	23	8	486
65	102	70	19	64	190.5	156.3	17	104.5	325	4.5	5.5	17	38	27	14.5	817
80	102	70	19	76	203	163.3	17	111.5	325	4.5	5.5	17	45	30	18.2	1150
100	125	102	19	98	229	190.9	23	135.5	325	5.5	6.5	22	55	37	29	1973

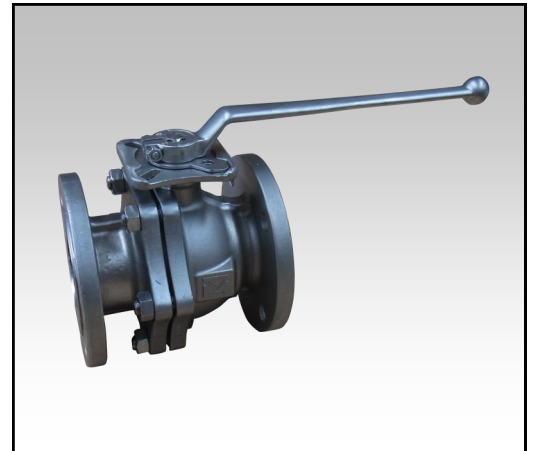
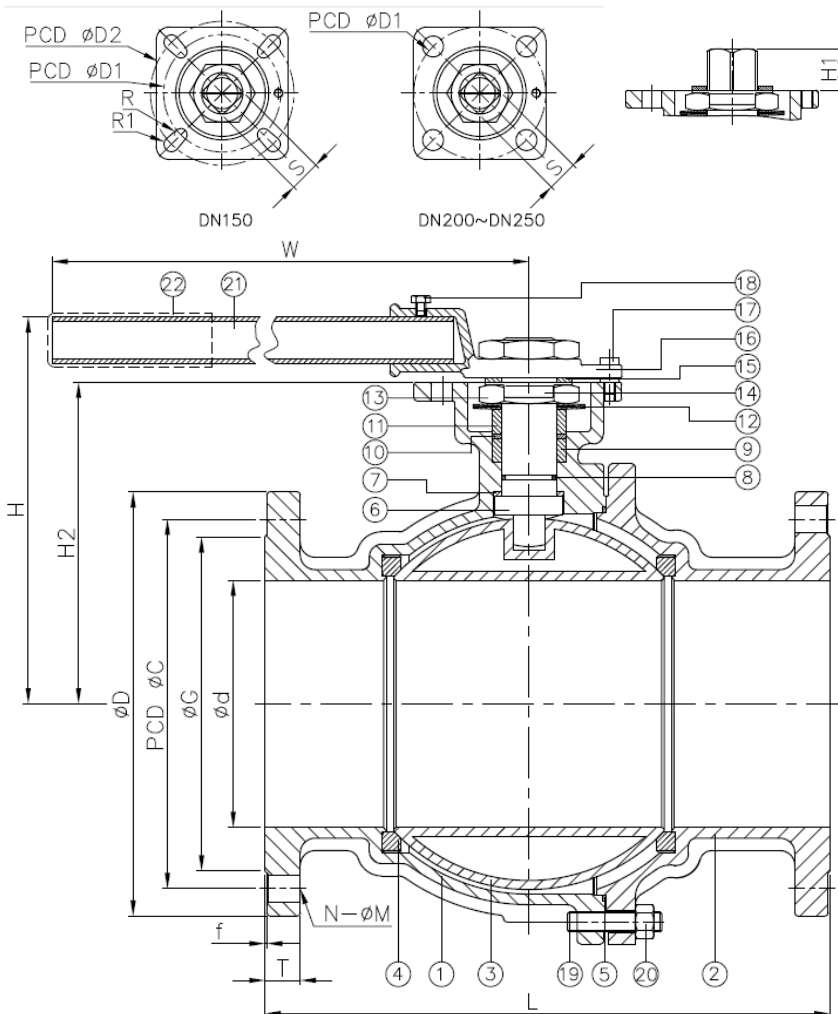
NO.	PART NAME	MATERIAL
1	Body	ASTM A351-CF8M
2	Cap	ASTM A351-CF8M
3	Ball	ASTM A240-316
4	Ball Seat	RTFE
5	Body Seal	Graphite
6	Stem	ASTM A276-316
7	Thrust Washer	CTFE
8	O-Ring	VITON
9	Packing A	Graphite
10	Packing B	CTFE
11	Gland Ring	AISI 304
12	Belleville Washer	AISI 301
13	Stem Nut	AISI 304
14	Lock washer	AISI 304
15	Flat Washer	AISI 304
16	Handle Head	AISI 304
17	Stop Pin	AISI 304
18	Bolt	AISI 304
19	Stud	AISI 304
20	Nut	AISI 304
21	Steel Tube	AISI 304
22	Handle Sleeve	PVC

DN	d	D	C	G	M	N	f	T	D1	D2	R	R1	H	H1	H2	L	S	W	Break-Away (Nm)	Action (Nm)	(Kg)	(Cv)
125	125	254	216	186	22	8	1.6	23.9	102	125	5.5	6.5	232	28	180	356	27	743	160	96	40.3	3304
150	150	279	241.5	216	22.4	8	1.6	25.4	102	125	5.5	6.5	230	27.5	201	394	27	743	250	170	52	4923
200	200	343	298.5	270	22.4	8	1.6	28.6	140	-	8.5	-	312	36	259	457	36	840	470	280	88	9036
250	250	406	362	324	25.4	12	1.6	30.2	140	-	8.5	-	350	36	295	533	36	1040	750	532	143	14126

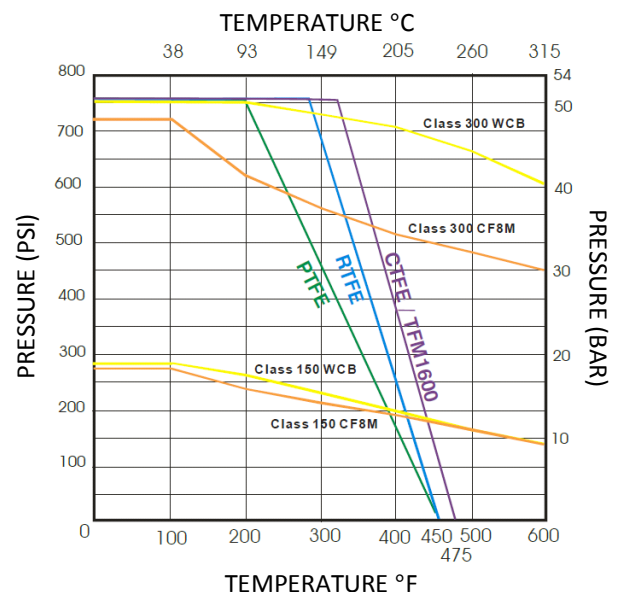
PRESSURE-TEMPERATURE RATING

In general the application of the valve shall comply with the pressure & temperature rating range below. If the risk of fire is present the client is recommended to select fire safe products according to API-607 approval. This means that the ball when in closed position will seal against the metal seat rim after the soft seats have been burned or melted in a fire.
