The Centre for
Biofield Sciences

Integrated Health

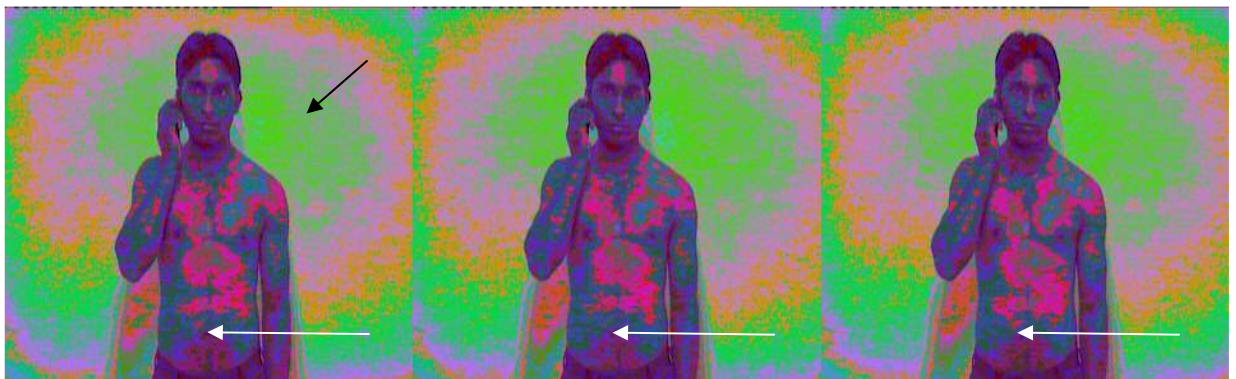
with electrodot on mobile. After 30 secs (during call)

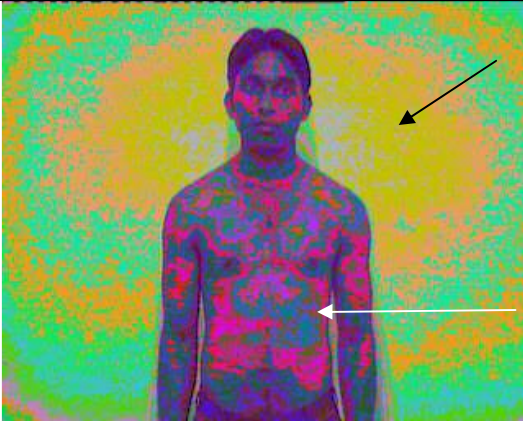
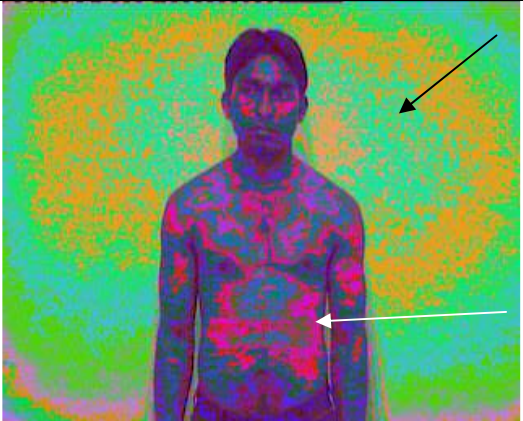
| <p>Before exposure to electrodot (16.03.2009)</p> | <p>After 2days using electrodot (19.03.2009)</p> |

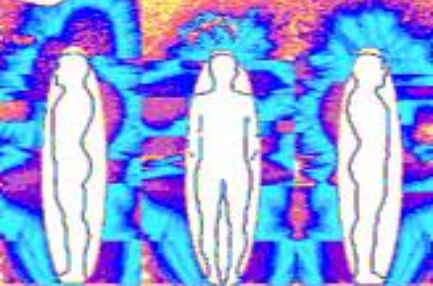
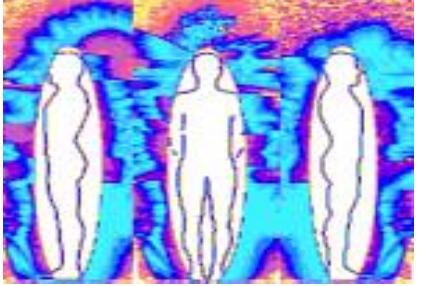
| <p>Analysis: Leaks are seen at level of heart solar and splenic chakra. Absence of energy at level of left lower limb is seen. After use of electrodot aura appears to be much more organized and symmetrical.</p> | |

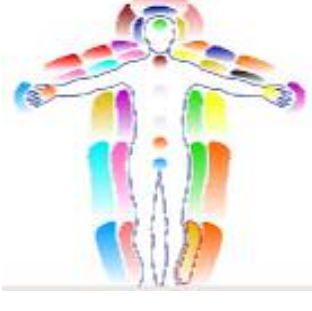
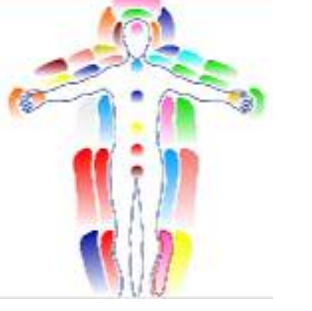
| <p>Analysis: positive shift from dull red to vibrant indigo is seen in crown. Replacement of low energy in brown colour with blue is seen in throat chakra which is a positive sign.</p> | |

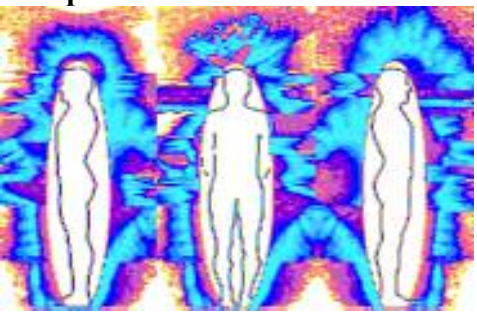
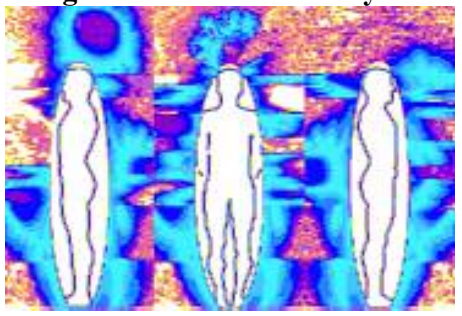
| <p>Before exposure to electrodot</p> | <p>After using electrodot for two days</p> |

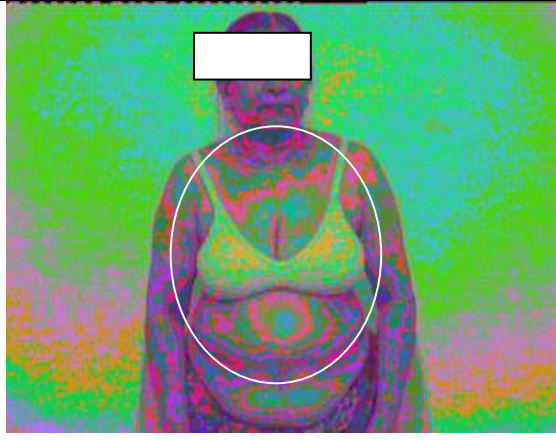
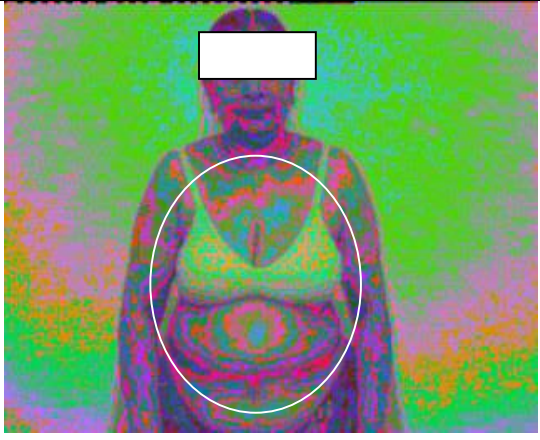
| <p>Before exposure to electrodot</p> | <p>After using electrodot for 2days</p> |

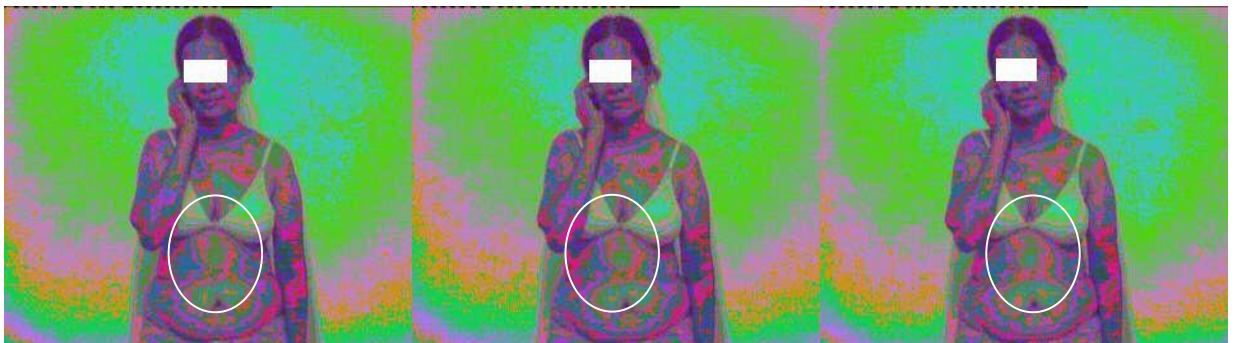
with electrodot on mobile. After 30 secs (during call)

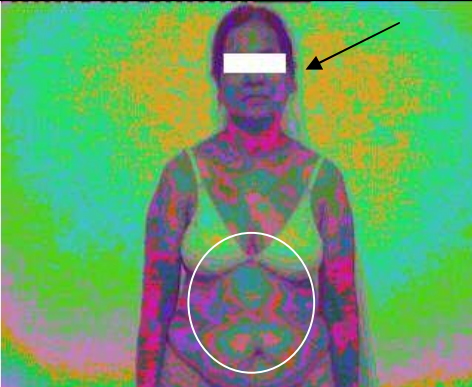
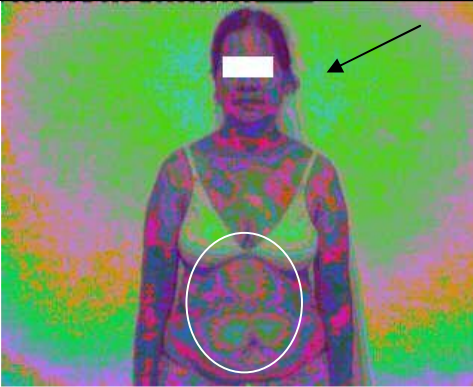
| <p>Before exposure to electrodot (14.03.2009)</p> | <p>After using electrodot for 2 days (17.03.2009)</p> |

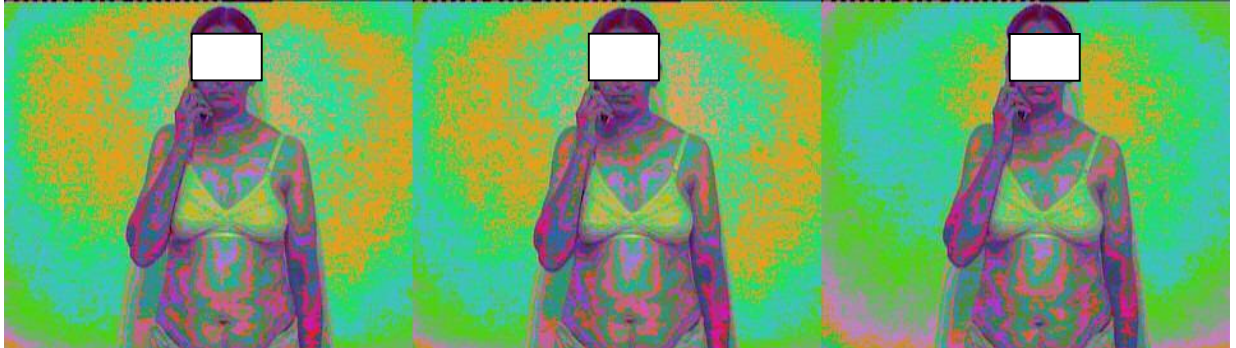
| <p>Subject holding mobile on standby without electrodot</p> <p>Orange colour has started increasing in the biofield. Navel chakra and solar plexus are showing low energy.</p> | <p>Mobile without electrodot During call</p> <p>Orange coloured low energy increases. Congestion near solar plexus and Navel chakra has started increasing.</p> | <p>Mobile on standby-electrodot introduced</p> <p>Orange coloured low energy is getting replaced by healing blue and positive green.</p> |

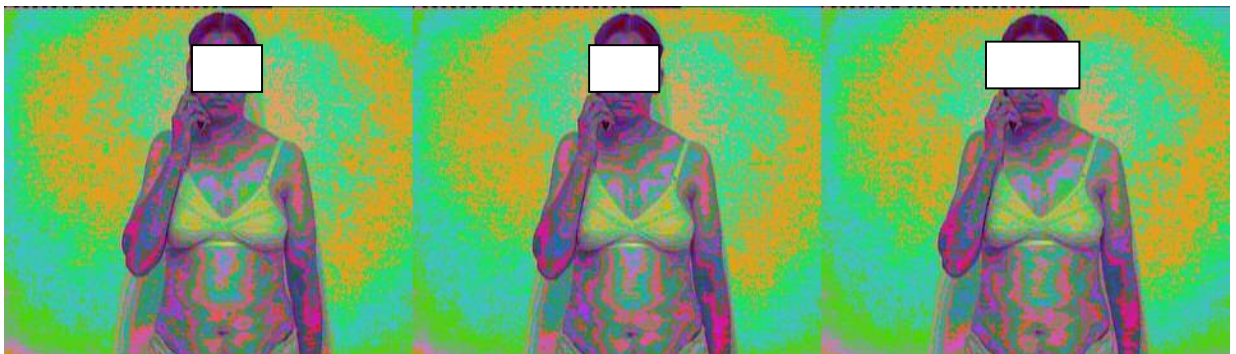
| <p>with electrodot on mobile. After 30 secs (during call)</p> <p>Congestion in the solar plexus is decreasing. Biofield is also getting positive energy.</p> | <p>Mobile with electrodot during call. After 1 min</p> <p>Lung fields are receiving more positive energy. Solar plexus is opening up by receiving positive energy.</p> | <p>Mobile with electrodot during call - After 5 mins</p> <p>Solar plexus is becoming vibrant.</p> |

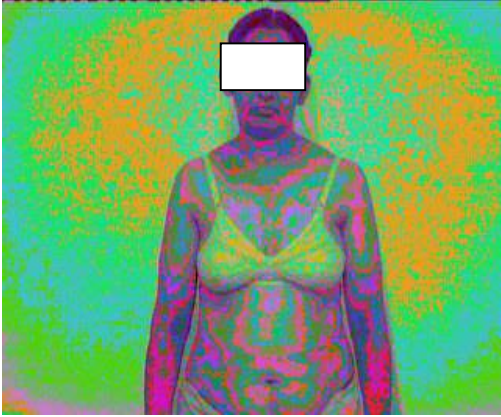
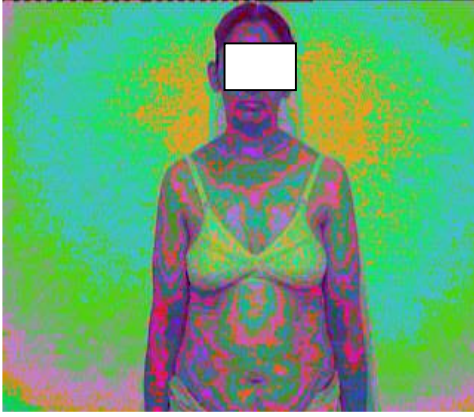
| <p>Before exposure to electrodot (23.03.2009)</p> | <p>After using electrodot for 2 days (26.03.2009)</p> |

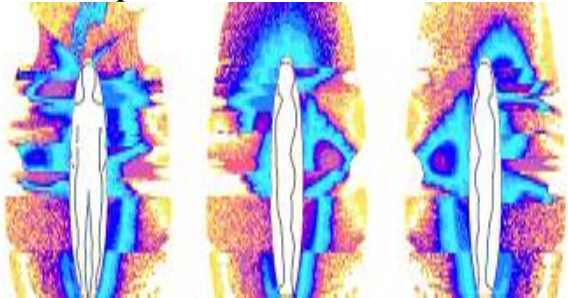
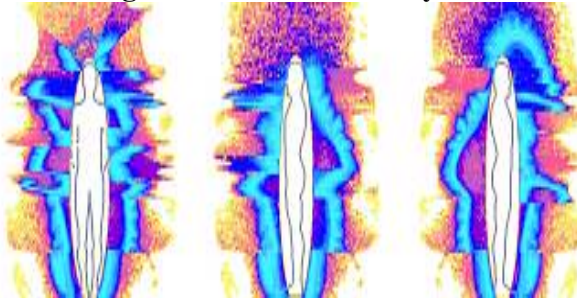
| <p>Analysis: Energy leak from lower part of the leg decreases. Rearranging of energy is seen. Distorted crown shows positive changes.</p> | |

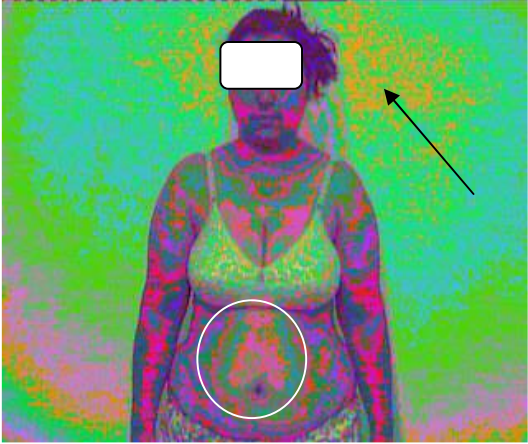
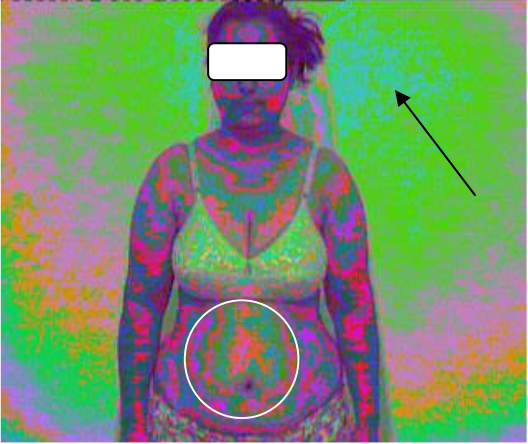
| <p>Before exposure to electrodot (04.03.2009)</p> | <p>After using electrodot for 2days(07.03.2009)</p> |

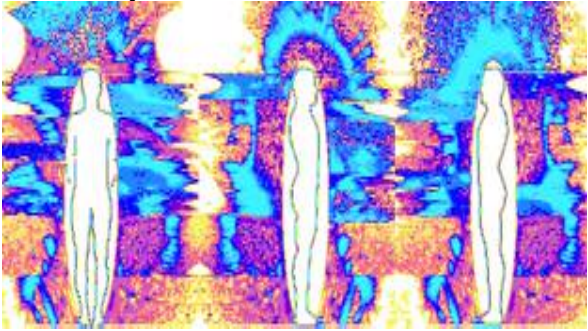
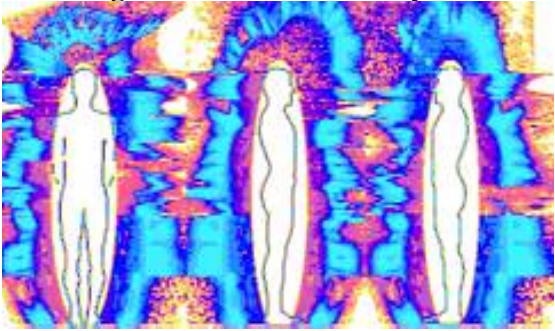
| <p>Before exposure to electrodot</p> | <p>After using electrodot for two days</p> |

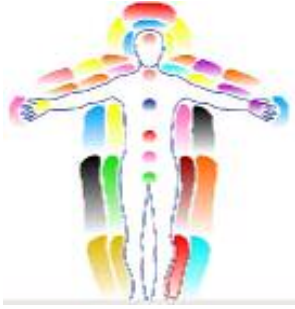
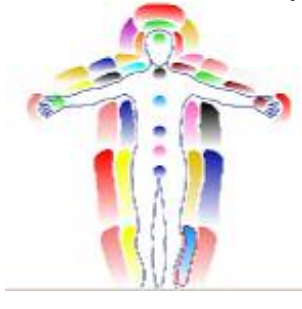
| <p>Before exposure to electrodot</p> | <p>After using electrodot for two days:</p> |

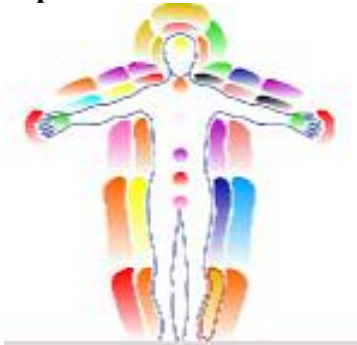
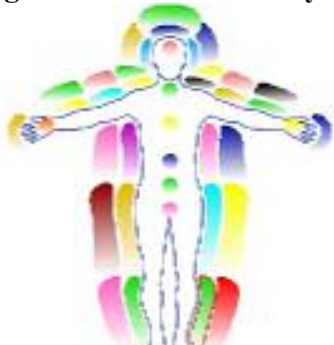
| <p>Analysis: Positive shift is seen in crown where low dull yellow is replaced by vibrant green. Similar changes are seen at level of throat and splenic chakra. Negative energy over hands and legs has been replaced by positive green and blue.</p> | |

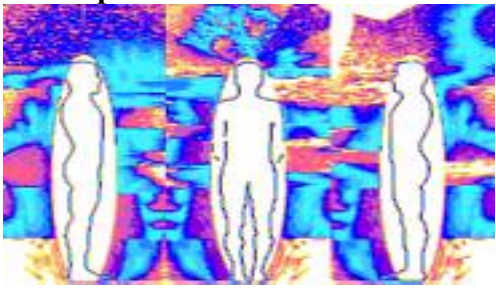
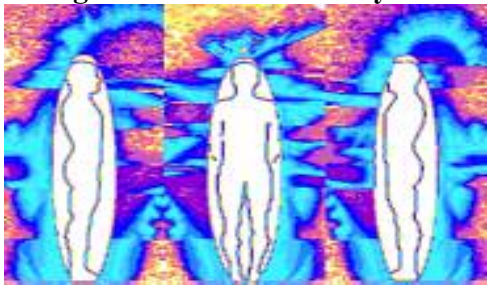
| <p>Before exposure to electrodot</p> | <p>After using electrodot for two days</p> |

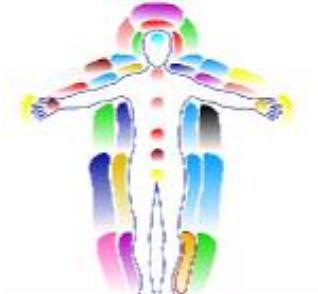
| <p>Before exposure to electrodot</p> | <p>After using electrodot for two days</p> |

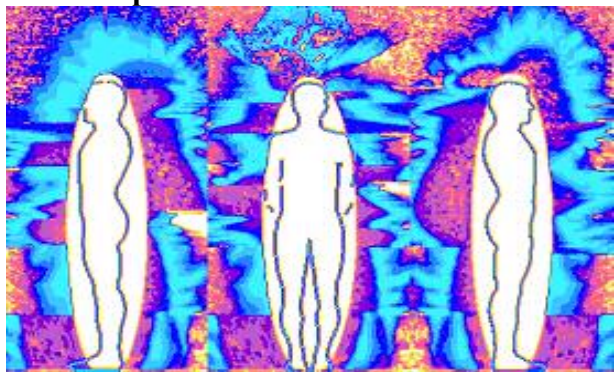
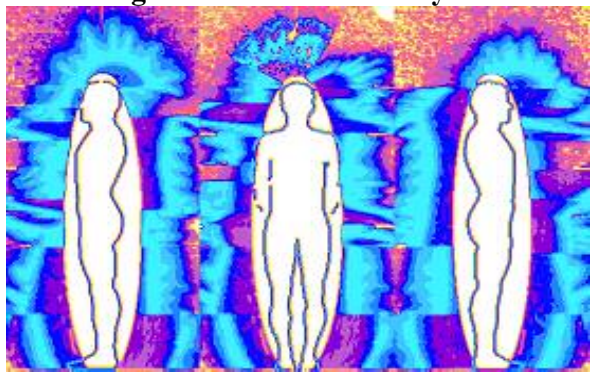
| GDV | GDV |
|---|--|
| <p>Before exposure to electrodot</p> | <p>After using electrodot for two days</p> |

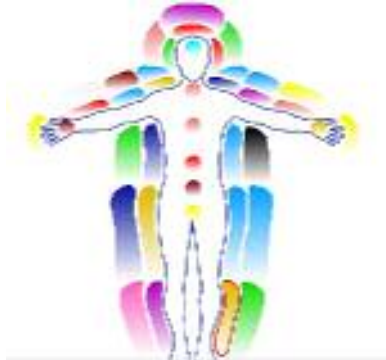
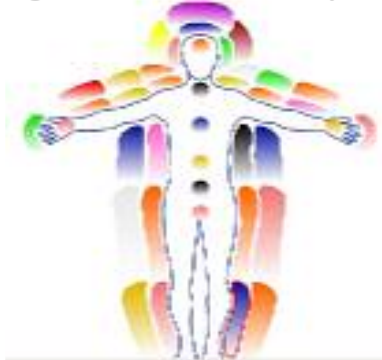
| RFI | RFI |
|--|---|
| <p>Before exposure to electrodot</p> | <p>After using electrodot for two days</p> |

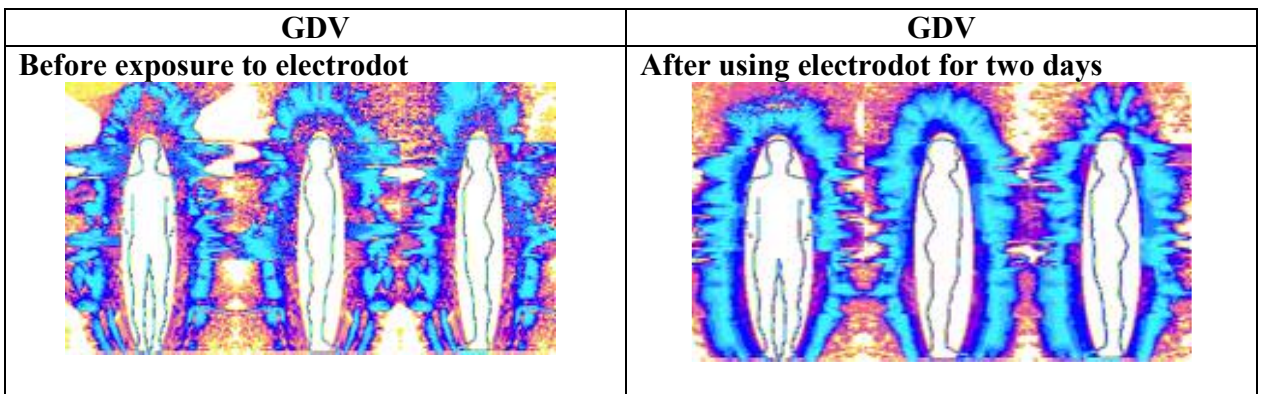
Analysis: Distortion at level of crown has reduced. Leaks have reduced. Over all distortion has reduced and aura appears to be much more symmetrical.

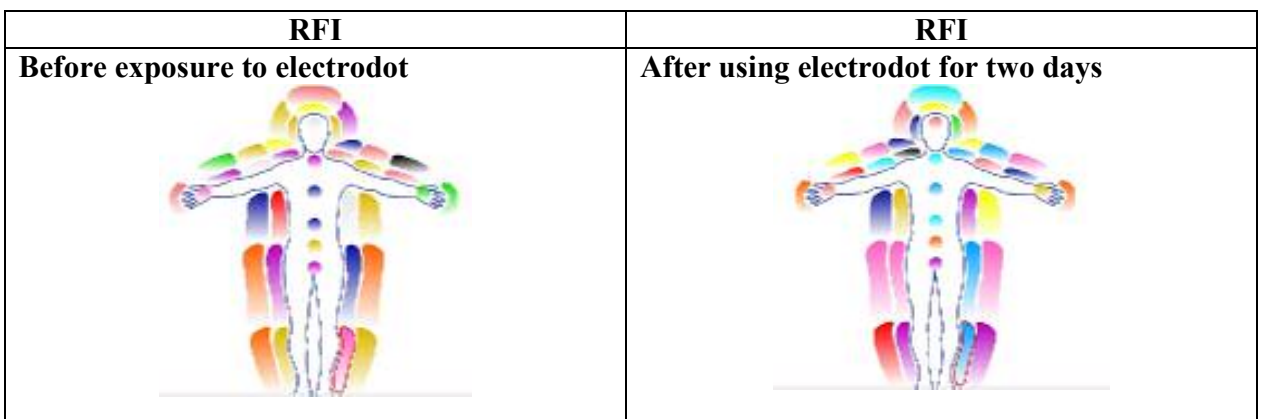
Analysis: Energy at level of crown and legs show positive shift from low red and orange to blue and violet which are healing colors. The vibrancy of heart and solar chakra has increased.

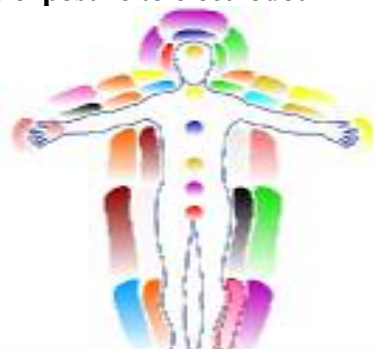
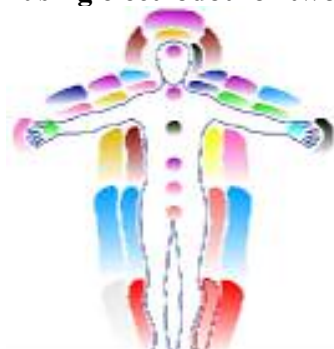
| RFI | RFI |
|--|---|
| <p>Before exposure to electrodot</p> | <p>After using electrodot for two days</p> |

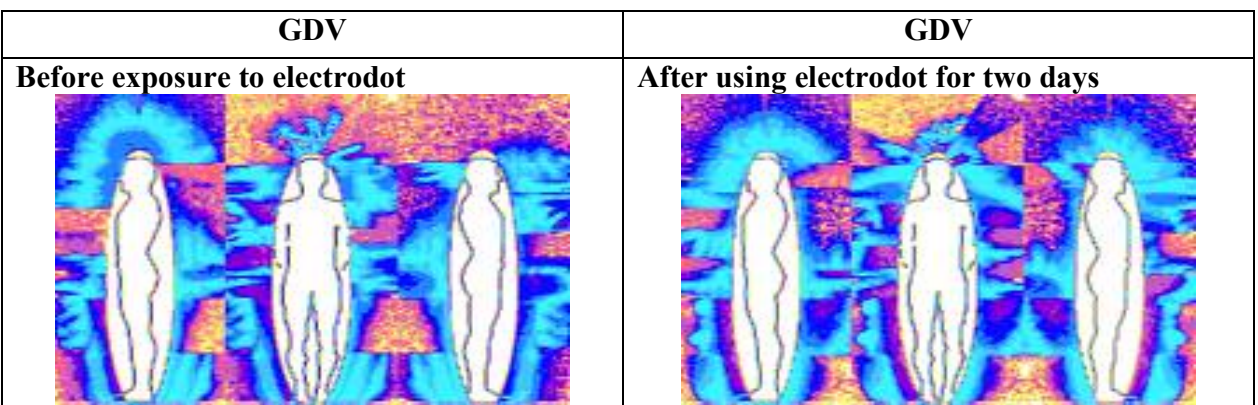
Analysis: Energy leak from solar plexus has reduced. Possibility of energy rearranging maybe because of prolonged use of electrodot. Distortion of crown has reduced.

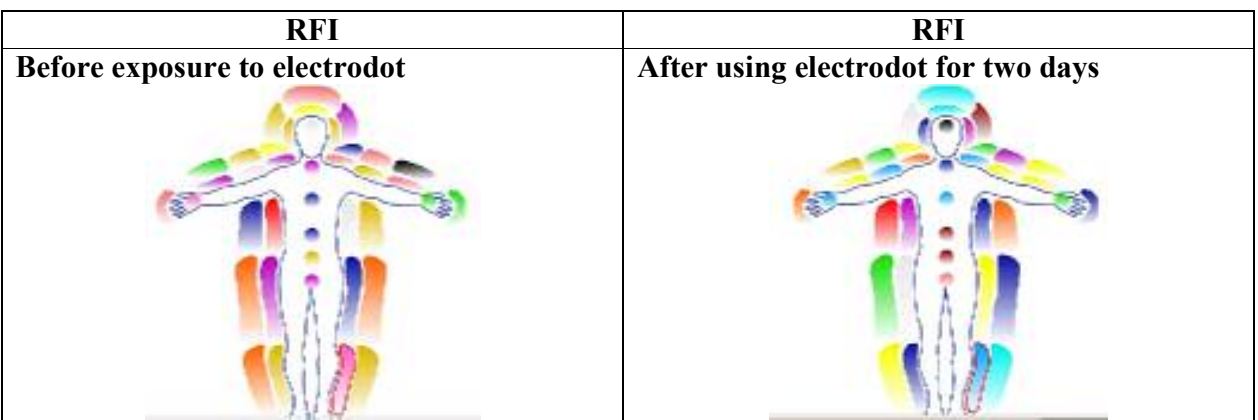
Analysis: Replacement of low energy at level of crown by blue is a positive sign.

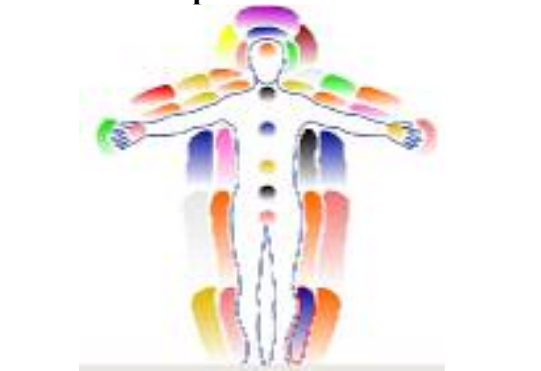
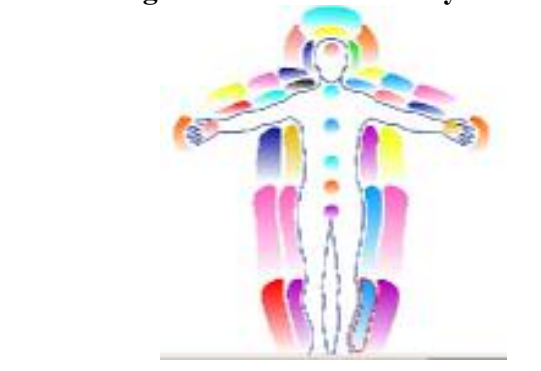
Analysis: Low energy in throat, brow, heart and solar has been replaced by vibrant blue which is a positive sign. Appearance of violet and blue indicate a healing frequency.

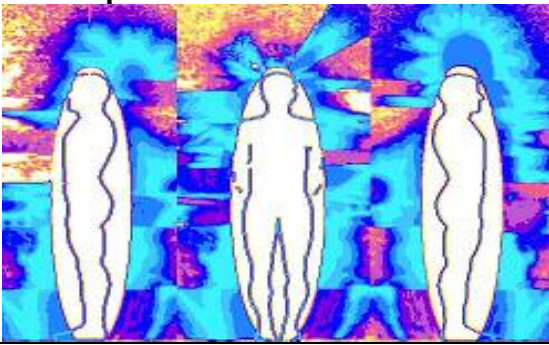
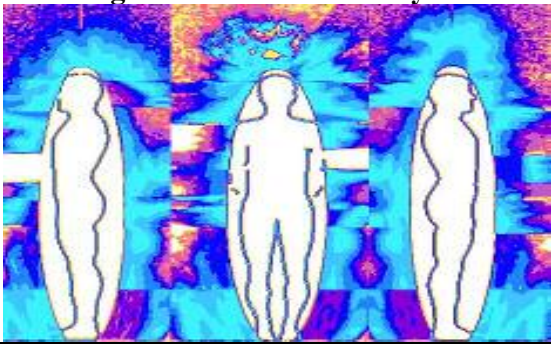
| <p align="center">Before exposure to electrodot</p> | <p align="center">After using electrodot for two days</p> |

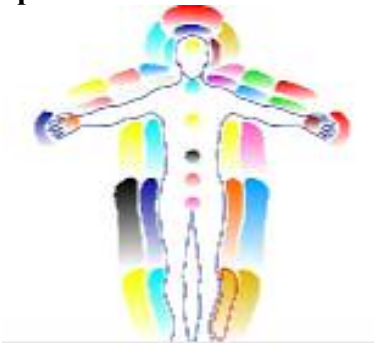
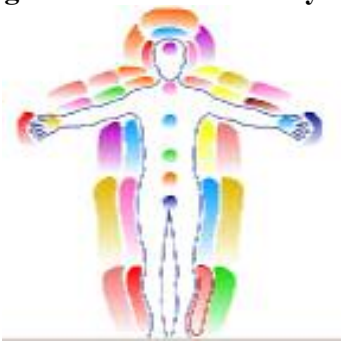
| <p align="center">Before exposure to electrodot</p> | <p align="center">After using electrodot for two days</p> |
