# EL01 : Indoor & Outdoor Unit Communication Error

Indoor Air Handler Can Not Communicate With Outdoor Heat Pump Condenser

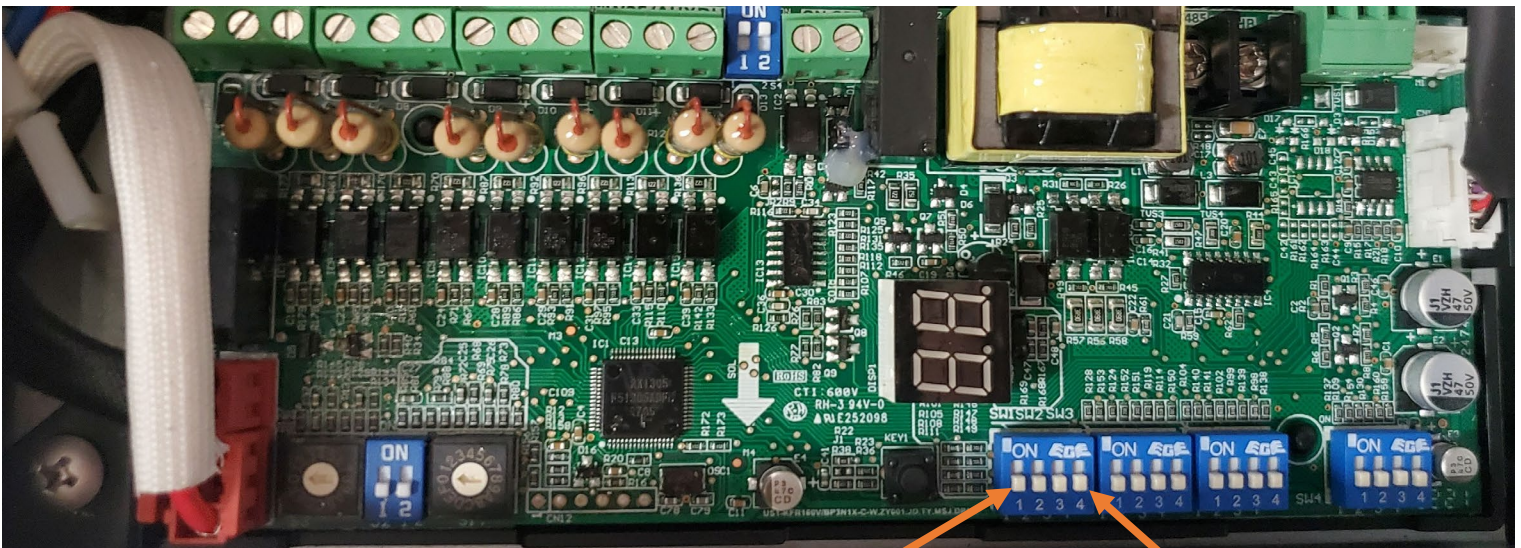
Data Transfer Board - Air Handler (Above)

If you have connected the indoor air handler and the outdoor heat pump condenser with standard 24 volt wires (meaning you are not using the communication feature) you must change DIP Switch SW1-4 to ON (on the air handler). If you fail to do so the unit will display error code EL01. You must adjust DIP switches with the power off to the air handler. SW1-1 should be on as well to allow a 24 volt thermostat to work (although if this is not done it gives a separate error code).

Please note SW1-1 should be ON as well

TURN ON

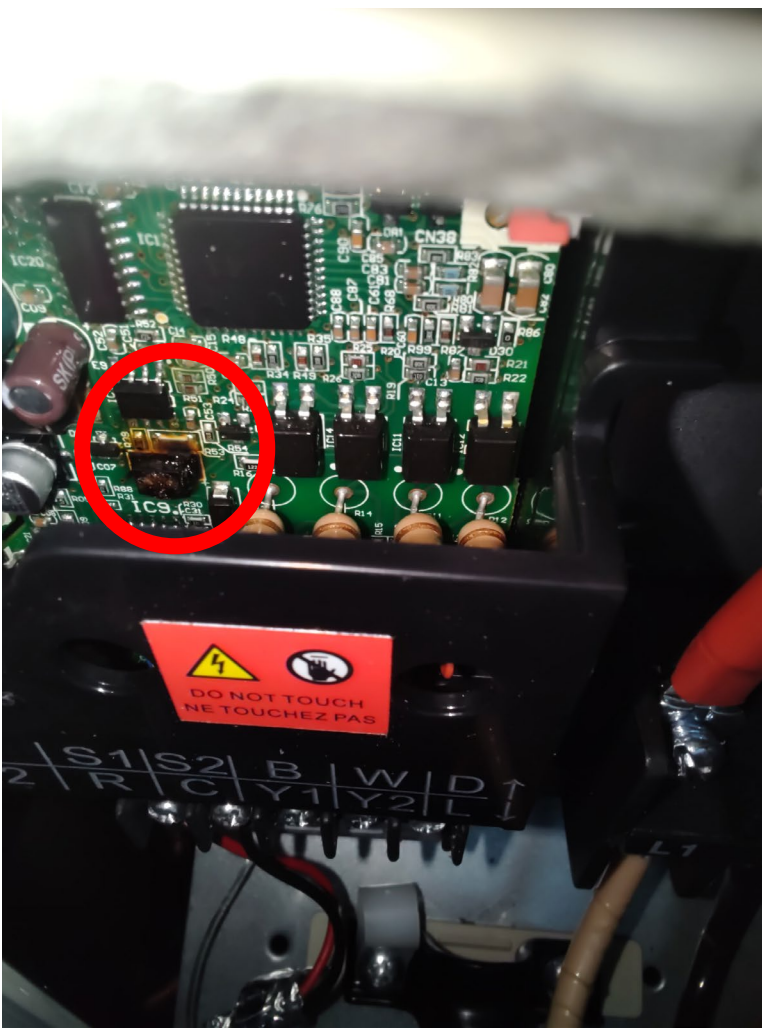
**(Step 4) Inspect Outdoor Communication Board, Does It Have A Burn Mark In This Location?**

The communication chip on the outdoor condenser will be damaged if the unit is improperly wired and powered up. Once the chip is burned up the board needs replaced.

To see this spot on the board you will need to take the cover off to the outdoor unit (where the wires are connected) and look at a downwards angle.

Circled in red is the location the board will burn up. Please take a picture and have it ready to share with tech support for verification.

Please **DO NOT** touch the board. This board has DC voltage present and can hold a charge even after the AC power has been shut off.

<p><b>Yes</b> = Board is bad. <b>IMPORTANT</b>. Find out what caused this failure. <b>No</b> = Move To Next Step.</p> <p style="text-align: center;"><b>(Step 5) Verify That 18/2 Shielded Wire Was Used.</b></p> <p><b>Yes</b> = Move To Next Step. <b>No</b> = Run Correct Wire (Move To Next Step If Still Getting Error After Fix)</p> <p style="text-align: center;"><b>(Step 6) Replace Indoor Main Control Board</b></p>
---
