**OBS Ford  
Leaf Spring  
Bushing Issue**

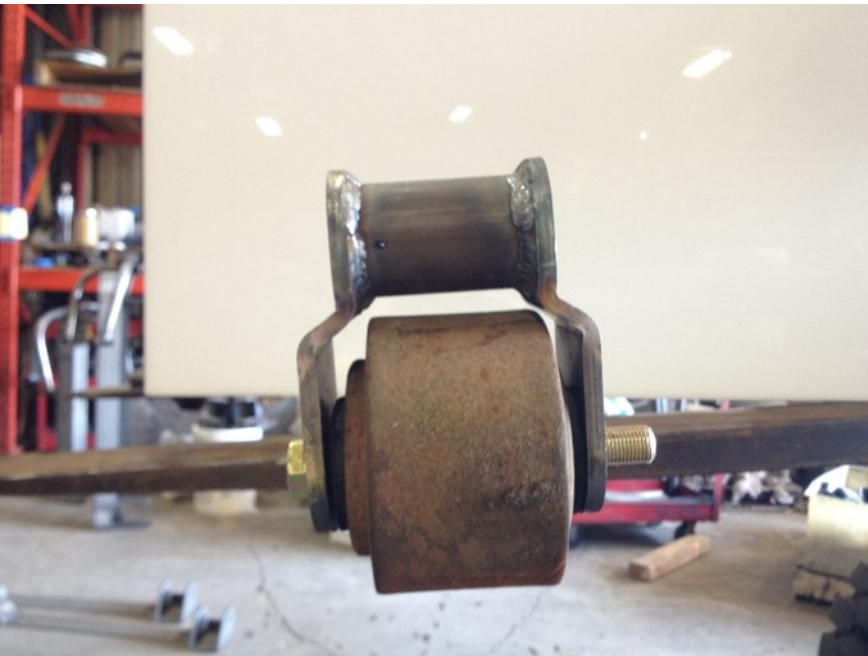
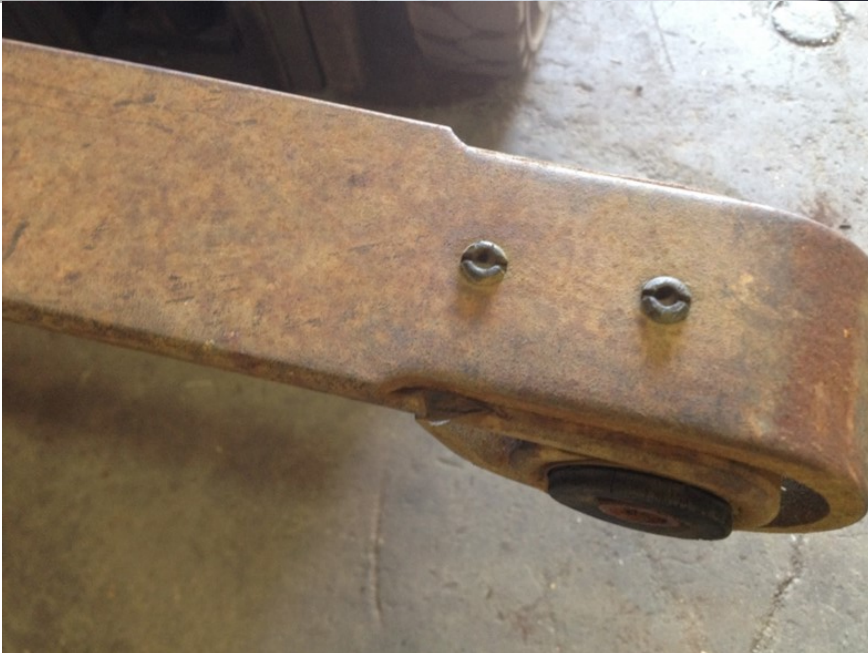
This shows a worn out spring bushing and no spring isolator causing the shackle to be too close to the military wrap on the leaf spring.

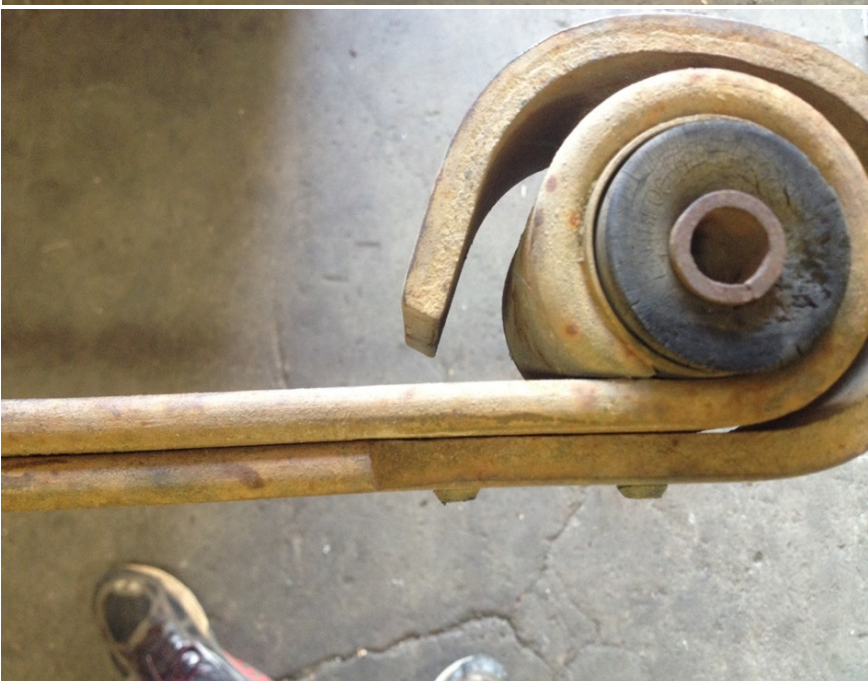
Backside of the Leaf spring where the isolator sticks through

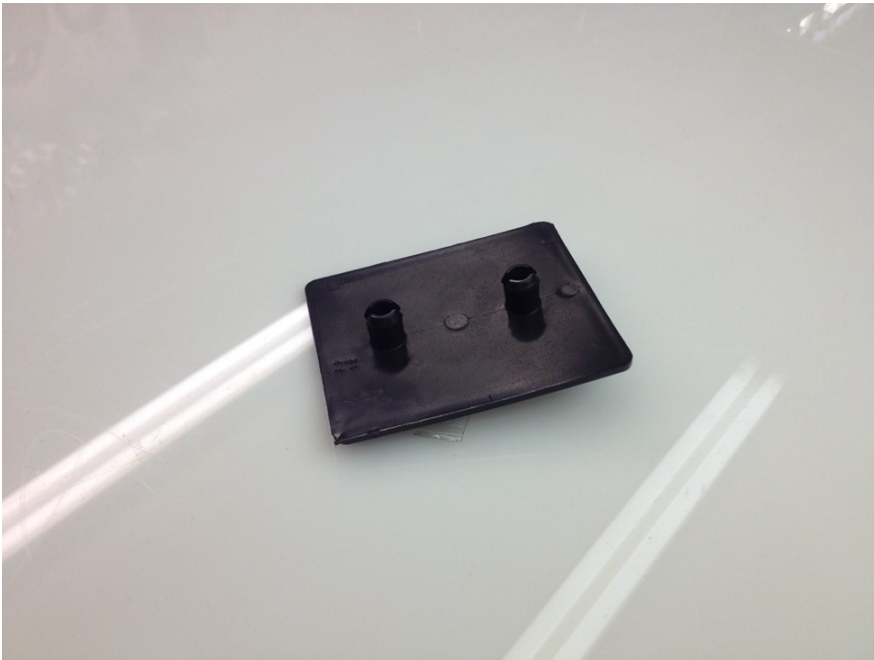
Having a worn out bushing locates the bushing pin farther down in the leaf spring from years of vehicle weight and abuse. The isolator pins are still in the leaf spring but the pad itself is worn through. This will cause the military wrap of the leaf spring to sit much farther up into the shackle.

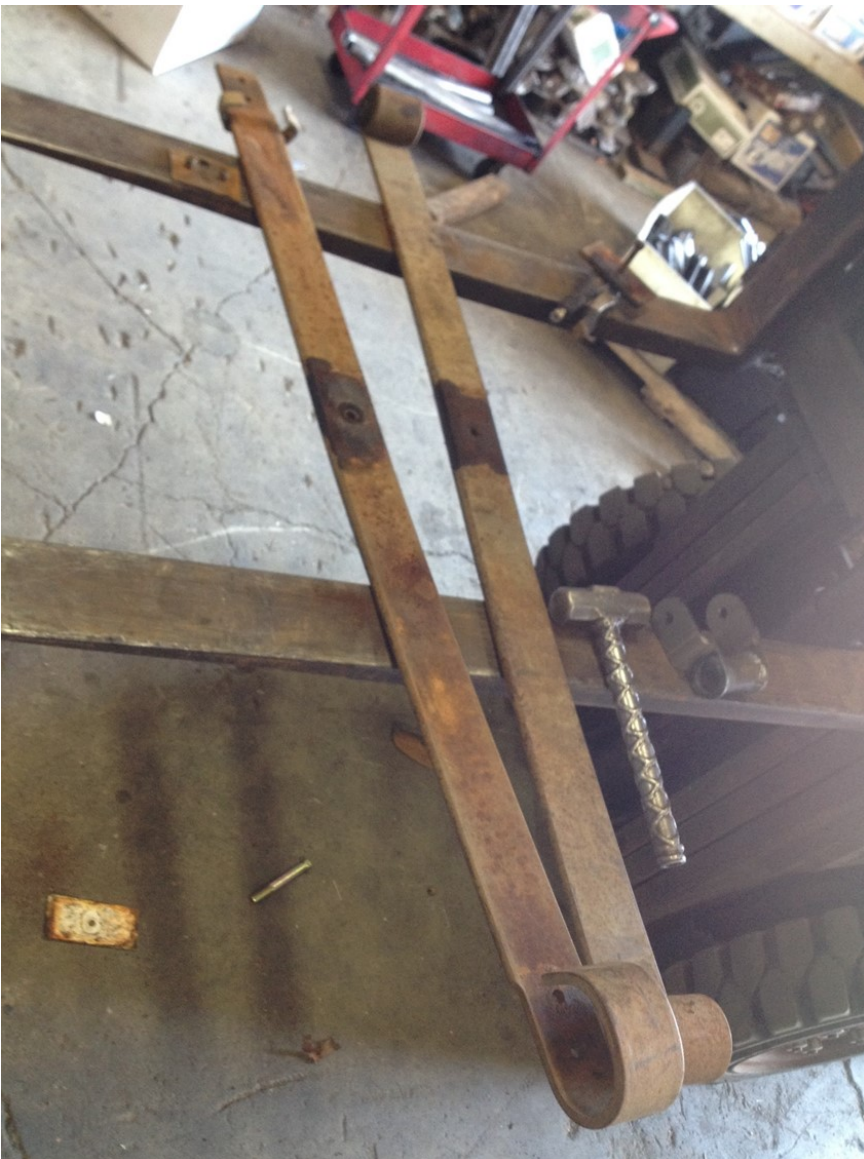
Spring isolators act as bearings and help dampen the springs themselves from noise and give the added 0.1" between the two packs

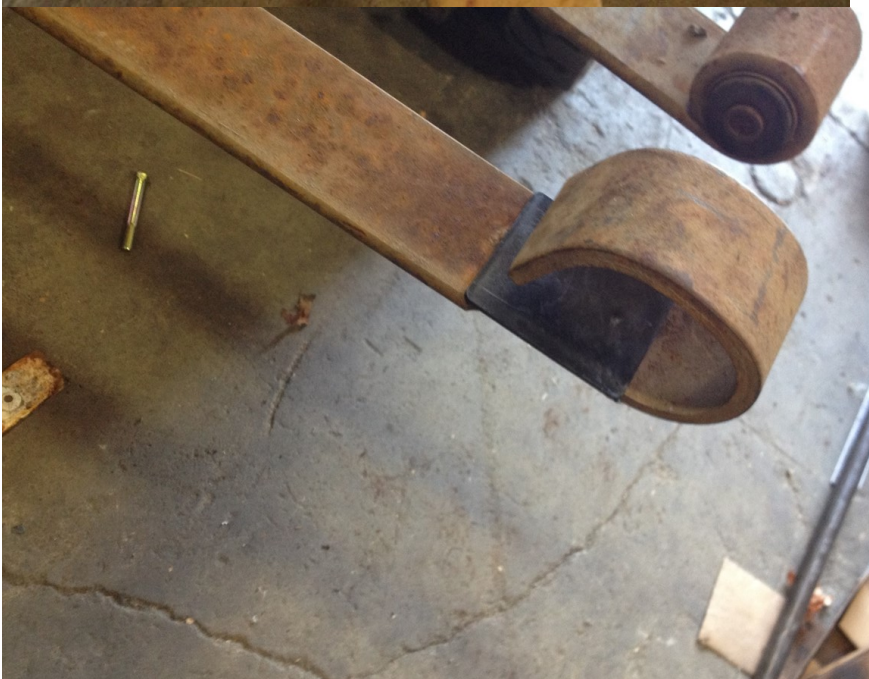
This is a correctly installed spring isolator and also better shows the spring clamp that needs to be spread for the separation of the leafs.

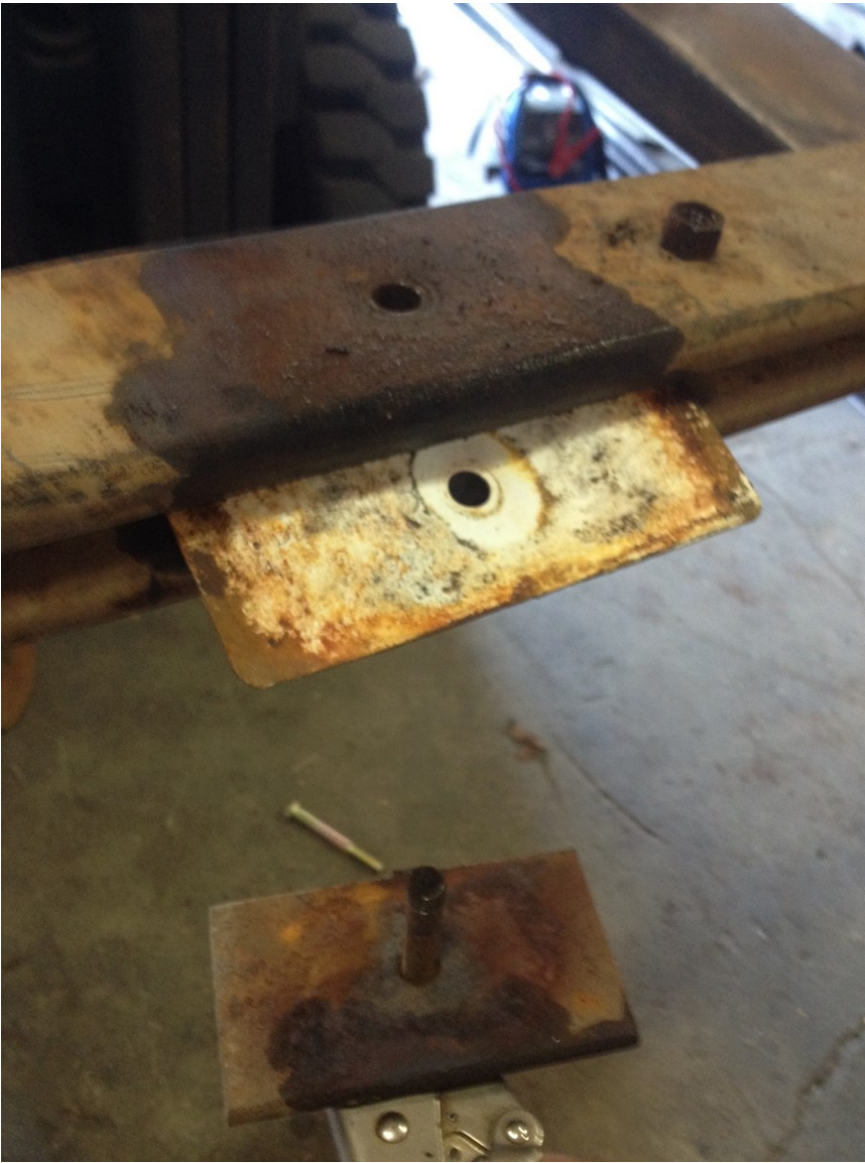
Here is the other spring isolator installed (two per leaf pack)

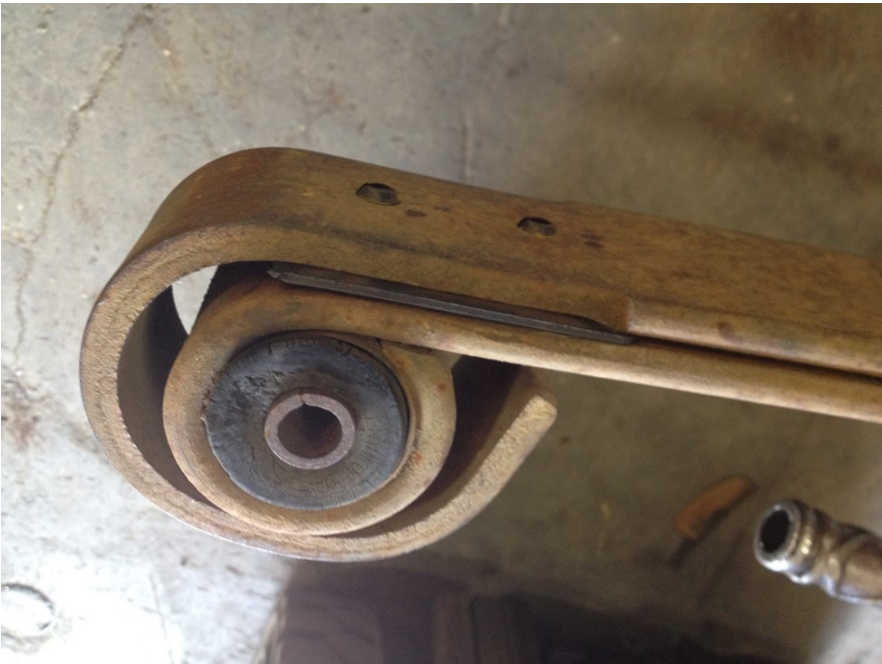
Correctly re-assembled leaf spring with isolators

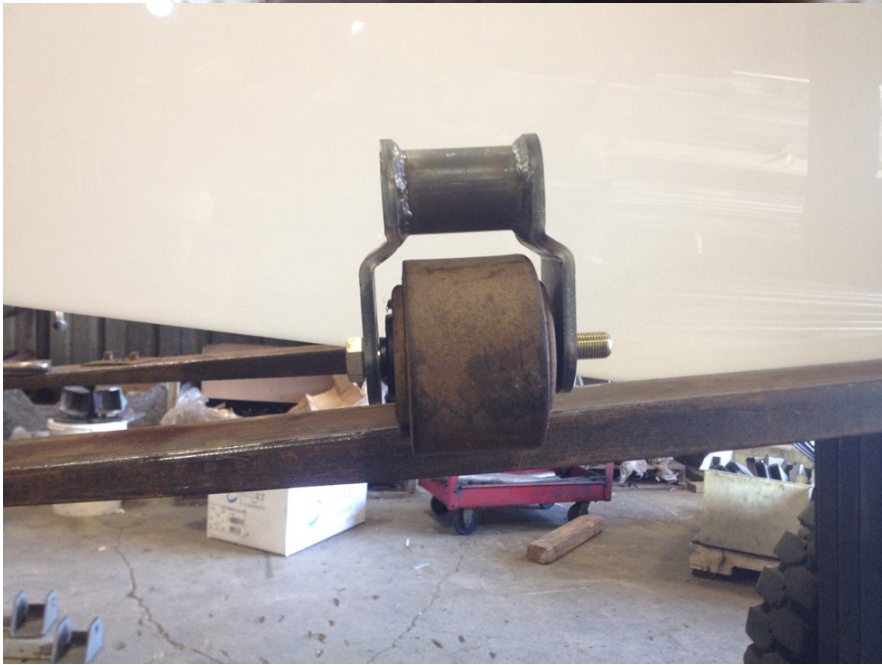
Military wrap side of the leaf spring with isolator installed.

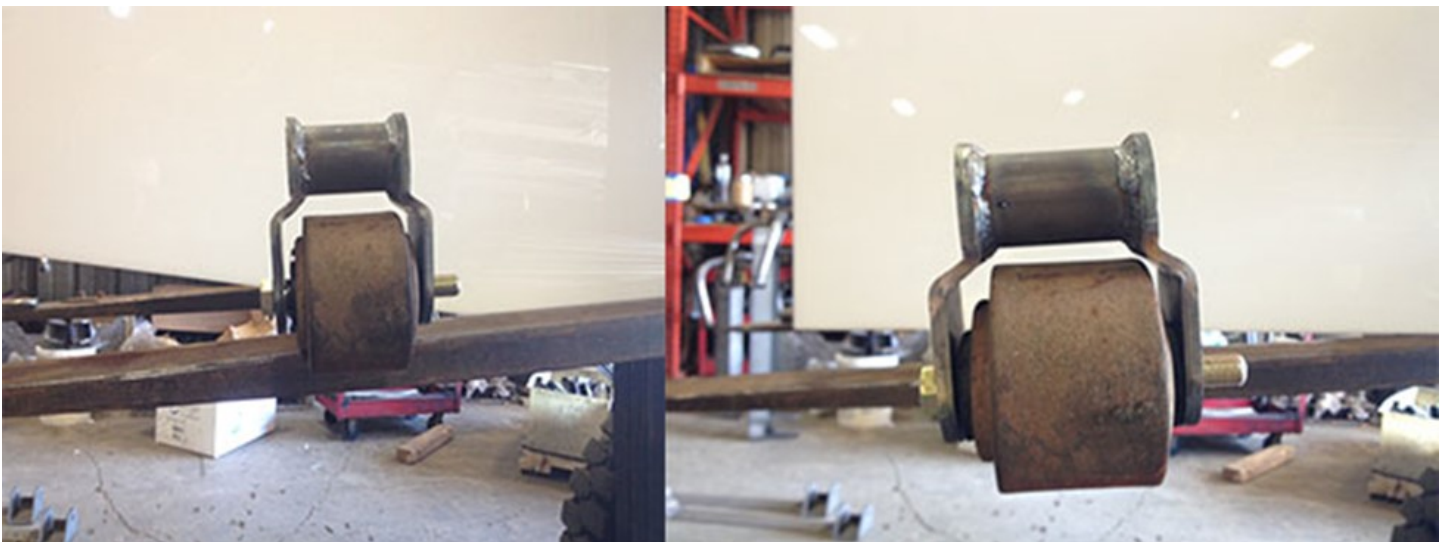
With correctly installed isolators/ bushings, military wrap to shackle clearance is not an issue.

**After**

**Before**
