MHC Kenworth Restores Odyssey Batteries with SC-12 Recovery Charger

Challenge: Lease department trucks sitting on the lot waiting for customer pickup experienced battery drain and dead batteries.

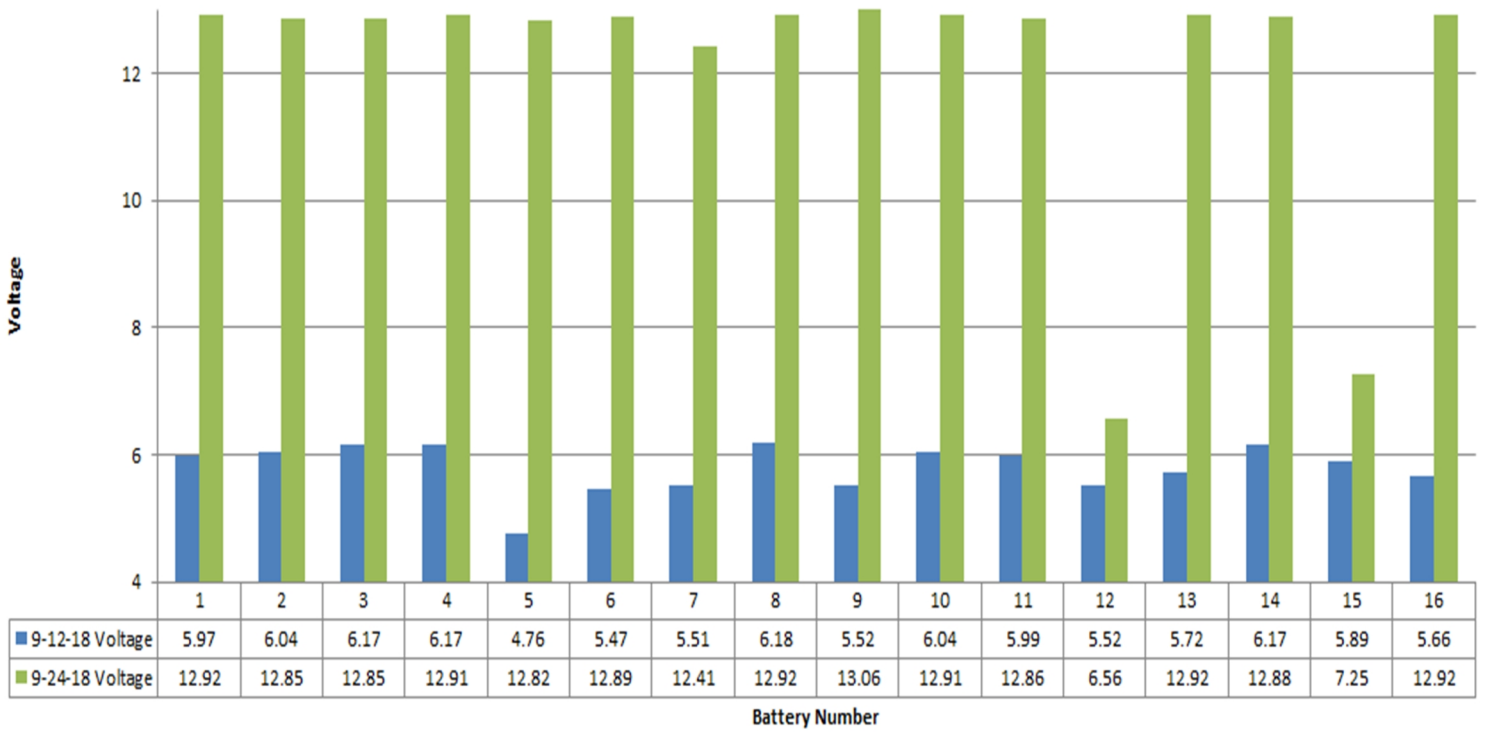
Voltage Improvement After Use of SC-12 Battery Recovery Charger

Battery #	Start 9-12-18 Voltage	After Use of SC-12 9-24-18 Voltage	Start 9-12-18 CCA	After Use of SC-12 9-24-18 CCA	
1	5.97	12.92	23	1319	
2	6.04	12.85	20	1199	
3	6.17	12.85	15	1284	
4	6.17	12.91	17	1419	
5	4.76	12.82	19	1250	
6	5.47	12.89	11	1203	
7	5.51	12.41	6	1205	
8	6.18	12.92	23	1232	
9	5.52	13.06	14	1279	
10	6.04	12.91	21	1288	
11	5.99	12.86	17	1283	
12	5.52	6.56	6	114	Bad Cell
13	5.72	12.92	3	1233	
14	6.17	12.88	14	1202	
15	5.89	7.25	17	160	Bad Cell
16	5.66	12.92	1	1233

Conclusion: 87% of the Odyssey batteries were recovered with the SC-12. The only two batteries unable to be recovered had bad cells. Saving 14 Odyssey Group 31 batteries meant an immediate \$3,800 savings in new battery purchases more than covering the cost of the equipment.

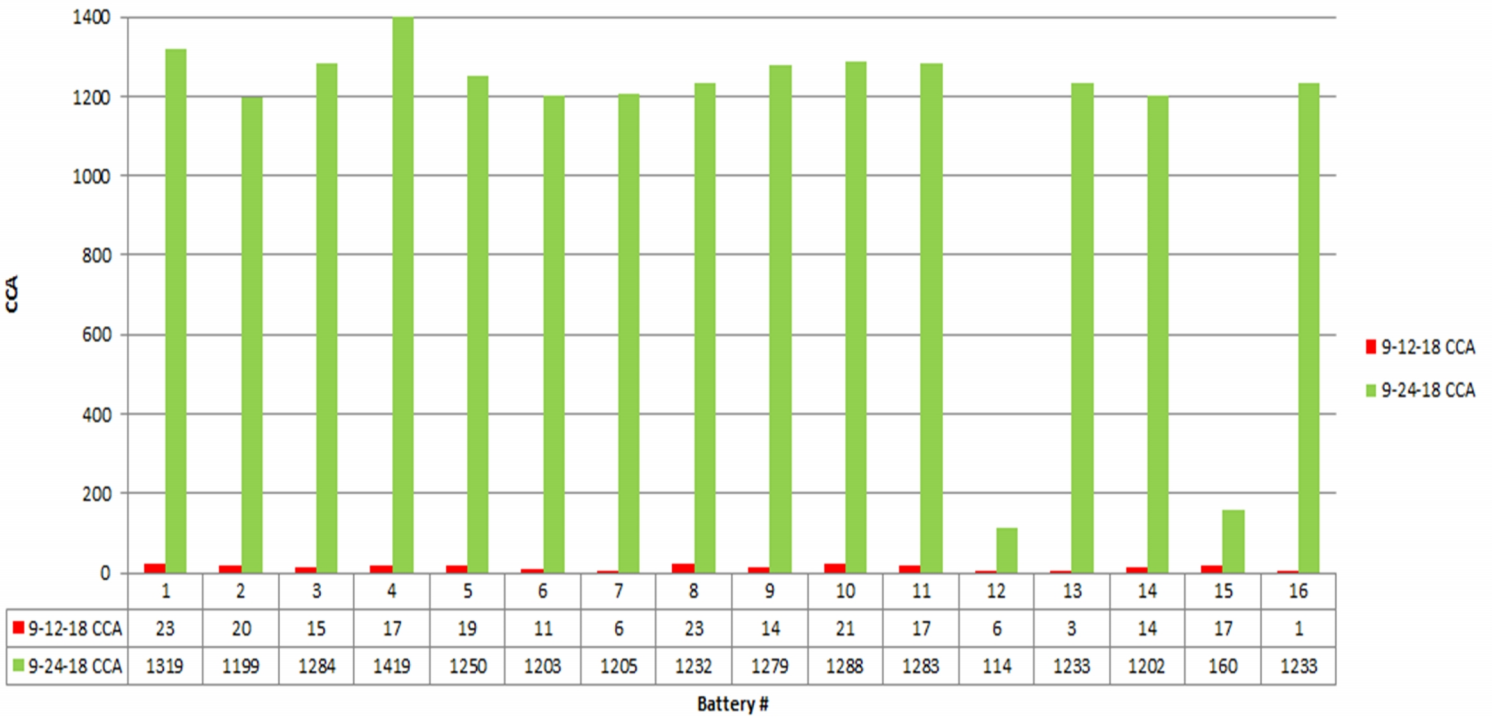
CCA Improvement After Use of SC-12 Battery Recovery Charger
