Marshall Creek Instream Flow Public Meeting

Spokane Conservation District
10/19/2023

Walt Edelen, Water Resources Department

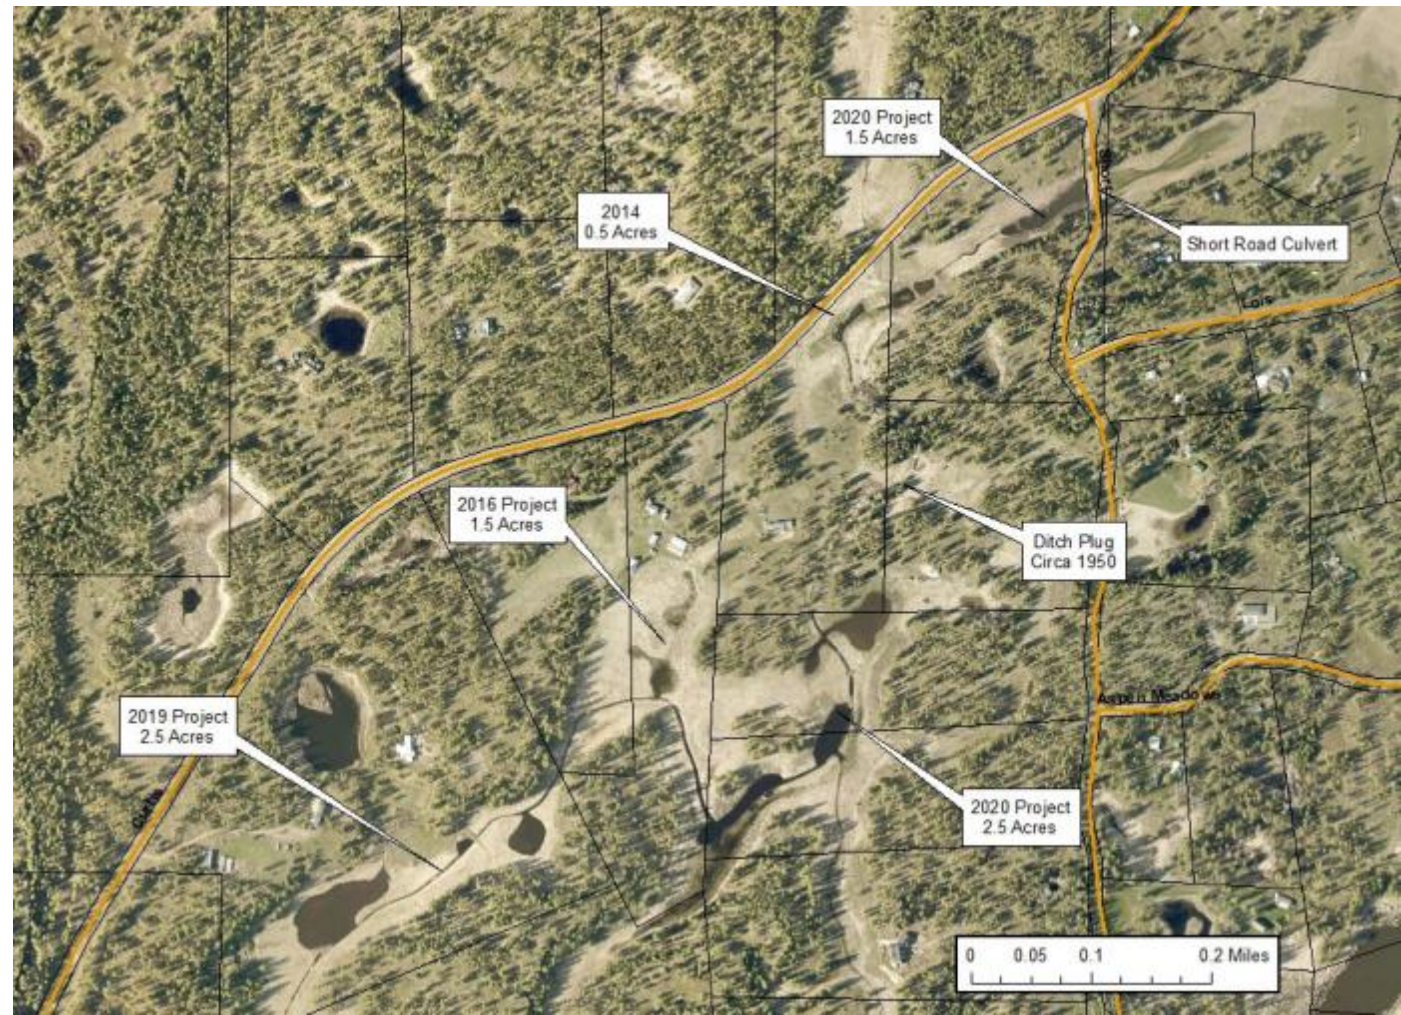
1.3 miles stream channel enhancement

- 15 acres riparian revegetation
Approximately 8,000 trees and shrubs
- Native grass re-establishment

6.7 acres shallow excavations

- Generally, 1 to 2.5 feet max depth

1 Concrete control structure with adjustable riser and gate

- Set at height of legacy ditch plug
- Allows for water release after waterfowl nesting season (July 15

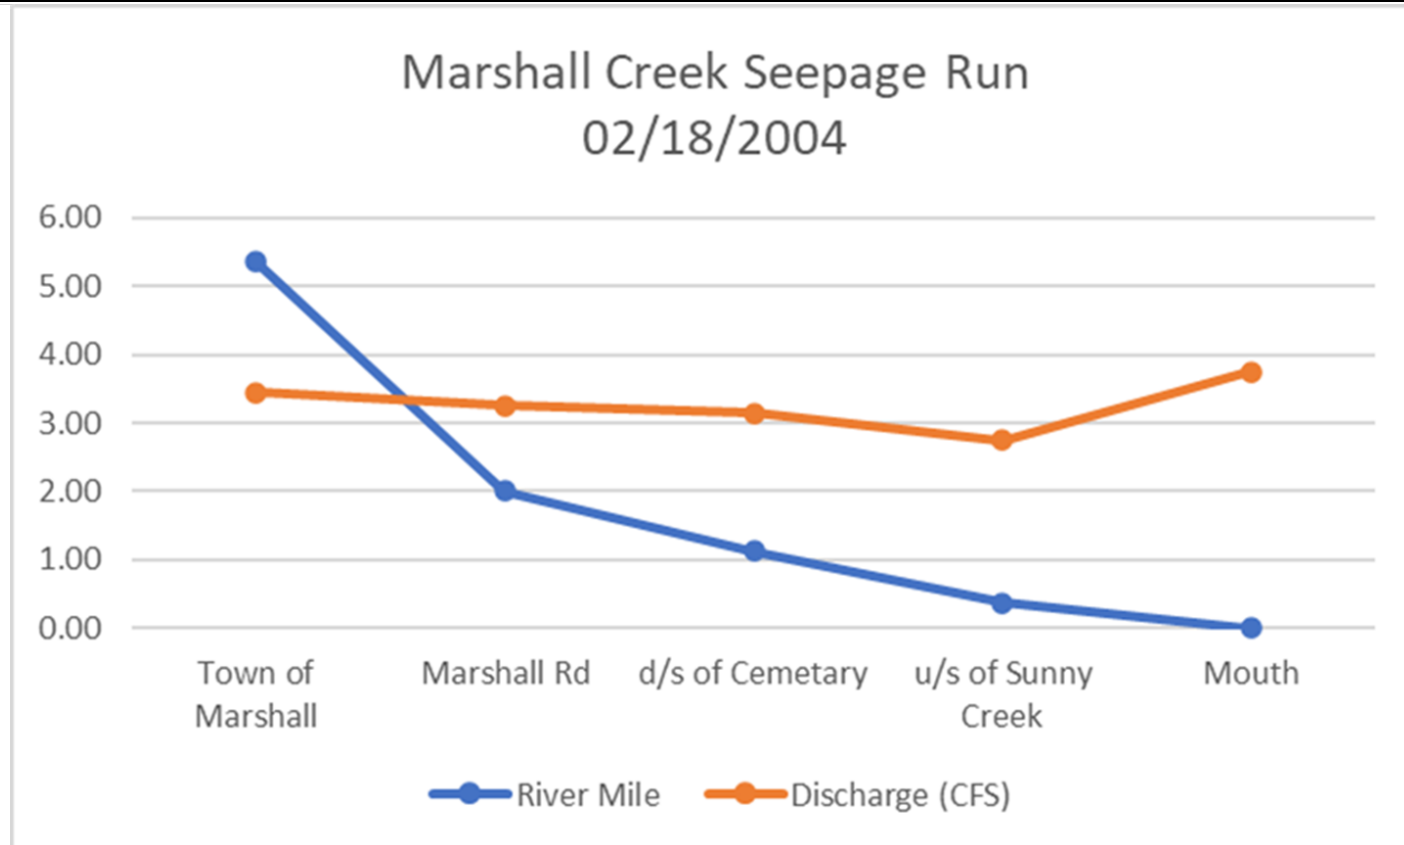
Marshall Creek Seepage Run 02/18/2004		
Sample Site		
	River Mile	Discharge (CFS)
Town of Marshall	5.36	3.45
Marshall Rd	2.00	3.26
d/s of Cemetary	1.13	3.15
u/s of Sunny Creek	0.37	2.75
Mouth	0.00	3.75

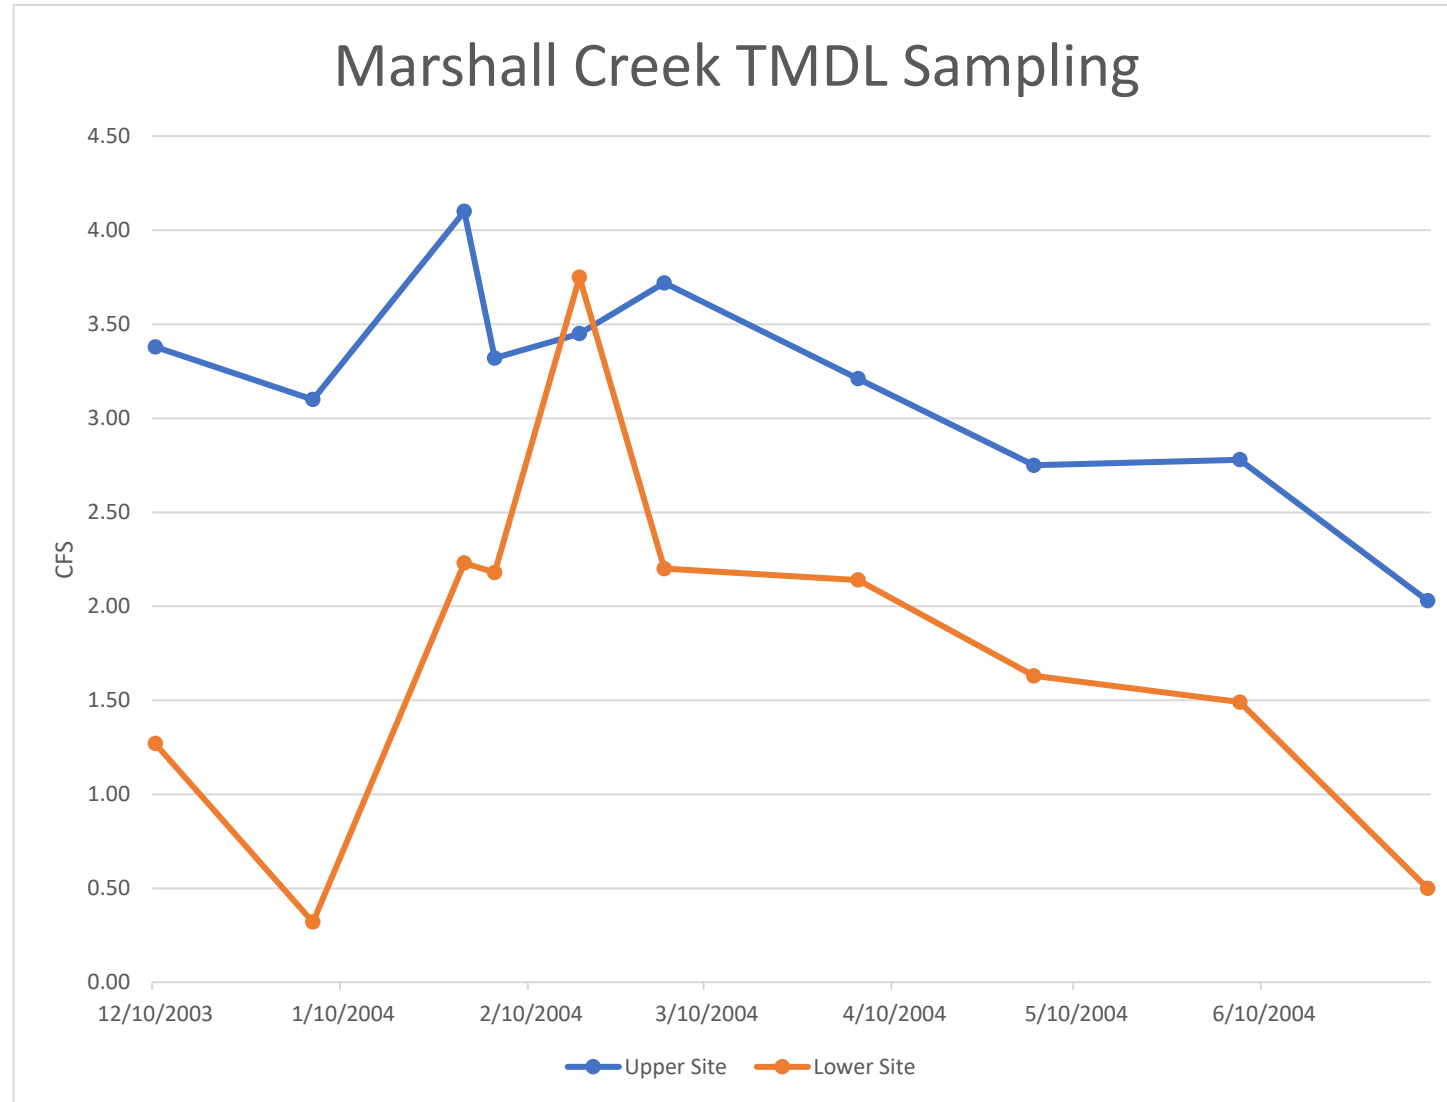
Marshall Creek TMDL Sampling		
Sample Date		
	Upper Site	Lower Site
12/10/2003	3.38	1.27
01/05/04	3.10	0.32
01/30/04	4.10	2.23
02/04/04	3.32	2.18
02/18/04	3.45	3.75
03/03/04	3.72	2.20
04/04/04	3.21	2.14
05/03/04	2.75	1.63
06/06/04	2.78	1.49
07/07/04	2.03	0.50

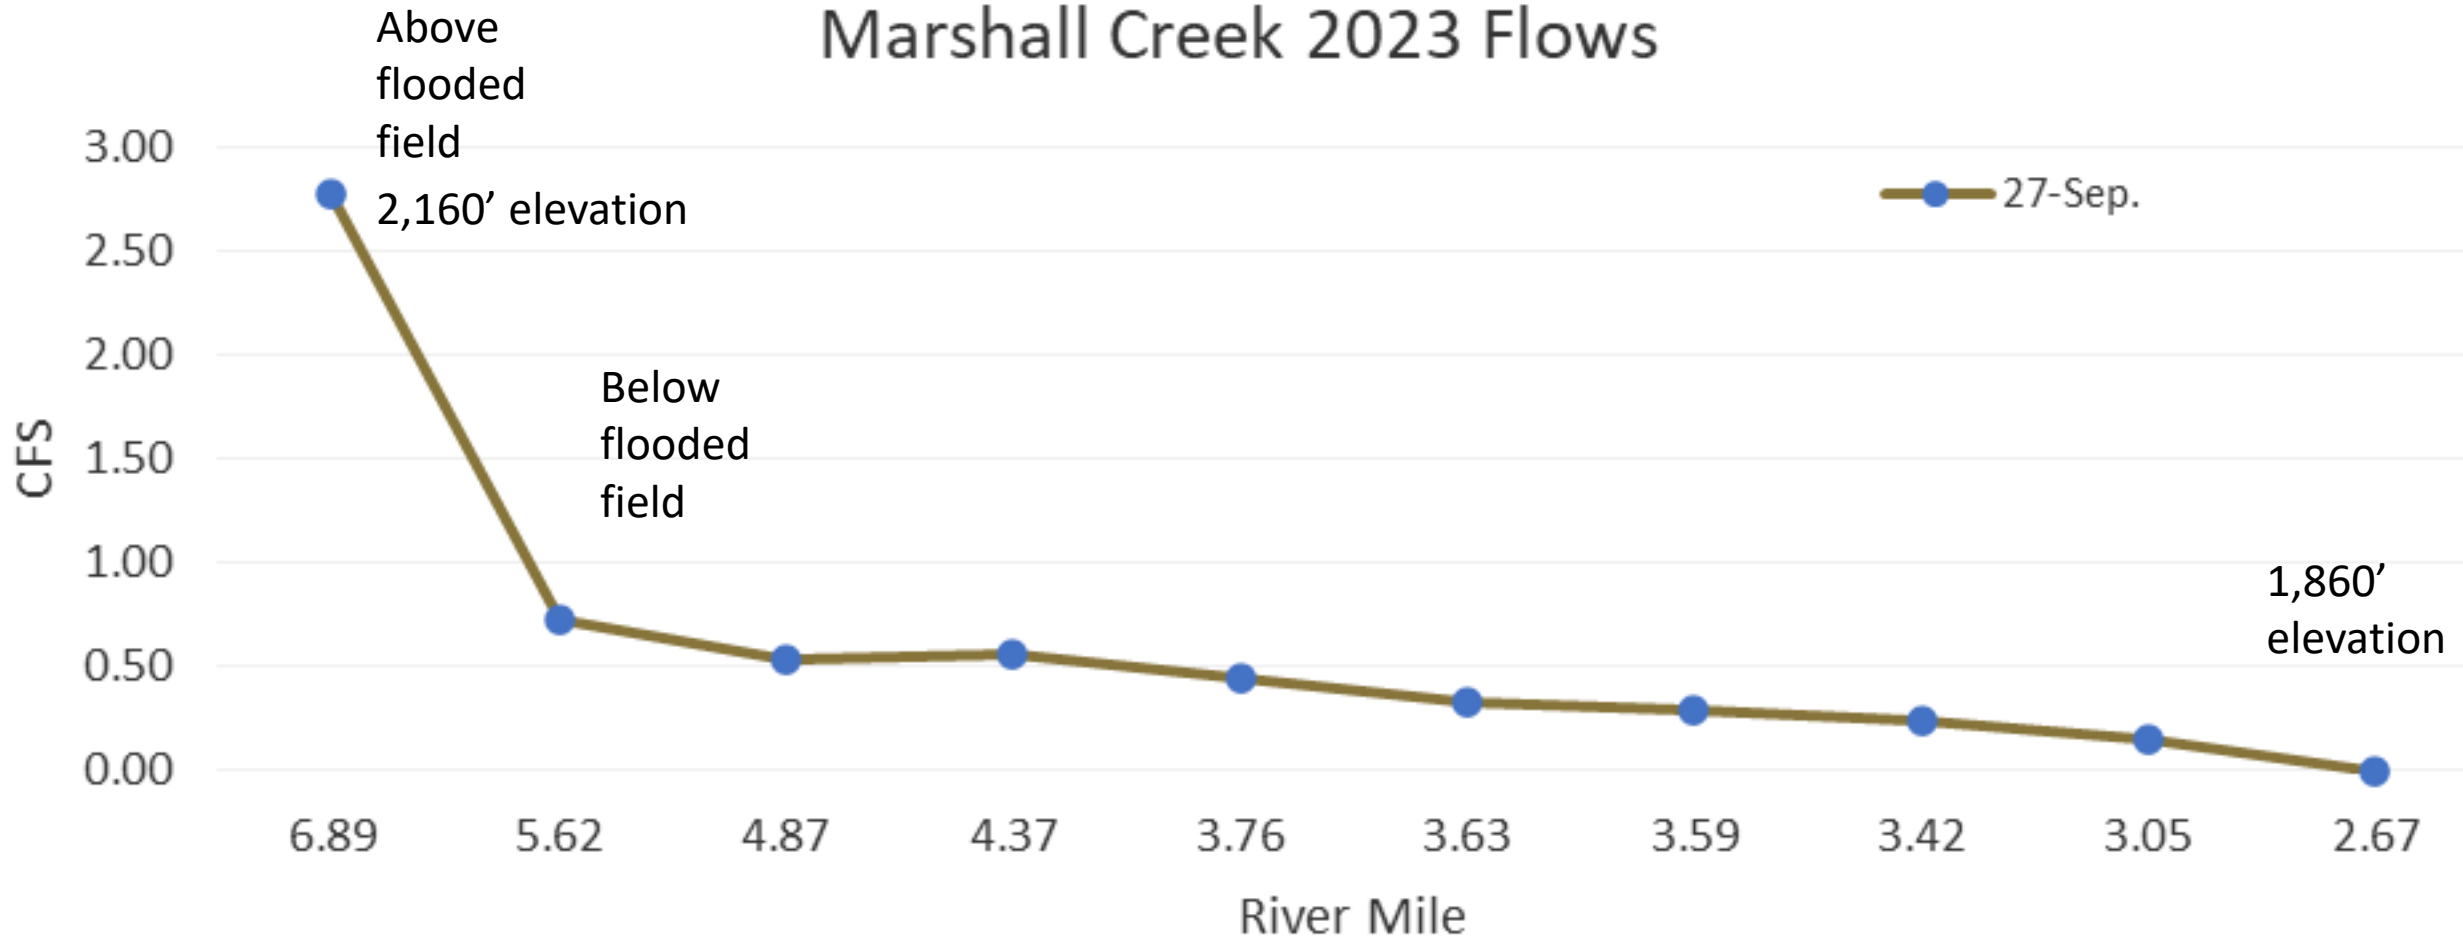
Marshall Creek 2023 Flows

**W. Marshall Creek Lane to Hangman Creek confluence is approx. 360' difference in elevation

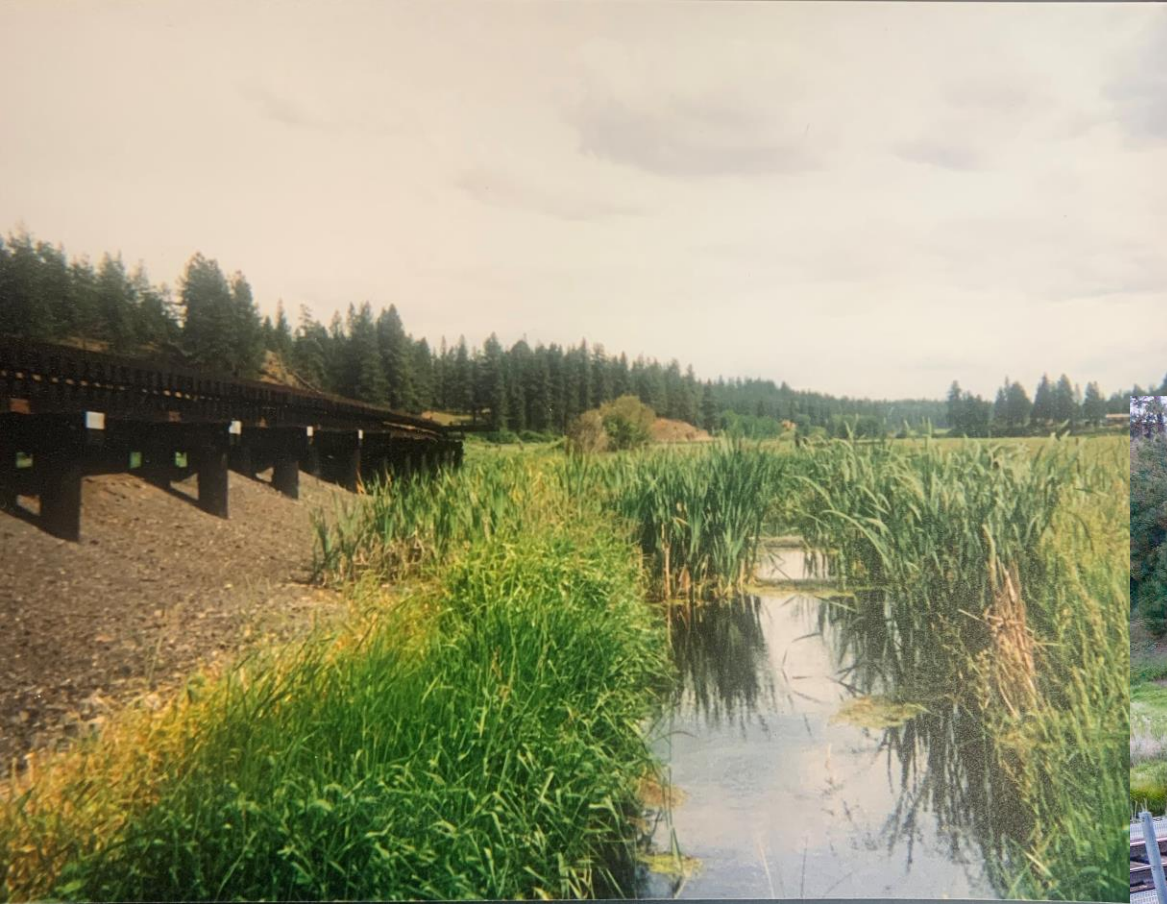
New Trestle – Berm Removed

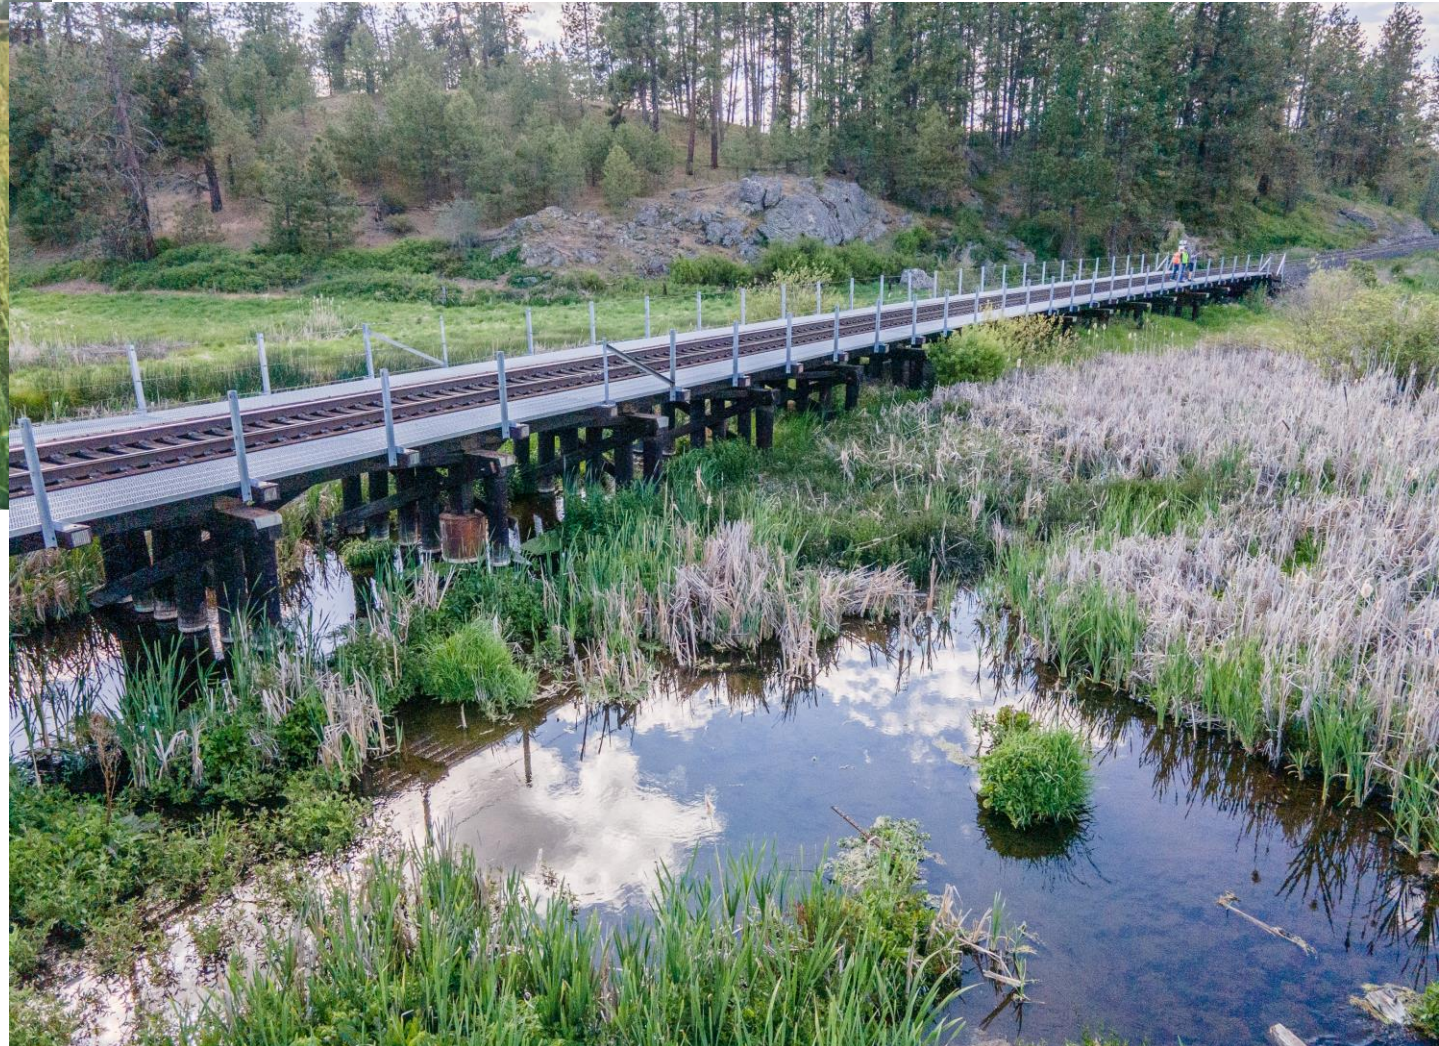
Old Trestle – Gravel Berm

- Peters – berm installed with help of Railroad to block cattle movement

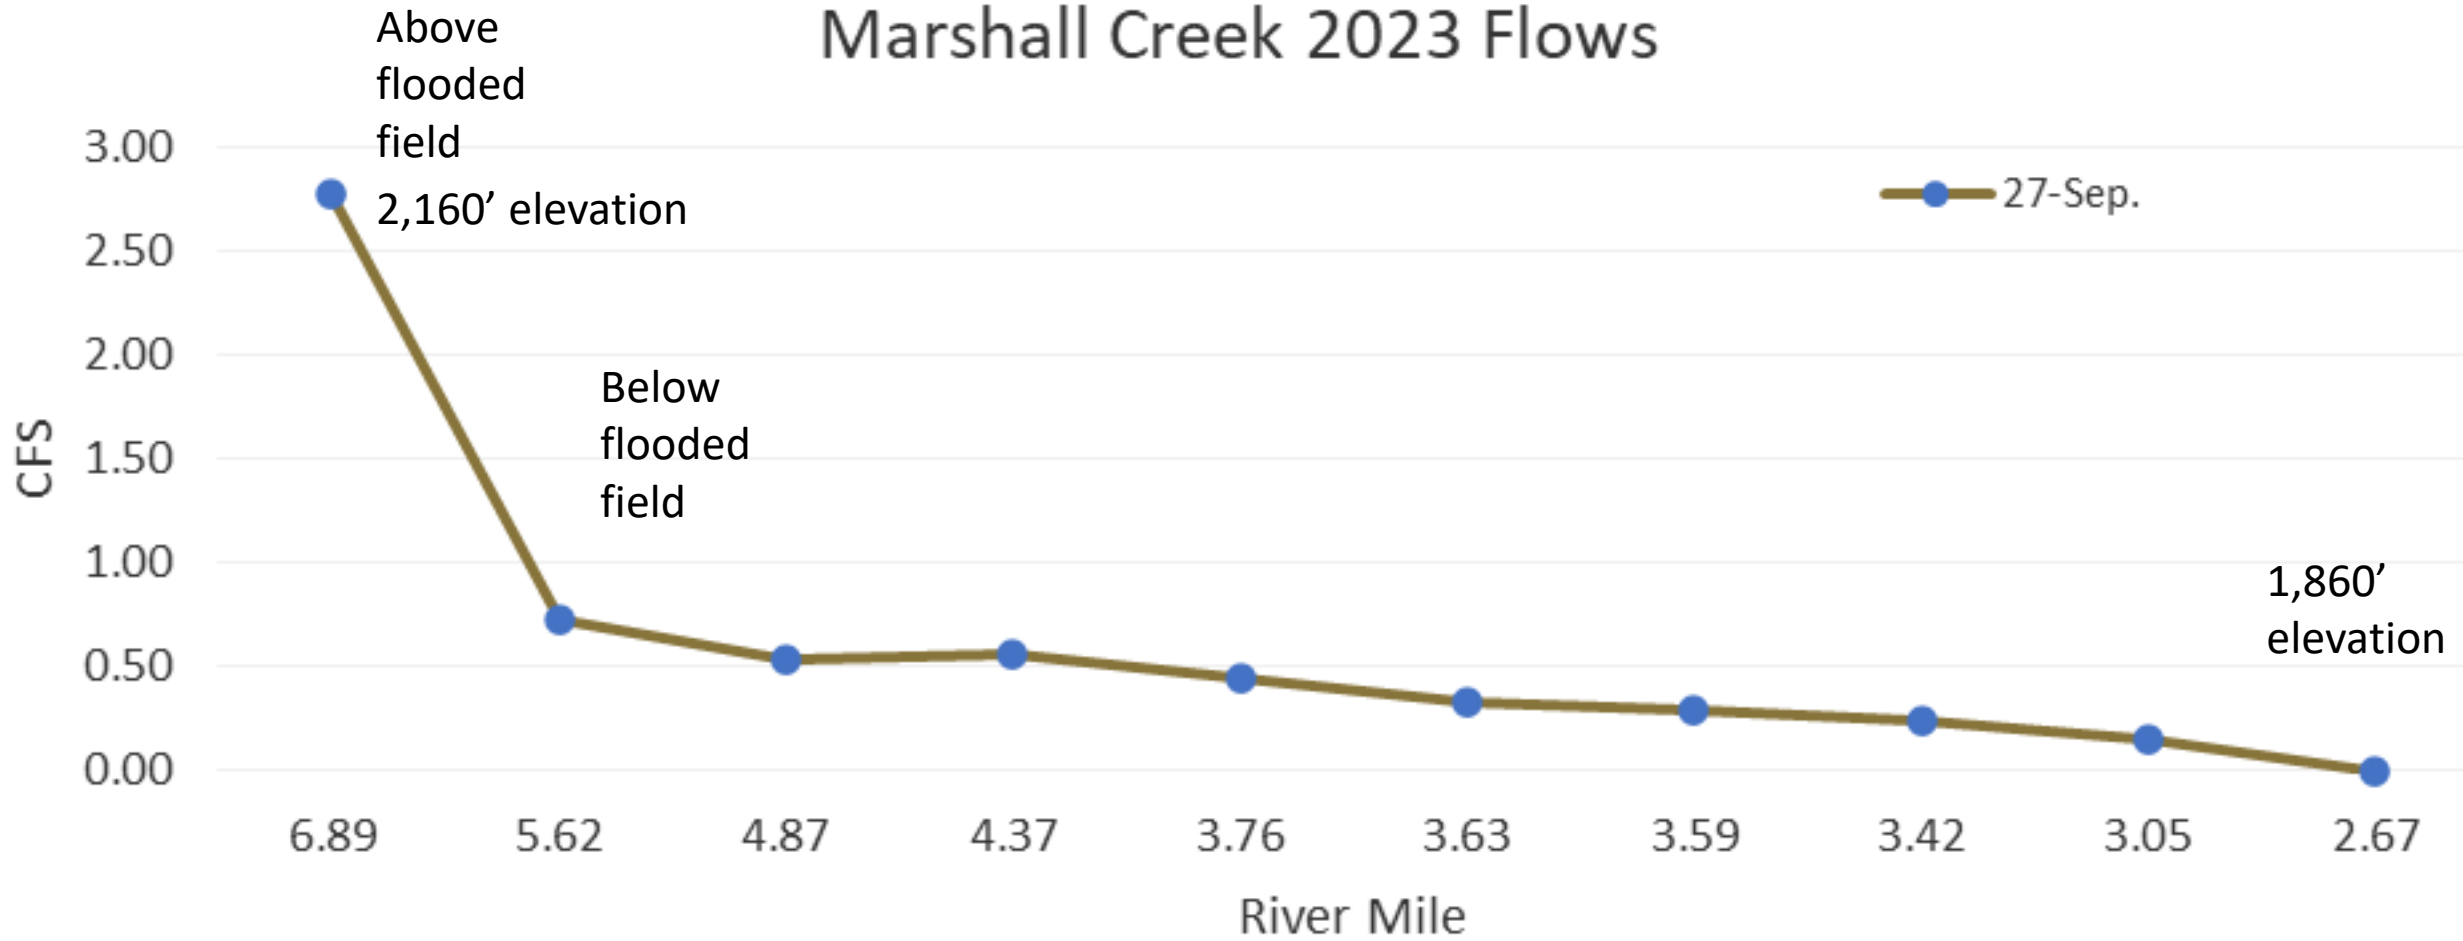
Marshall Creek 2023 Flows

**W. Marshall Creek Lane to Hangman Creek confluence is approx. 360' difference in elevation

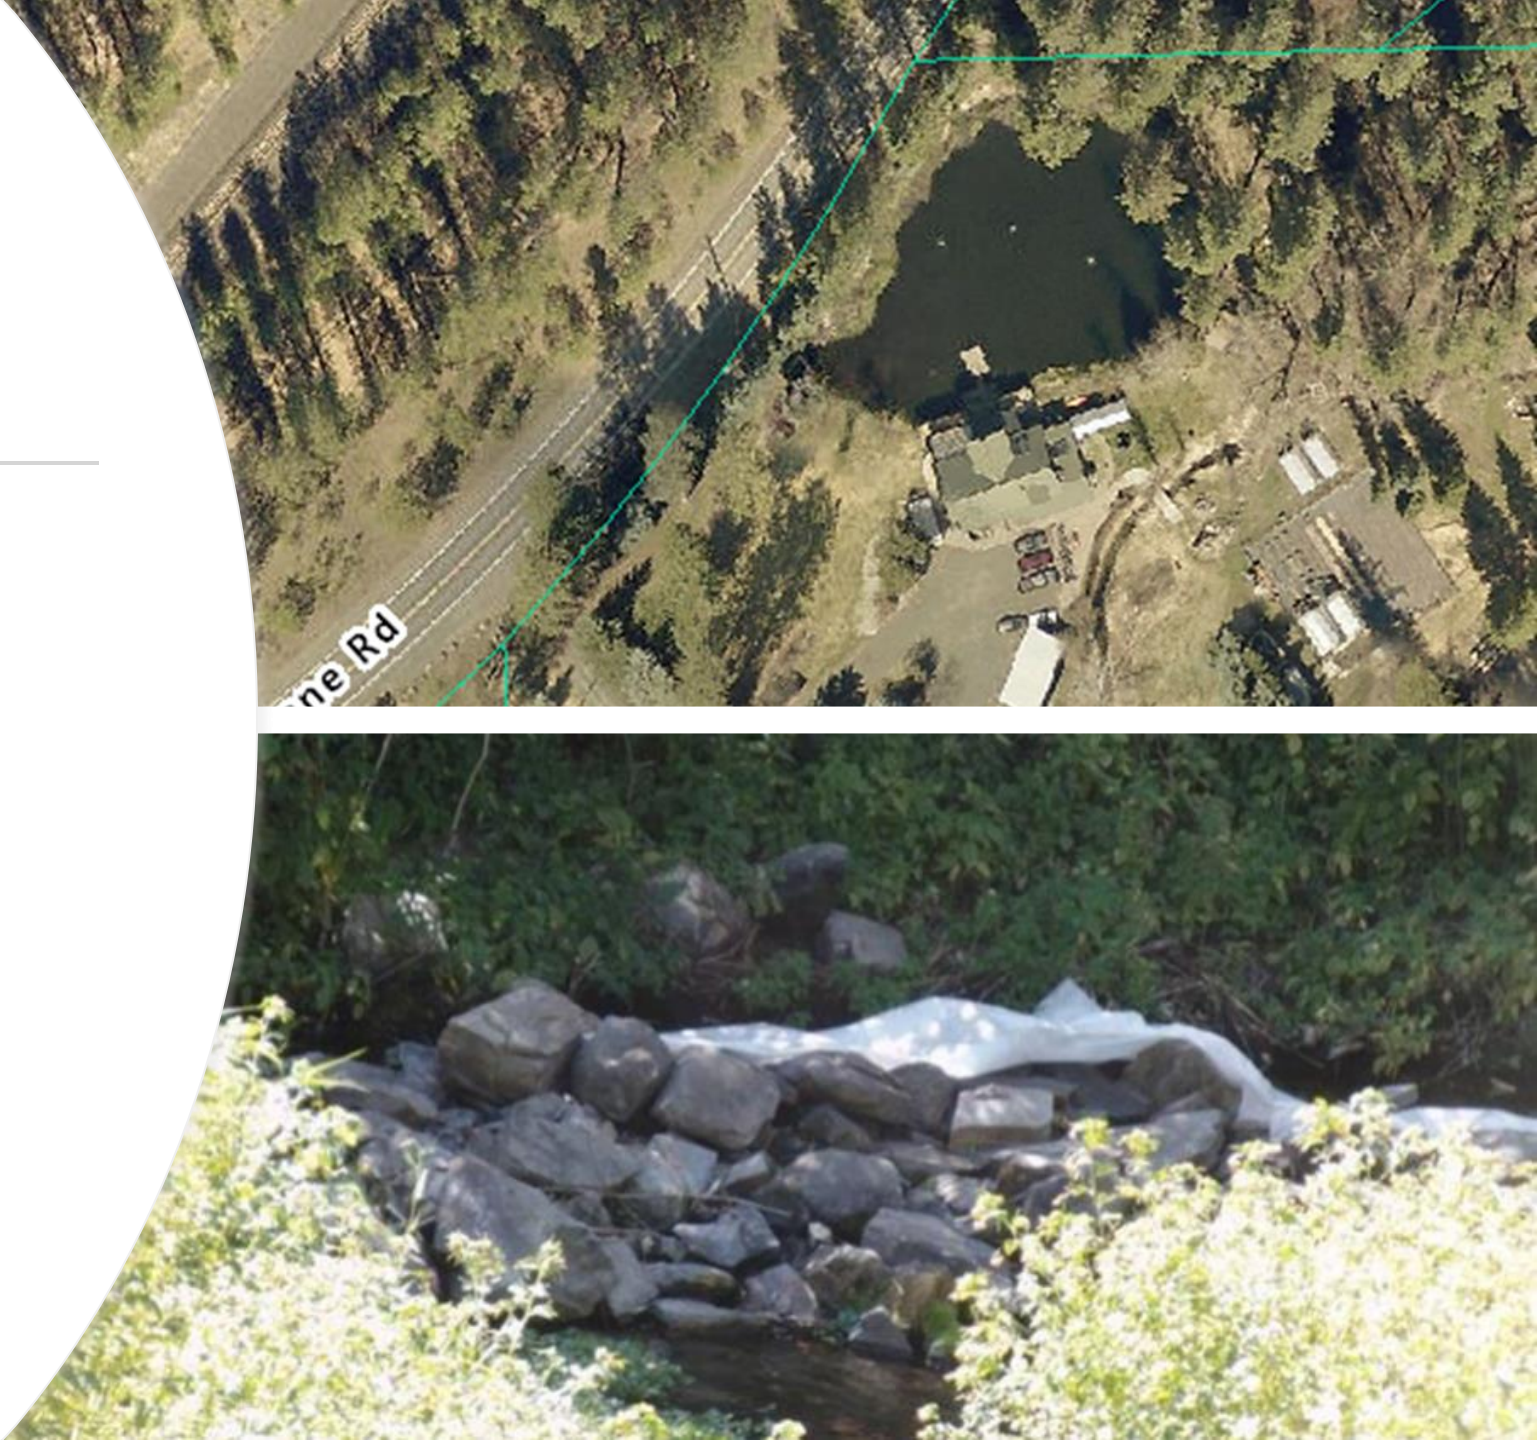
Marshall Creek Diversions, Dams, and Ponds

- 4 Ponds (up to .5 ac)
- 4 diversions (rock)
- 1 other dam

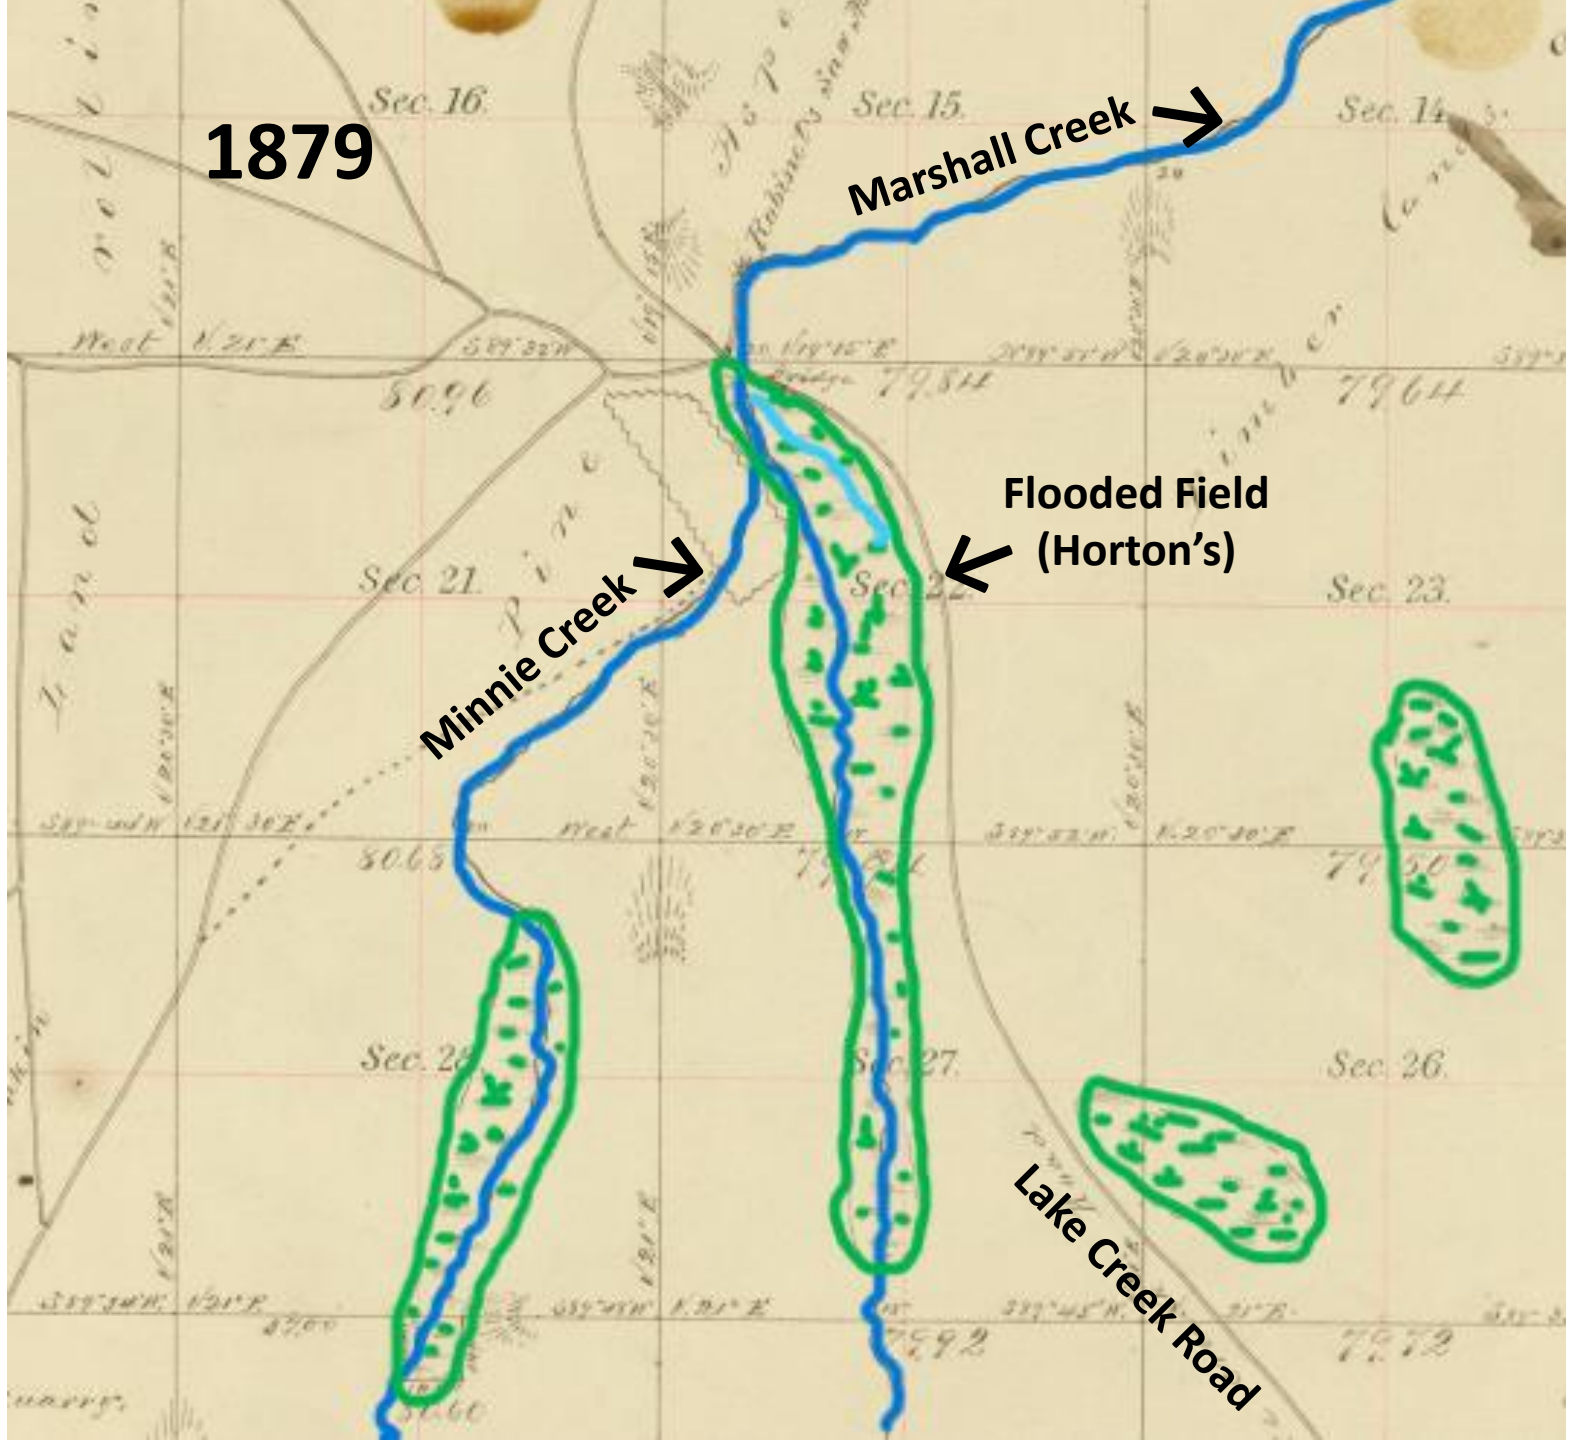
Marshall Creek →

→ Minnie Creek

← Flooded Field (Horton's)

Lake Creek Road
