Manual for motor cable connector refitting

CUS-Z5-0423-01- Motor cable refitting - VB

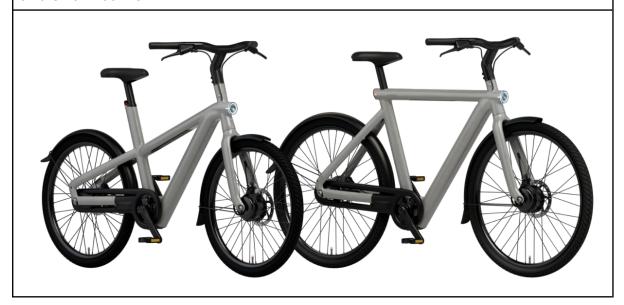
In this manual, we will check the motor cable connector and ensure it is properly connected to the Smartunit Main ECU. Underneath the top tube of the bike, you will find the Smartunit Main ECU. This is basically the computer of the bike. There are multiple components connected to the Smartunit Main ECU, including the motor cable. For this manual, we used the VanMoof S5 as an example, but the procedure is the same on the Vanmoof A5

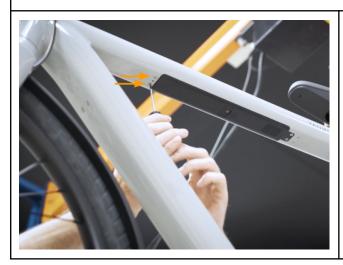
Let's start with removing the 2, silver-colored, screws that are mounted through the frame and into the front end of the Smartunit Main ECU.

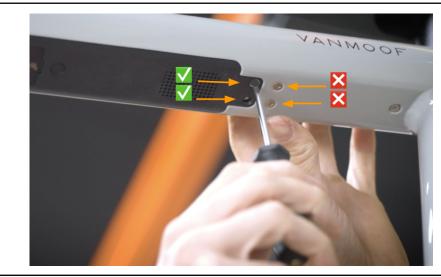
Next, unscrew the 2 **black** screws at the rear end of the Smartunit Main ECU. **!! Do not** remove the 2 other, silver-colored, screws next to it.

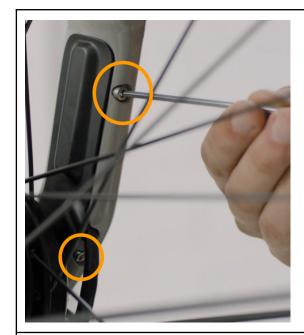
Remove the motor cable cover from the front fork, by unscrewing the 2 screws. Use Allen key #3 for these.

Keep the motor cable connector connected, and push the connector up into the front fork as shown in the picture.

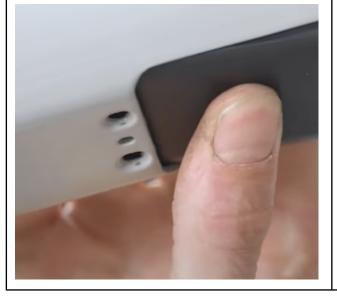
Now push the front end of the Smartunit Main ECU upwards and slide it into the frame, 1 cm beyond its mounting point.

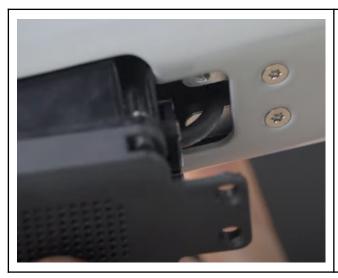
This way you can push the rear end of the Smartunit Main ECU all the way up.

Ensure the backlight cable goes through the recess in the mounting bracket. And hold the Smartunit Main ECU in position.

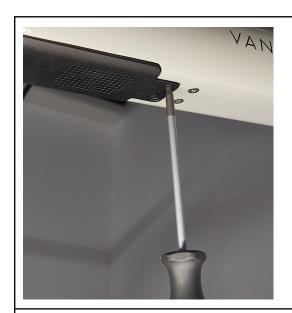
Attach the Smartunit Main ECU with the 4 screws.

Start with the 2 black screws at the back of the Smartunit Main ECU.

Tighten them to 0.45Nm

Followed by the 2 at the front end of the Smartunit Main ECU.

Tighten these also to 0.45Nm

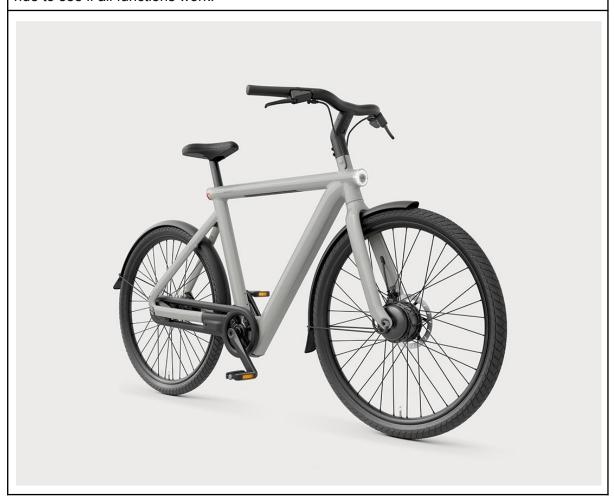
Place back the motor cable cover and tighten both screws with an Allen Key #3.

You have now successfully refitted the motor cable. Great job. Now you can go for a test ride to see if all functions work.
