NATURES COMPOSITES ACOUSTICAL PERFORMANCE TEST REPORT

ASTM E90 SOUND TRANSMISSION LOSS TESTING ON AN NCterra, PRIVACY FENCE ASSEMBLY

Q6284.01-113-11-R0

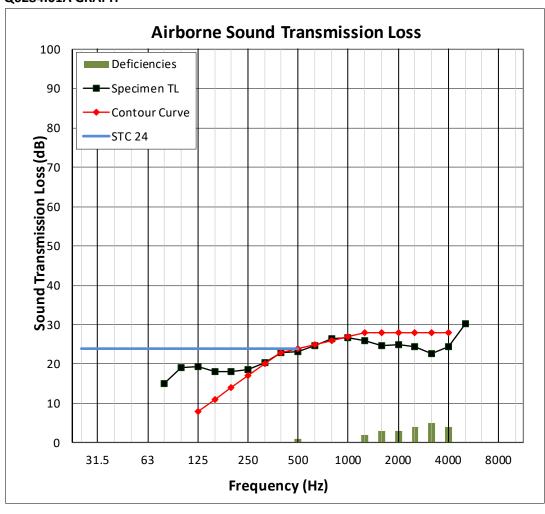
Q6284.01A GRAPH

FREQ	BACKGROUND	ABSORPTION	SOURCE	RECEIVE	SPECIMEN	95%	NUMBER
	SPL		SPL	SPL	TL	SAMPLING	OF
(Hz)	(dB)	(m²)	(dB)	(dB)	(dB)	LIMIT	DEFICIENCIES
80	41.0	7.4	104	86	15	2.14	-
100	32.2	7.1	107	84	19	1.48	-
125	37.2	6.7	107	85	19	1.28	0
160	40.0	6.2	109	88	18	0.90	0
200	37.5	6.7	108	87	18	1.00	0
250	32.3	7.0	105	83	18	0.63	0
315	29.9	6.3	105	82	20	0.42	0
400	28.6	6.0	105	79	23	0.40	0
500	27.1	6.1	104	78	23	0.32	1
630	25.6	6.3	103	75	25	0.40	0
800	26.2	6.6	102	73	27	0.21	0
1000	25.4	6.6	104	74	27	0.18	0
1250	26.6	7.0	103	73	26	0.37	2
1600	21.6	7.5	100	72	25	0.19	3
2000	12.0	7.9	102	73	25	0.22	3
2500	8.1	9.2	103	74	24	0.26	4
3150	7.5	11.0	101	73	23	0.24	5
4000	8.2	13.5	99	68	24	0.37	4
5000	8.9	16.8	99	62	30	0.42	-
STC RATIN	iG	24	(Sound Transmission Class)				
DEFICIENC	CIES	22	(Sum of Deficiencies)				
OITC RATI	NG	22	(Outdoor-Indoor Transmission Class)

Transmission loss (TL) at each 1/3 octave frequency is the average source room sound pressure level minus the average receive room sound pressure level, plus, 10 times the log of the specimen area divided by the sound absorption of the receive room with the sample in place.

To obtain the Sound Transmission Class (STC), read the TL of the contour curve at 500 Hz. The sum of the deficiencies below the contour curve must not exceed 32. The maximum deficiency at any one frequency must not exceed 8.

The Outdoor-Indoor Transmission Class (OITC) is calculated by subtracting the logarithmic summation of the TL values from the logarithmic summation of the A-weighted transportation noise spectrum stated in ASTM E1332.

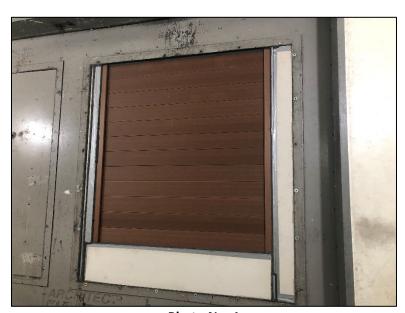
Photo No. 1
Receive Room View of Installed Test Specimen

Each picket measured 66-13/16" wide by 6-5/16" high by 7/8" thick. The pickets were semi-hollow, each with a tongue and groove. The pickets were stacked horizontally between two solid composite C-posts that measured 2-1/2" by 2-1/2" by 72" high.
