VEHICLE CONTROL ARM LOAD TEST REPORT

Customer¹	Munji 4x4 Accessories Pty Ltd as trustee for The McLeod Family
Customer Address¹	4/27 Motorway Circuit, Ormeau, QLD, 4208
Requested By¹	Jared McLeod
Purchase Order¹	–
Issuing Laboratory	MechTest - Brisbane Laboratory
Report Number	RB23-9393-03
Job Description¹	Client requirements – Load each sample till failure, record peak load achieved
Identification	SB23-9393-03-01 through 03
Material Specification¹	SB23-9393-03-01 & 02 – Aluminium – Not further specified SB23-9393-03-03 – Steel – Not further specified
Test Specification¹	Client requirements – Load the test items to failure, record peak load achieved.
Test Results	Information only

RB23-9393-03 Vehicle Control Arm Load Testing Report, Page 1 of 11

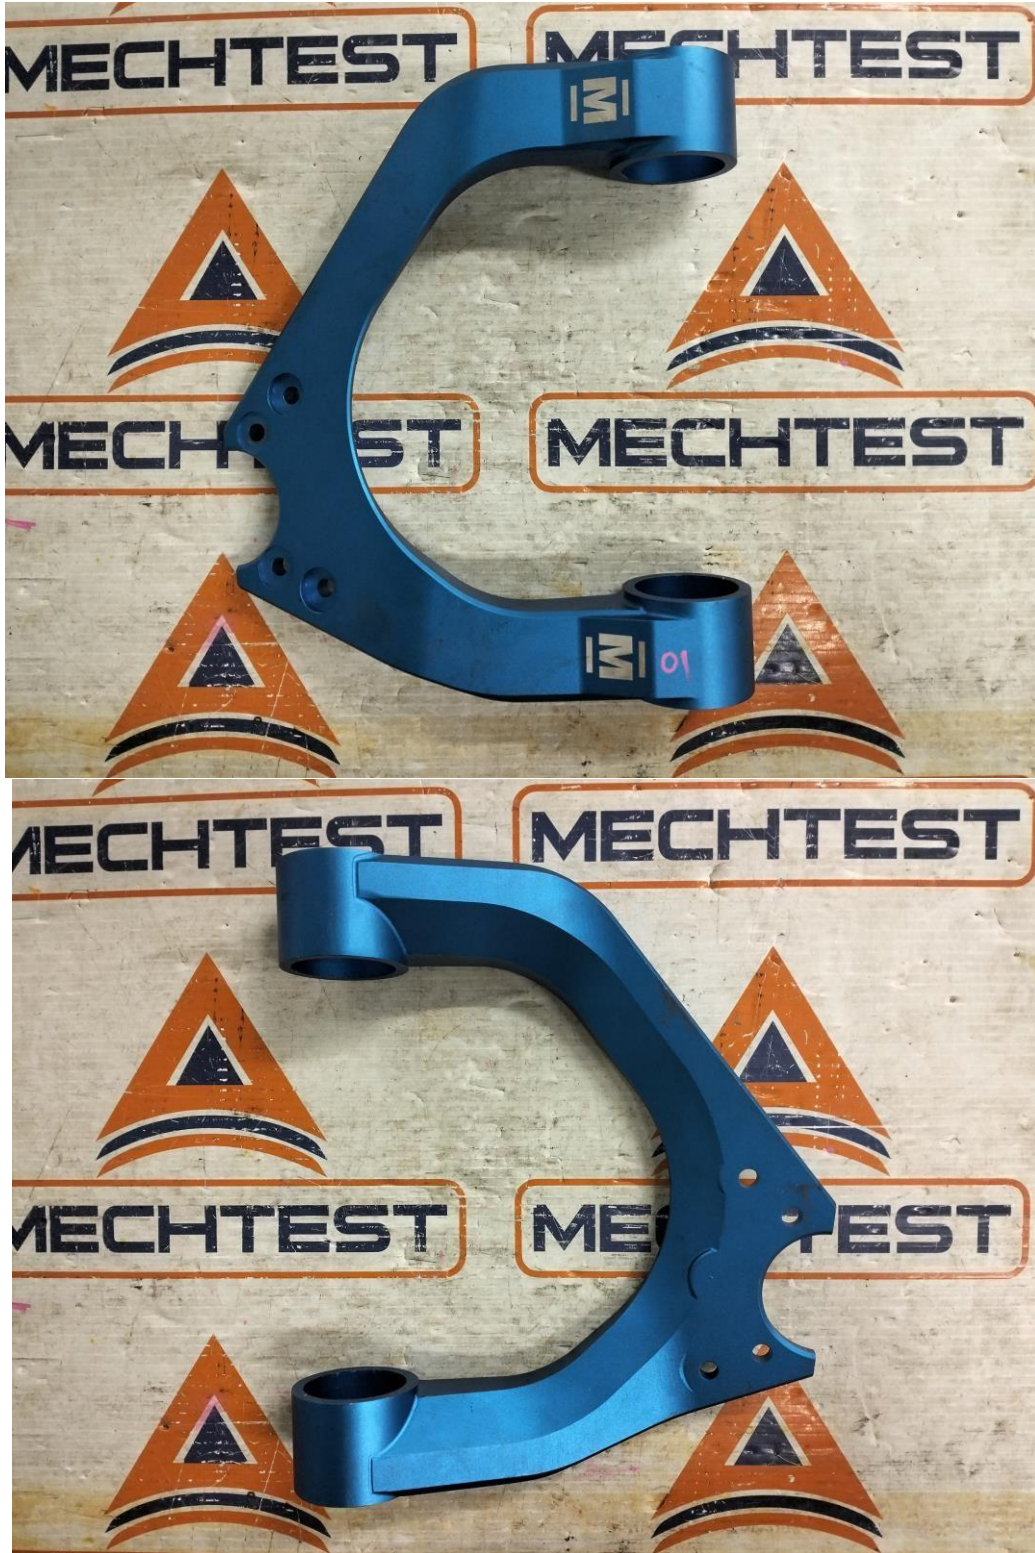
Figure 1: View of test item 01.

Type of Component	Upgraded Munji vehicle suspension control arm
Manufacturer ID	I-S4-UCA
Item Material (if known)	Aluminium – Not further specified
Other Details	four M8 x 60 mm, grade 8.8 bolts used to transfer the load from the UTM to the test item

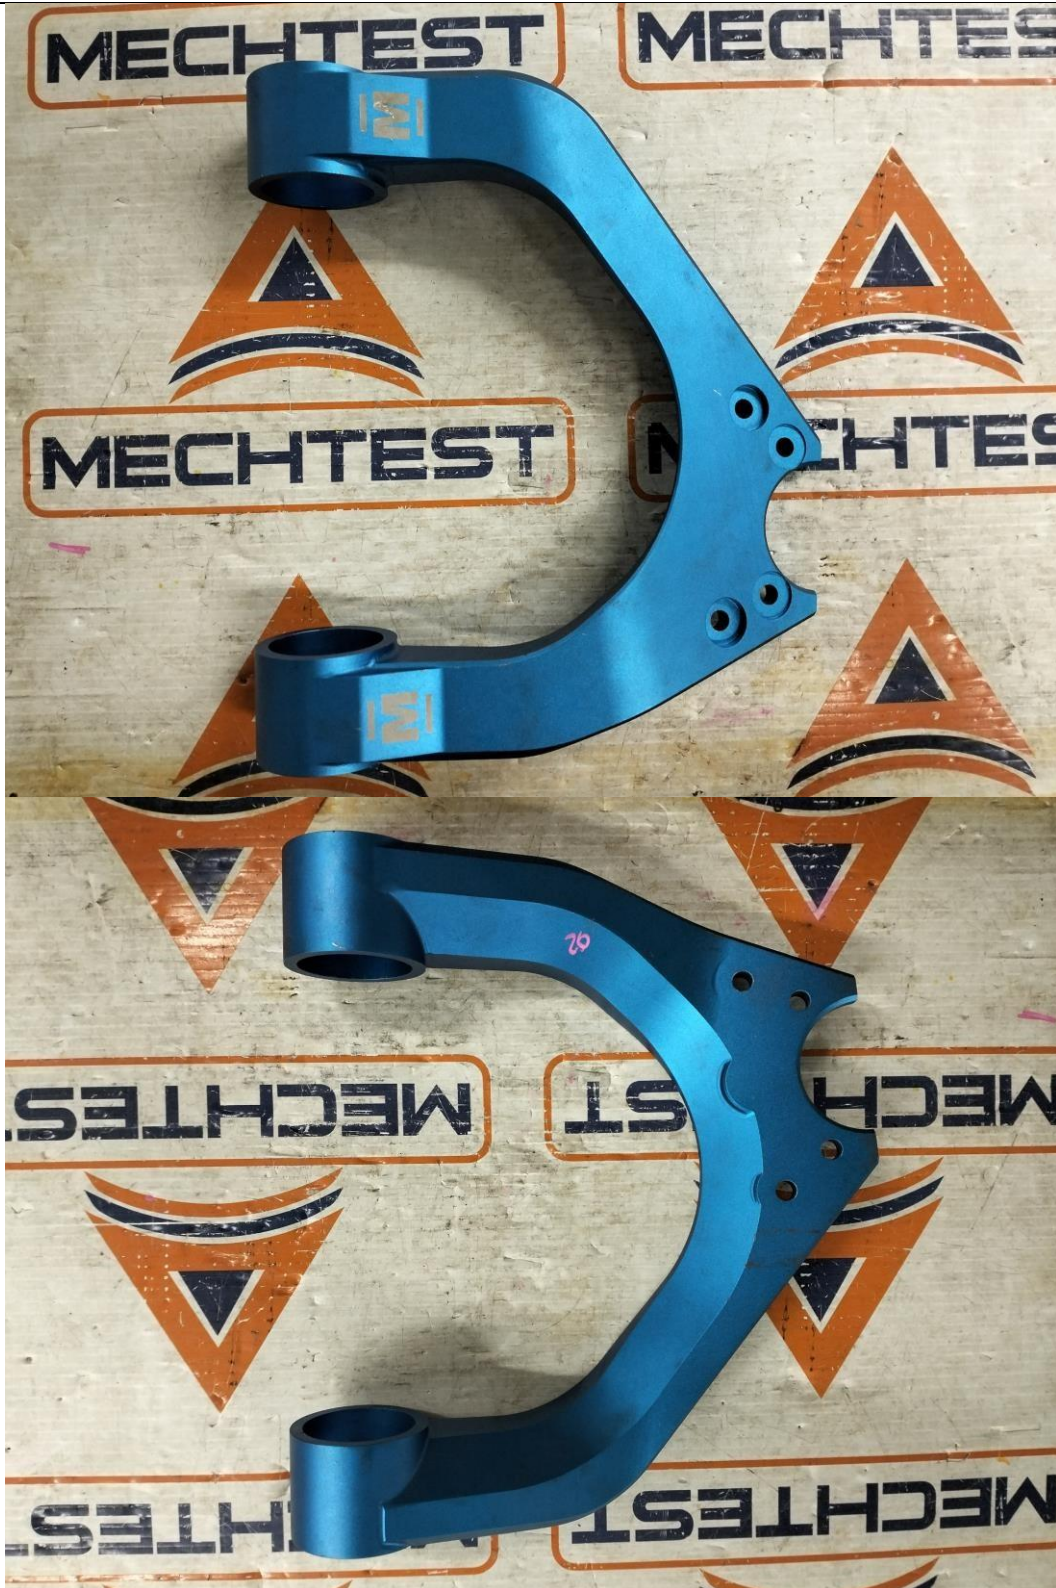
Figure 2: View of test item 02.

Type of Component	Upgraded Munji vehicle suspension control arm
Manufacturer ID	I-S4-UCA
Item Material (if known)	Aluminium – Not further specified
Other Details	four M8 x 60 mm, grade 8.8 bolts used to transfer the load from the UTM to the test item

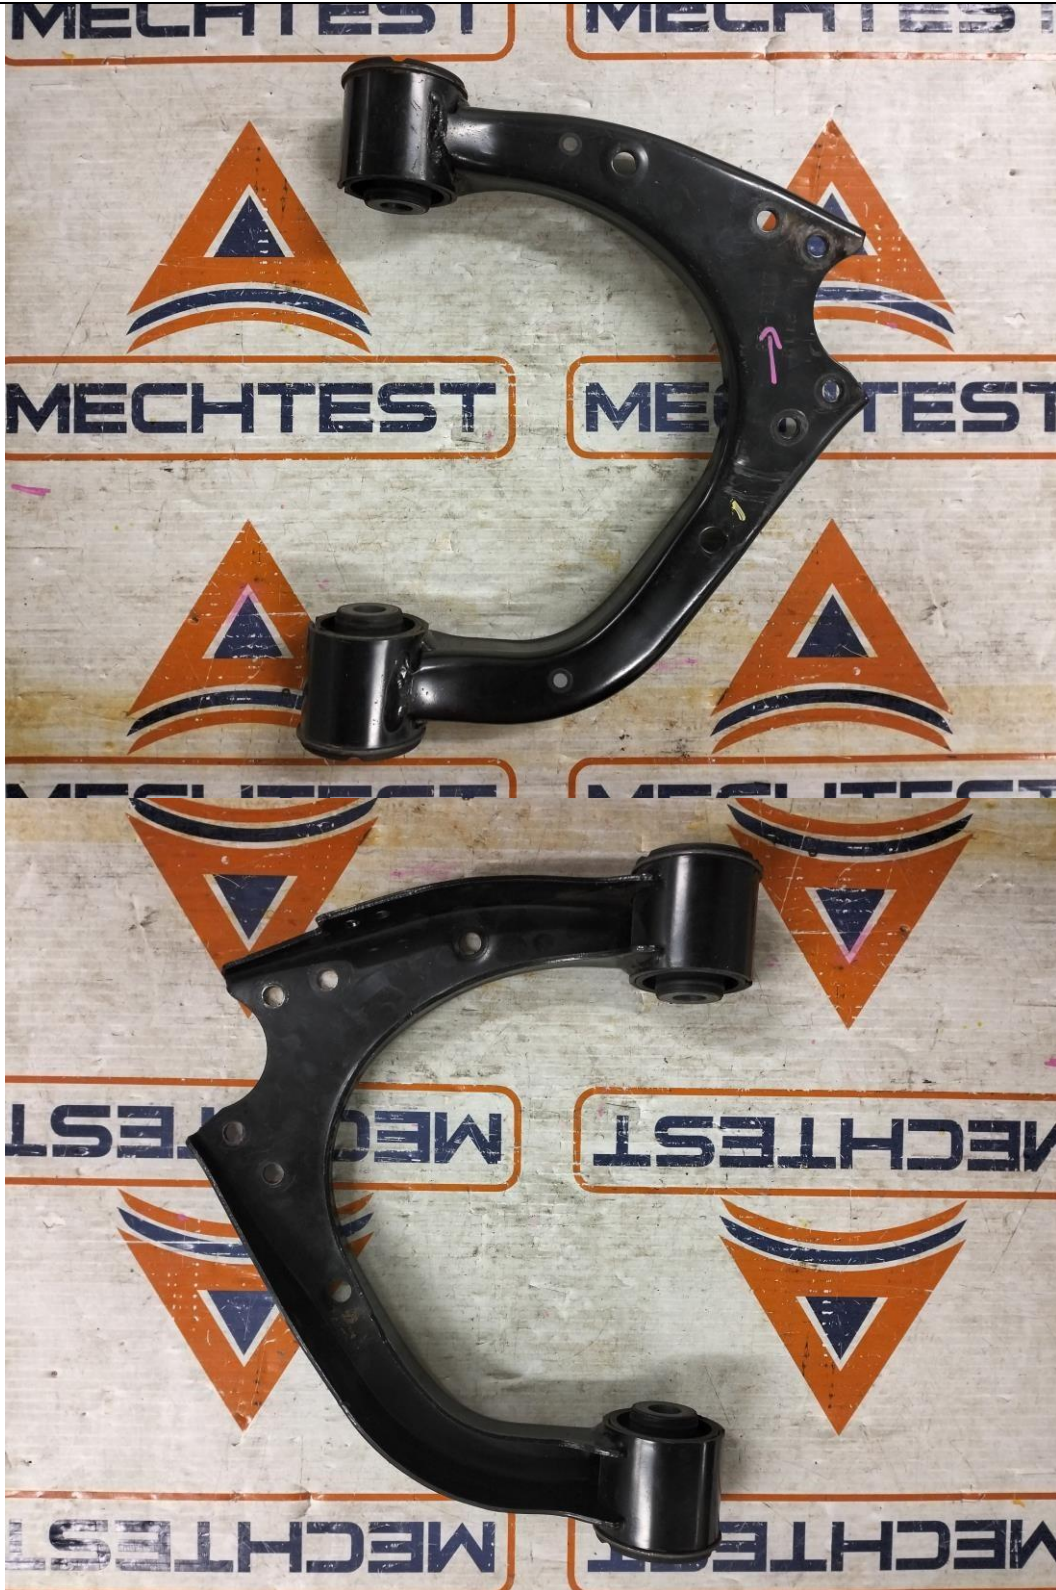
Figure 3: View of test item 03.

Type of Component	OEM vehicle suspension control arm
--------------------------	------------------------------------

Manufacturer ID	–
Item Material (if known)	Steel – Not further specified
Other Details	four M8 x 60 mm, grade 8.8 bolts used to transfer the load from the UTM to the test item

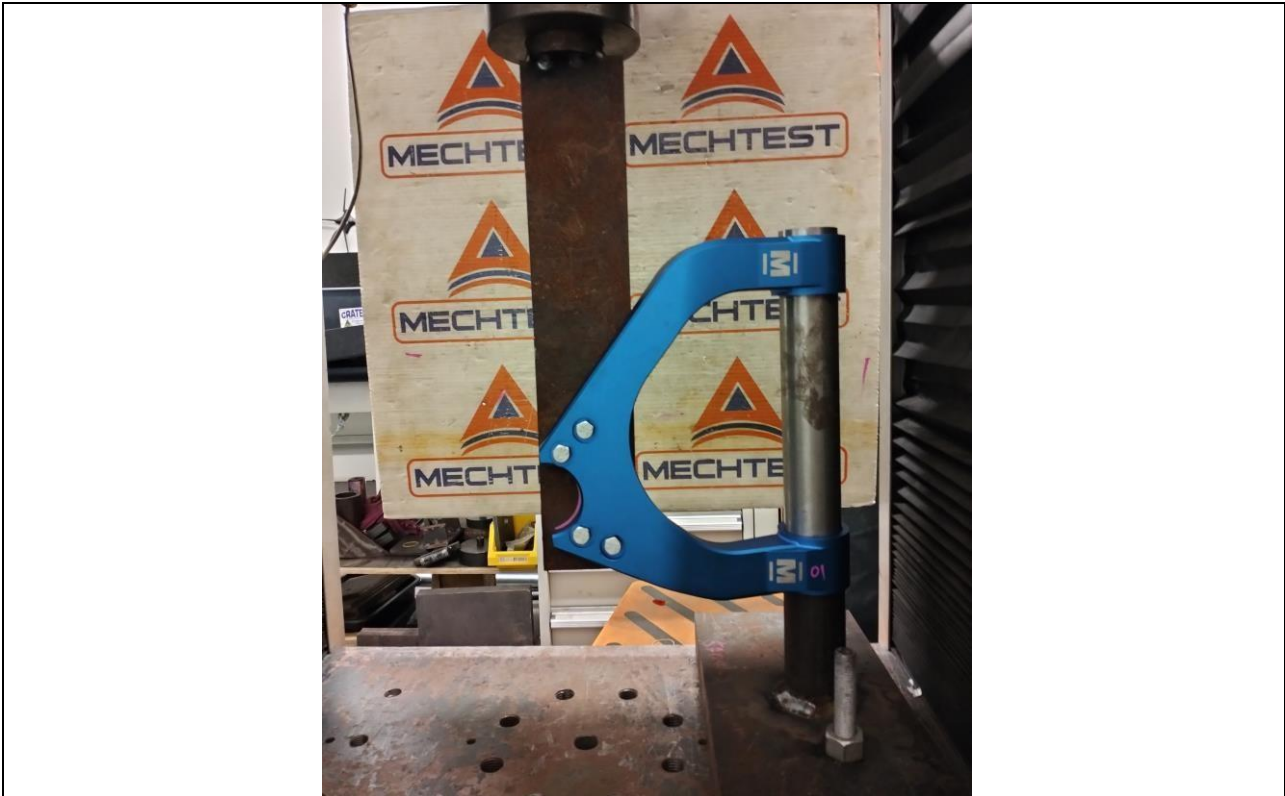
Figure 4: View of test arrangement for item 01.

Test Method	AMTS-04-06-01 & Client requirements: <ul style="list-style-type: none"> – Label each sample with a unique item number. – Position the sample into the jig so that the test item is supported through the bushing/cylinder and the load is applied perpendicular to the 4 holes on the other end of the sample. – Apply a gradual load to the test item till failure occurs. – Record the peak load achieved. – Release the load and inspect the sample for damage, deformation and failure modes.
Test Technician	Nikita Eshchenko
Job Location	MechTest – Brisbane
Test Date	26 July 2023
Loading Device	T00002 – 300 kN UTM

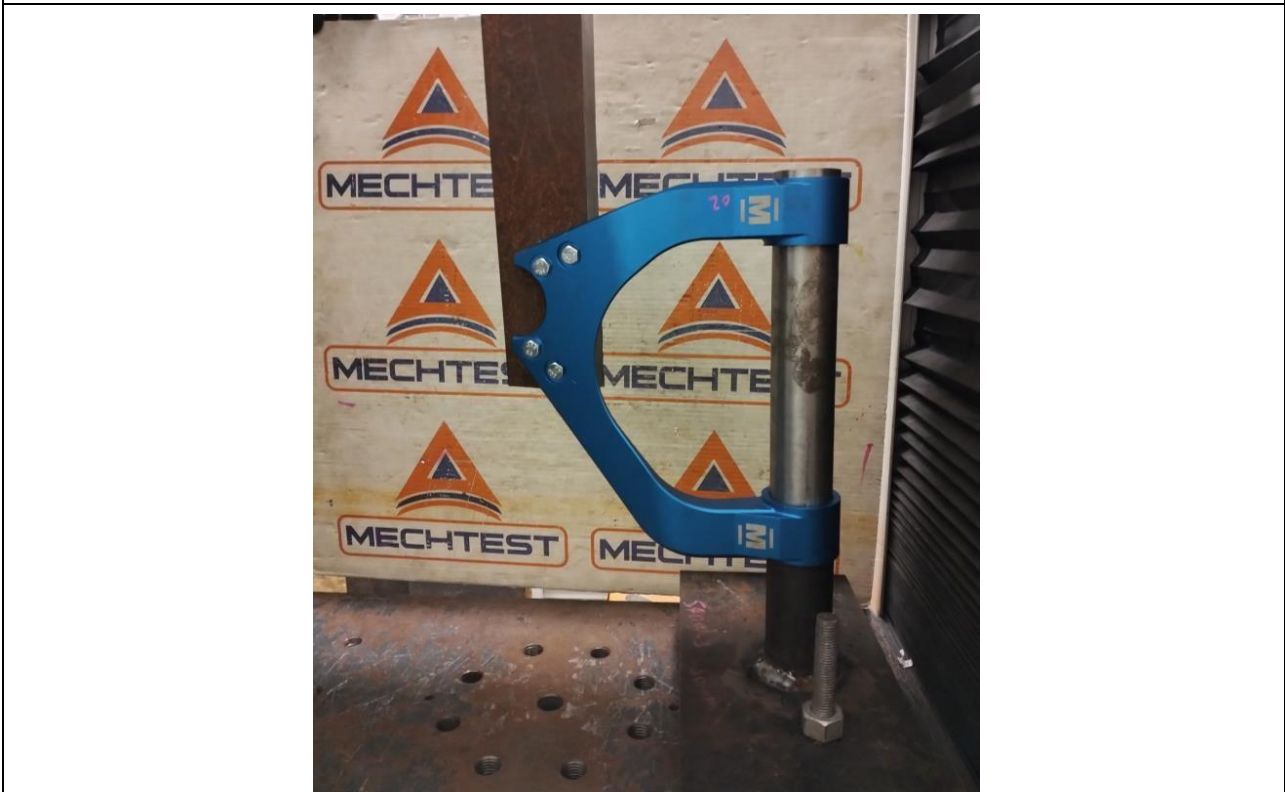
Figure 5: View of test arrangement for item 02.

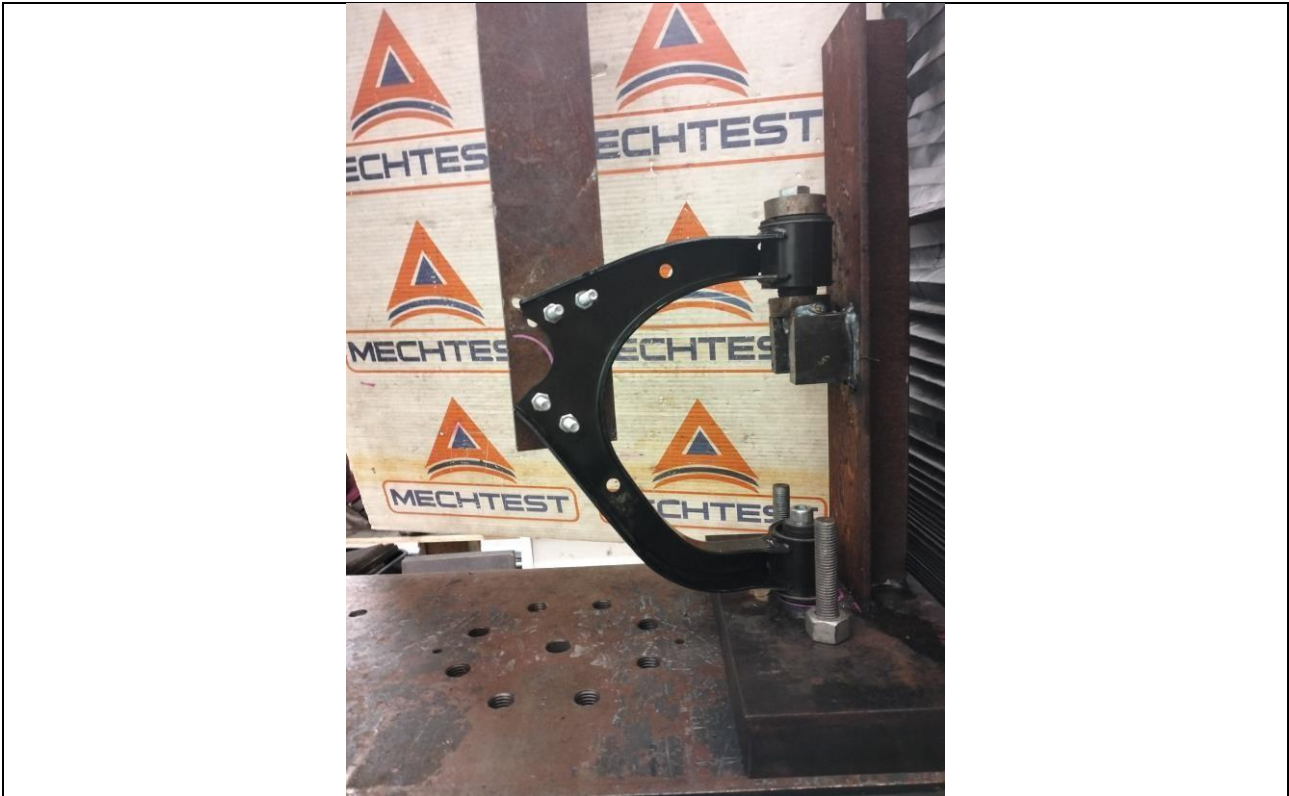
Figure 6: View of test arrangement for item 03.

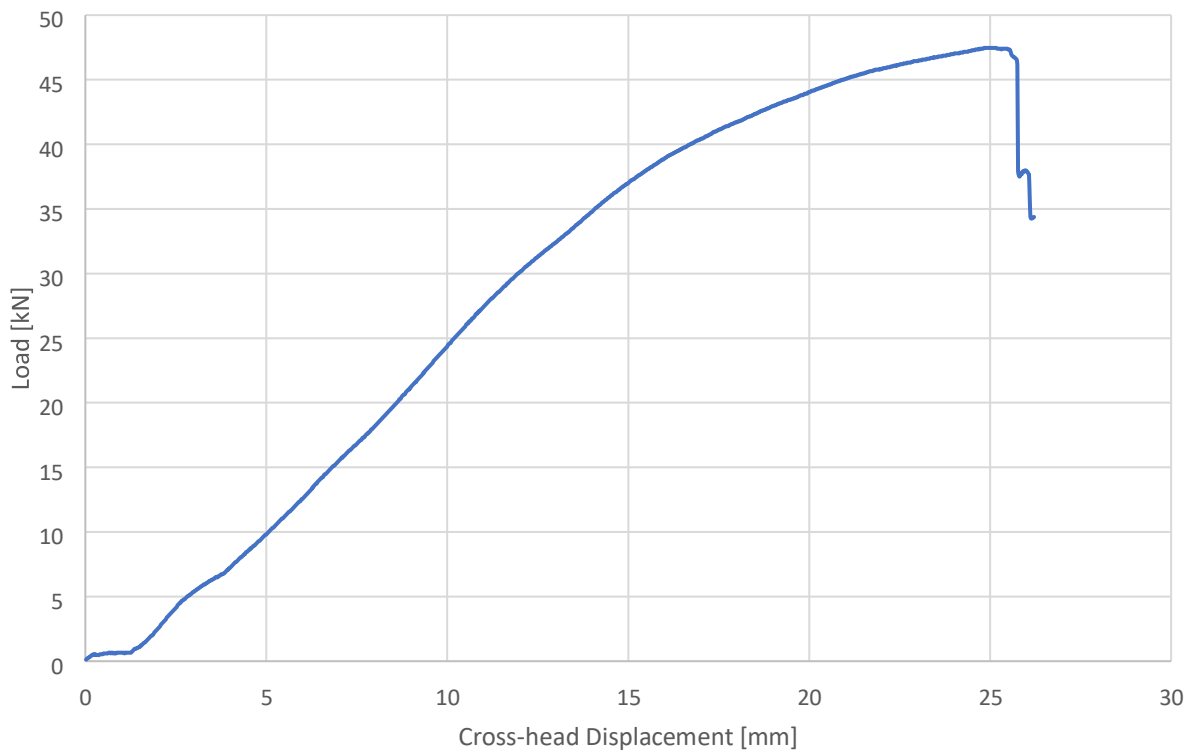
Figure 7: View of load vs cross-head displacement for sample 01.

Item	Peak Load [kN]	Comments
01	47.46	Failure occurred at the bottom bushing cylinder, cracking of material.
02	43.86	Failure occurred at the bottom bushing cylinder, cracking of material.
03	30.96	Test item deformed and begun to compact on itself at ≈ 23 kN.

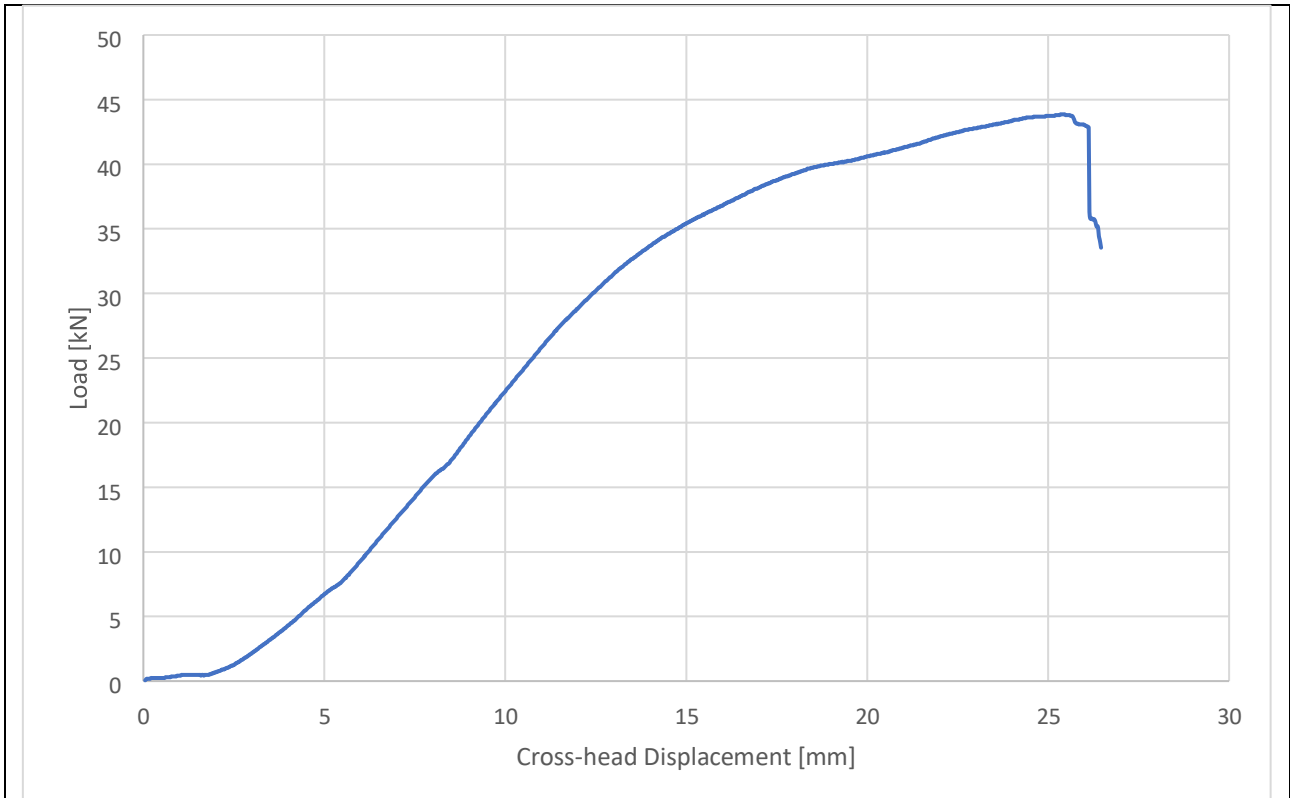
Figure 8: View of load vs cross-head displacement for sample 02.

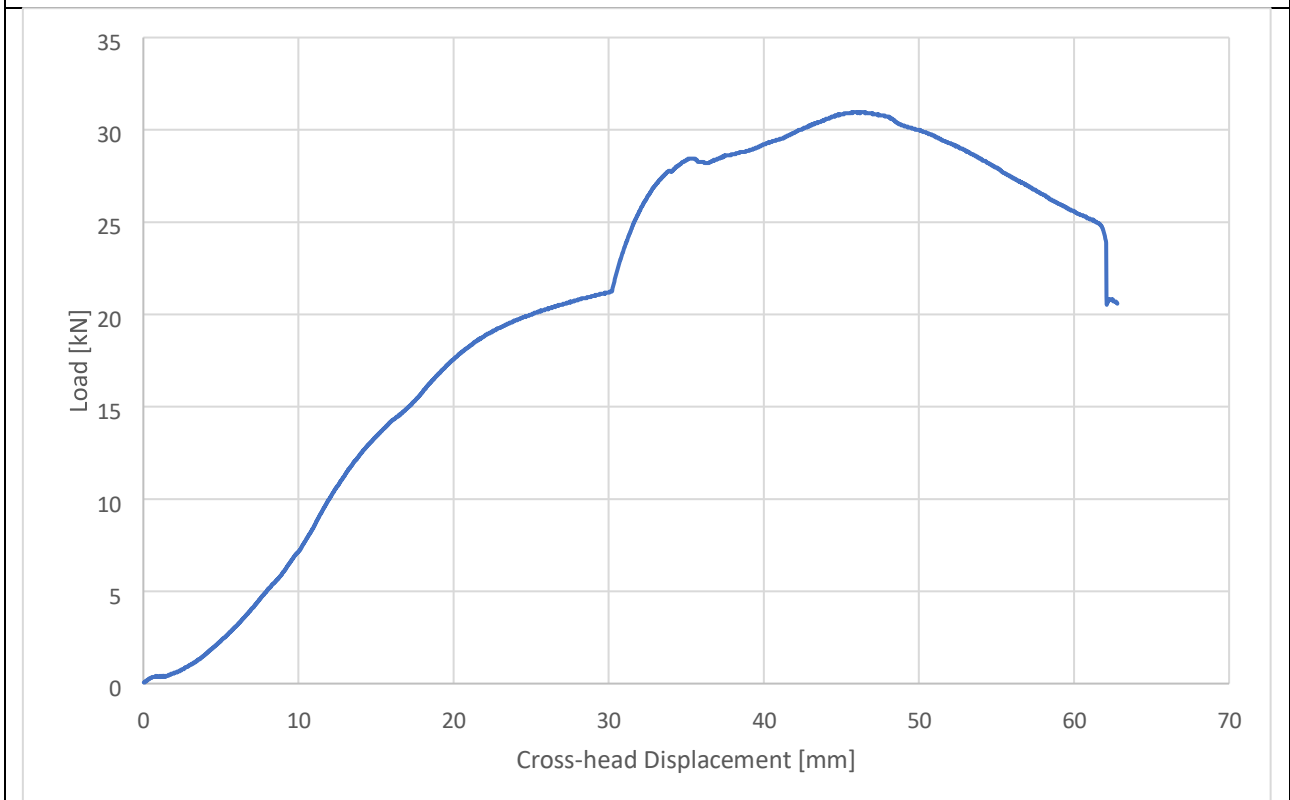
Figure 9: View of load vs cross-head displacement for sample 03.

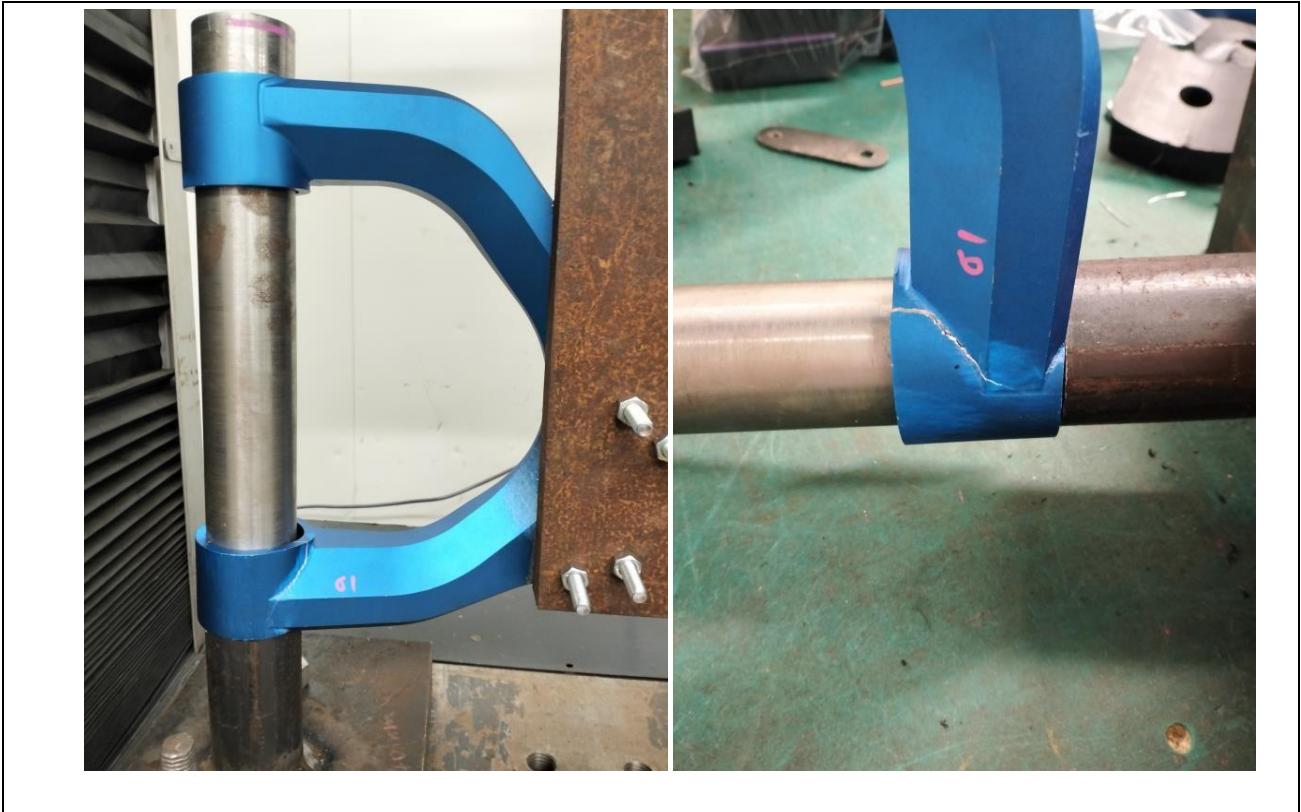
Figure 10: View of failure mode for sample 01.

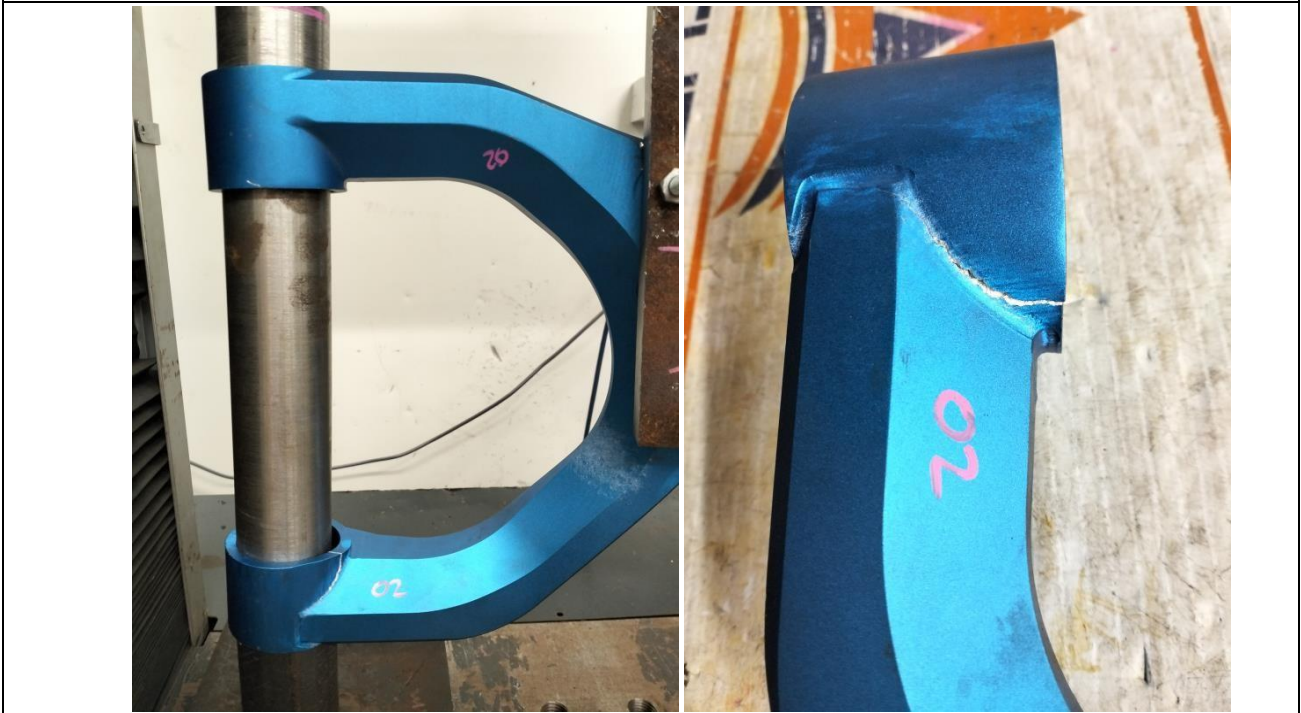
Figure 11: View of failure mode for sample 02.

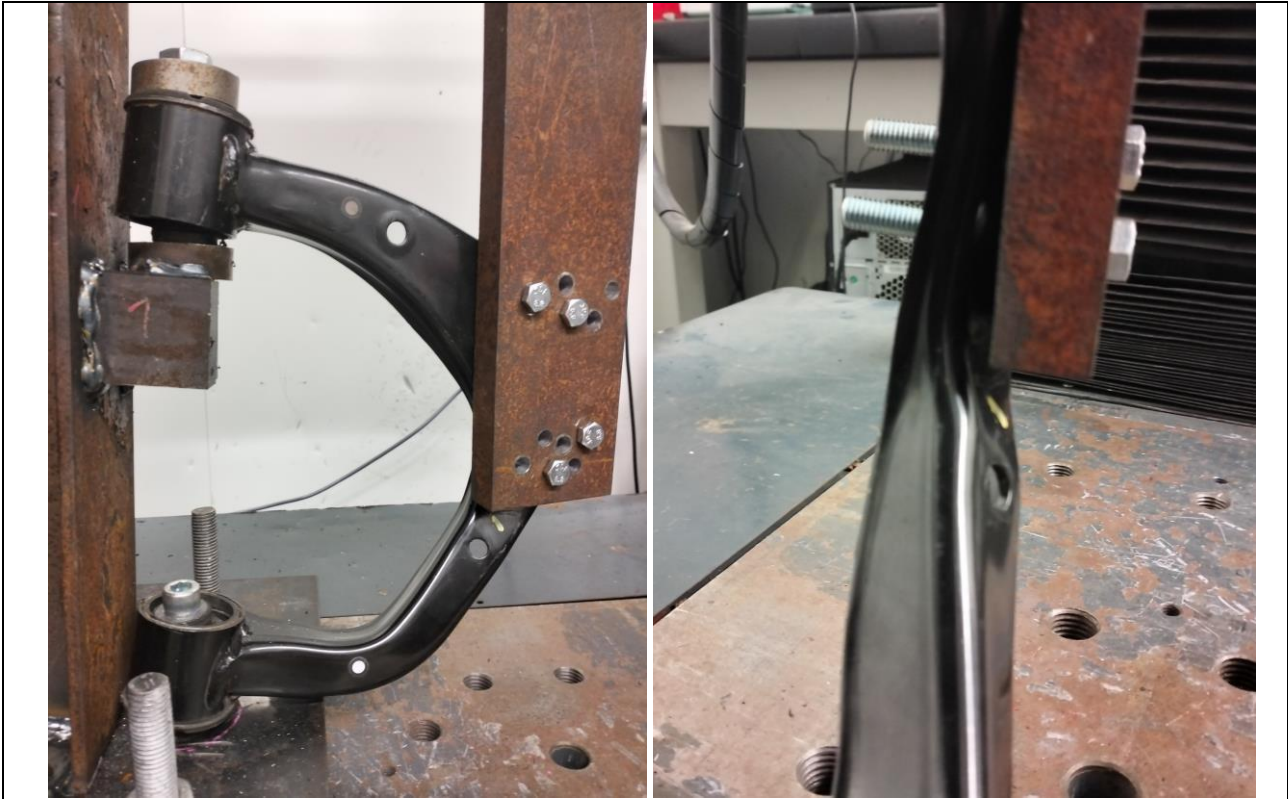
Figure 12: View of failure mode for sample 03.
